AGENCY 390: WASHINGTON STATE HISTORICAL SOCIETY  
BI23 CAPITAL BUDGET REQUEST

**390 - Washington State Historical Society  
Ten Year Capital Plan by Project Class  
2021-23 Biennium**

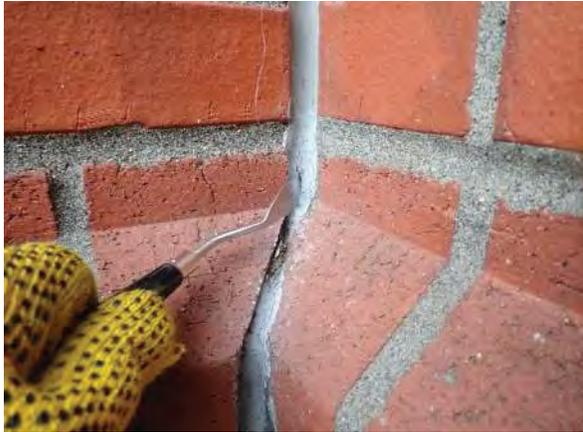
**Photo No. 44** - View of flat probe inserted into a cohesively failed sealant joint at brick masonry veneer inside corner expansion joint. This is a typical condition.

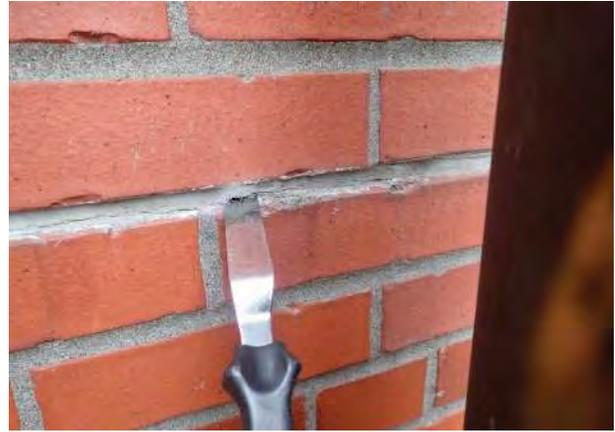
**Photo No. 45** - View of flat probe inserted into an adhesively failed sealant joint at brick masonry veneer floor-line joint. This is a typical condition.

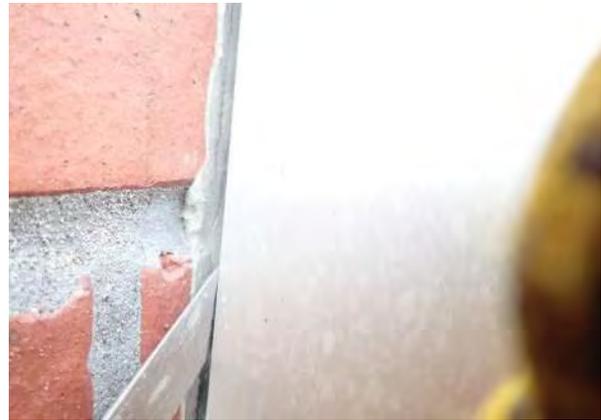
**Photo No. 47** - Depicts weathered, aged, and failing sealant at the brick masonry veneer-to-decorative archway aluminum panel intersection. Of note, the Project Record Drawings do not show a sealant joint at this location. It is possible the sealant may have been installed during the brick masonry cleaning and sealing project of 2002.

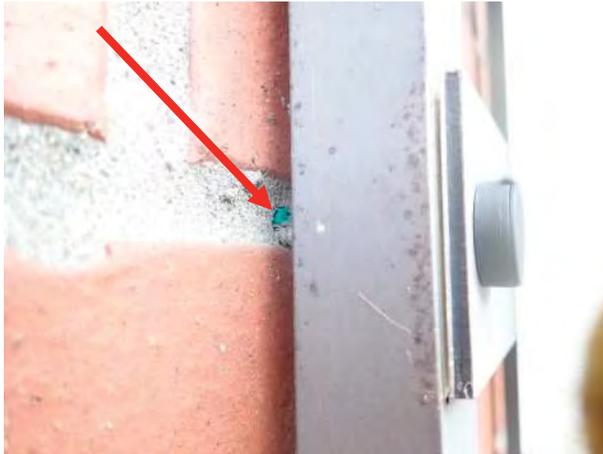
**Photo No. 48** - View of typical bolted connection at signage anchor for the Anthem Café is open to leakage and water migration in to the wall.

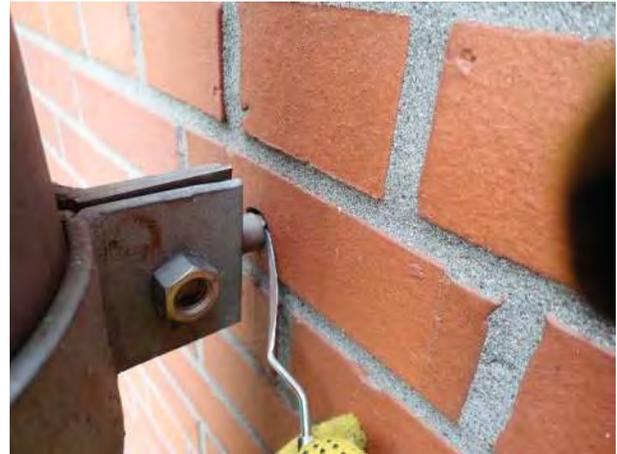
**Photo No. 49** - View of typical bracket sleeve connection for downspouts through the brick veneer that is unsealed and open to water leakage/migration.

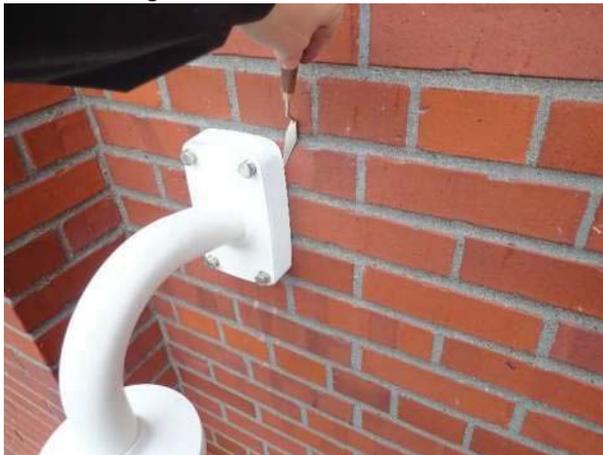
**Photo No. 50** - Depicts flat probe inserted behind light fixture base mount at brick veneer, which is open to water entry and leak water migration into wall system.

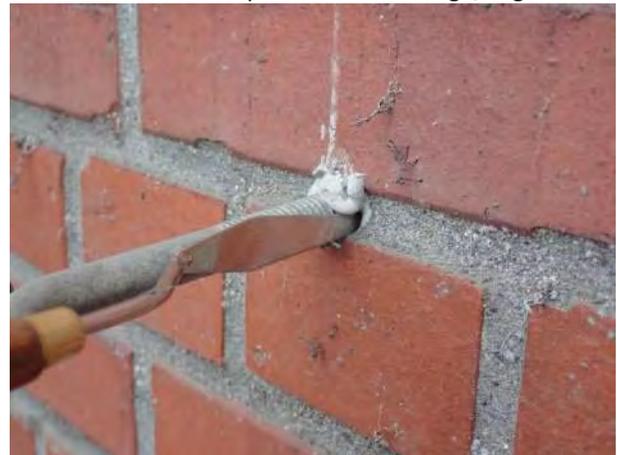
**Photo No. 51** - Depicts epoxy set eye-bolt locations through the brick veneer that are not fully sealed and are open to leakage and water migration into wall.

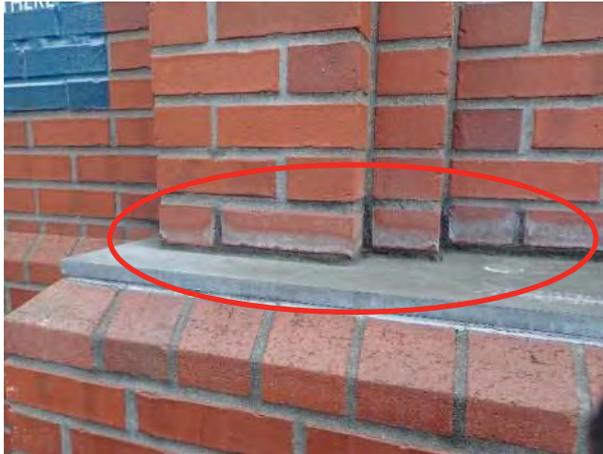
**Photo No. 52** - View of moisture-migration related staining at archway base locations at the West Elevation of the Museum above the steel base plates that do not have proper slope to drain.

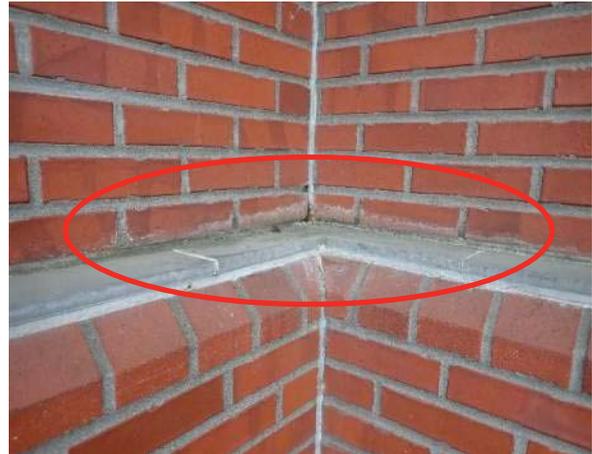
**Photo No. 53** - Another view of moisture-related staining at horizontal shelf, at the steel base plate, near the Main Entry at the North Elevation that appears to be holding/ponding and absorbing water.

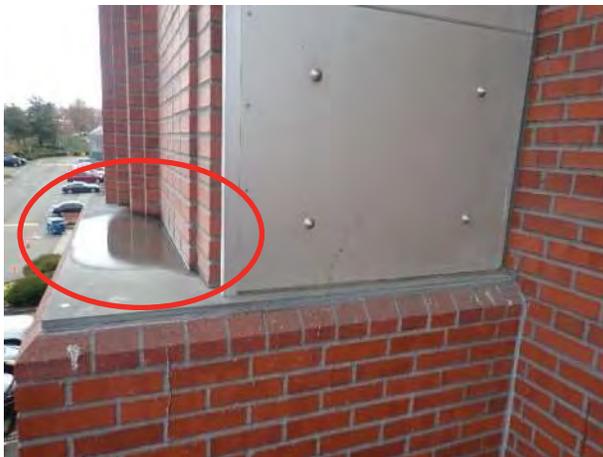
**Photo No. 54** - View of negative shelf slope and resultant pooling water discovered at steel plate archway bases contributing to the staining and moisture absorption issues at the brick masonry.

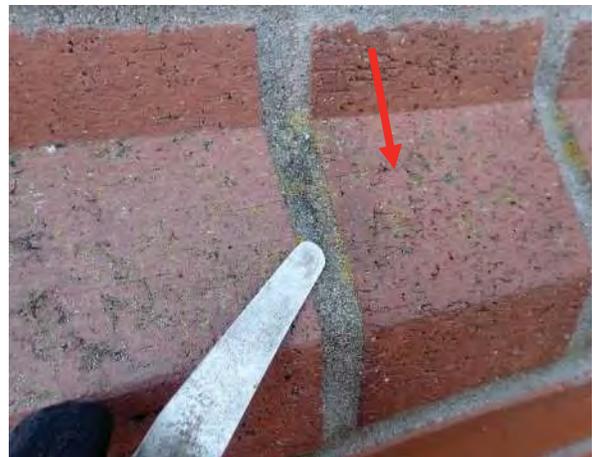
**Photo No. 55** - View of yellowish-green colored moss or lichen growing on the chamfered, skyward-facing rowlock course, indicating that numerous mortar joints are showing signs of weathering, and getting a bit porous, and capable of holding a bit of moisture in their slightly eroded surface, which are beginning to support some organic growth.

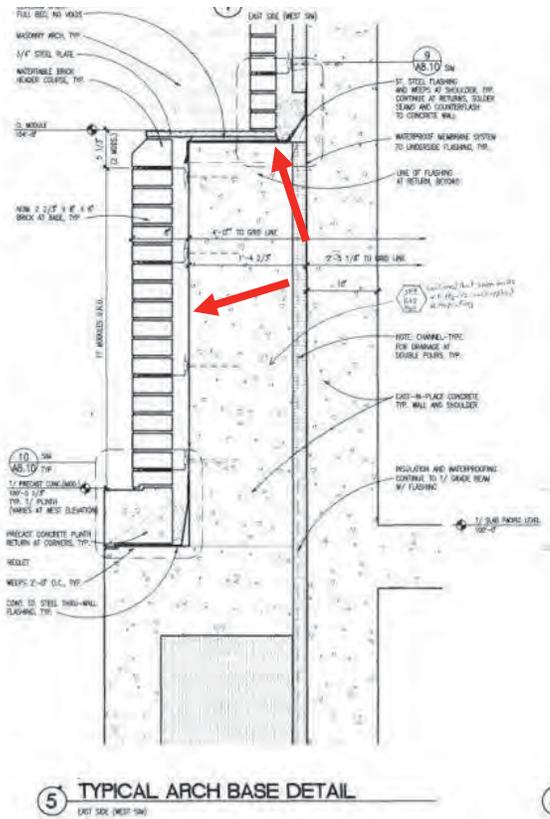
**Photo No. 57** - Project Record Detail A-8.4/5 and Transition at ¼-inch steel plate. The transition is depicted to be waterproofed under the steel plate. As such BET&R does not suggest the tops of the steel plates be waterproofed, even though water is pooling at these locations and staining the brick mortar joints and base of brick.

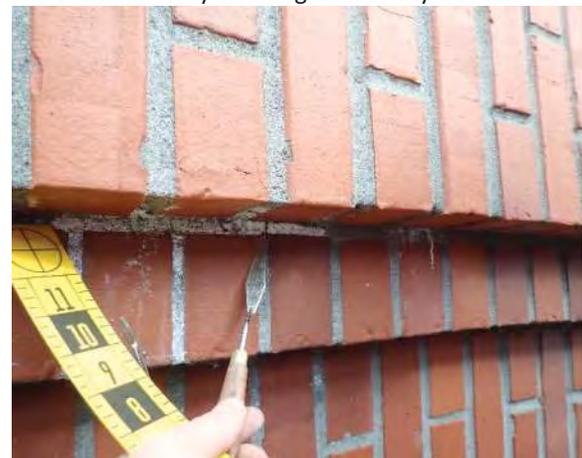
**Photo No. 58** - Closer view of relatively heavy efflorescence deposits along the underside of archway brick detail.

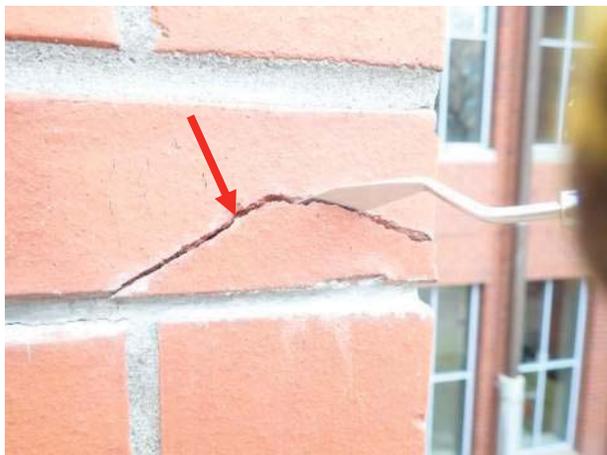
**Photo No. 59** - View of fractured brick unit discovered at the West Elevation of the Facility. This type of crack and resultant wide differential separation of the clay brick appears indicative of strain in the wall assembly or floor-line movement. It would be prudent to have a brick masonry-experienced structural engineer review this portion of the facility with BET&R, from the interior and exterior, so as to determine if there is more to a "repair" of the building than just to this isolated portion of the brick masonry veneer. Please see recommendation below for more information.

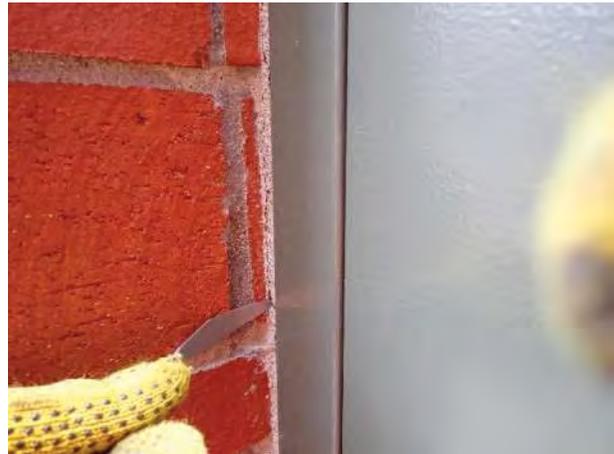
**Photo No. 62** - Close up view of cracked and fracturing mortar joint at jamb of HMD.

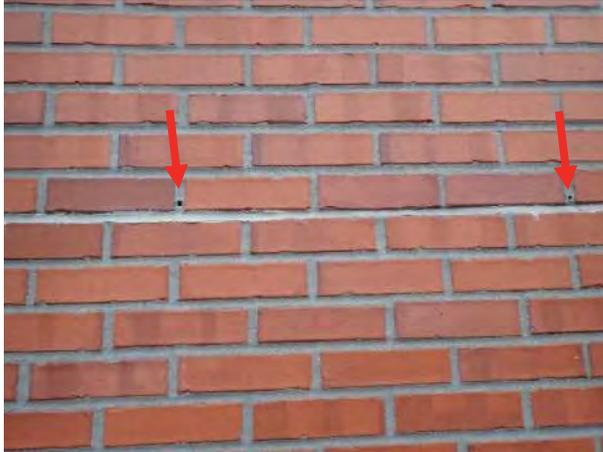
**Photo No. 63** - Overview photo of brick veneer weep tubes located approximately every three brick head joints. Many of the weep tubes observed are to be blocked.

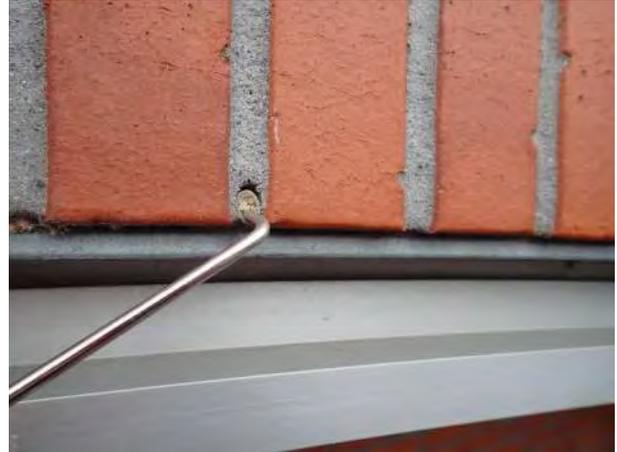
**Photo No. 64** - Close-up of plugged weep tube discovered at a brick archway. In areas, the numerous clogged weep tubes may be adding to the moisture absorption and resultant staining observed at portions of the brick veneer cladding.

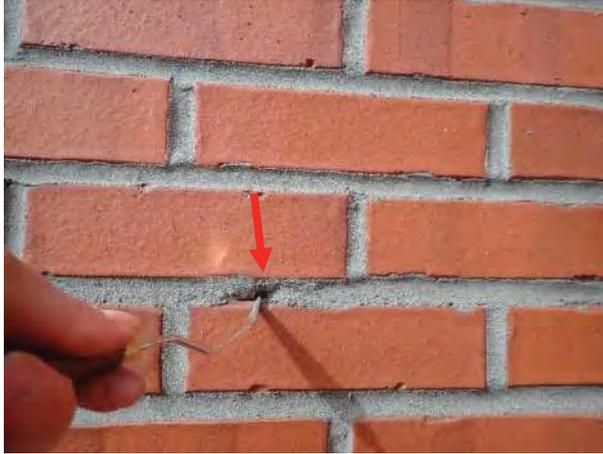
**Photo No. 65** - View of scaffolding tie-back, carelessly left embedded in mortar joint, and causing mortar spalling as the steel corrodes.

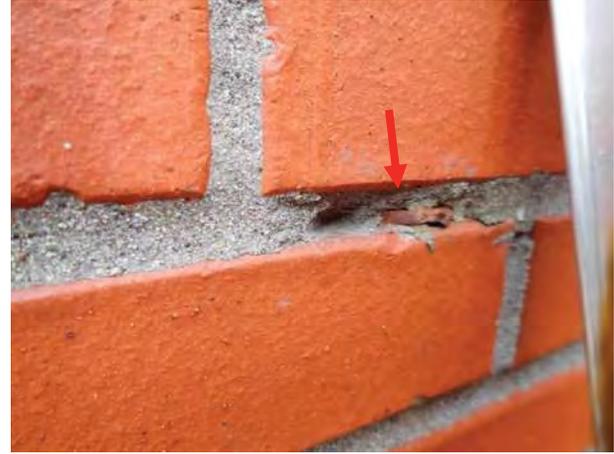
**Photo No. 66** - View of scaffolding tie-back embedded in mortar joint and causing isolated spalling as it corrodes.

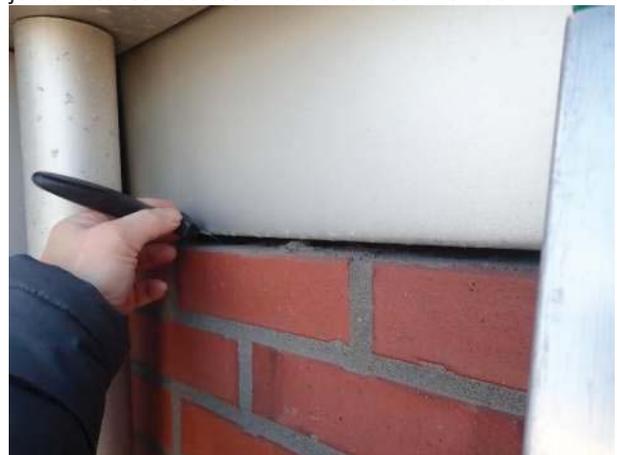
**Photo No. 70** - View of the errantly left gap at the top of the brick veneer wall, at the East Elevation of the Anthem Café, which has been susceptible to water migration. This open joint should receive a backer rod and sealant joint to close this vulnerable location.

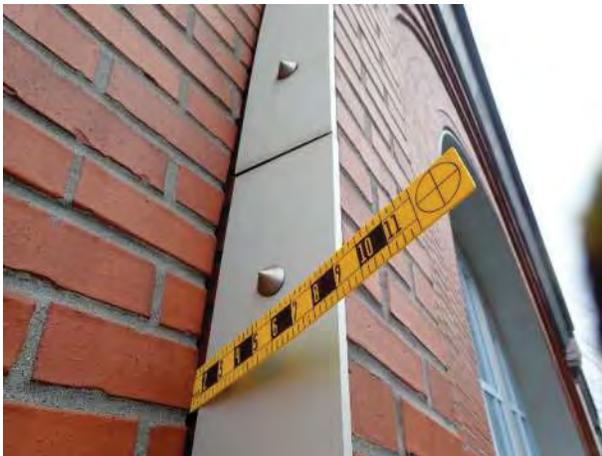
**Photo No. 71** - View of Building Envelope Technologist's high-vis ruler, carefully inserted into open gap at archway-to-brick veneer wall intersection. This large gap is susceptible to water migration and leakage into the cladding system.

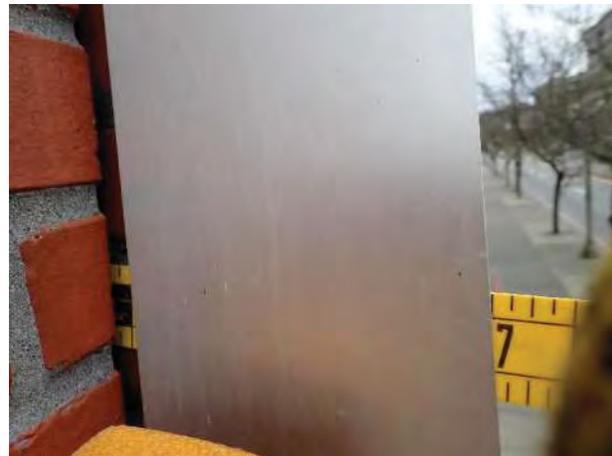
**Photo No. 72** - View of ruler inserted under decorative aluminum panel at brick archway and into deficiently left open gap at archway-to-brick veneer wall intersection. The void is susceptible to water migration into the wall assembly, which may be causing hidden degradation and damage to underlying components.

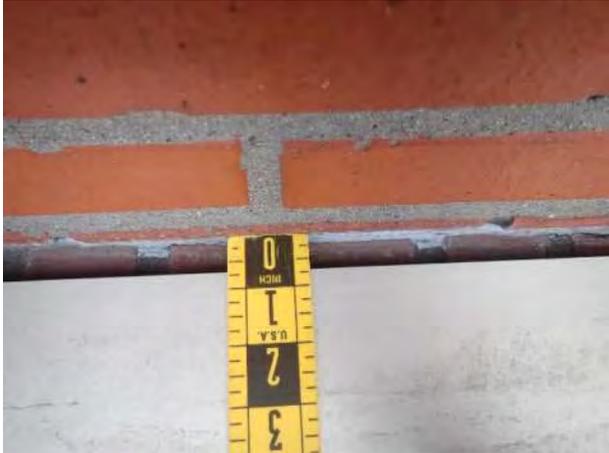
**Photo No. 73** - Approximately 3/4-inch gap deficiently left open at backs side of decorative aluminum panels. The panels and gap acts as a shelf where water can collect and migrate into the brick and cladding assembly, as the underlying brick is not flashed as otherwise indicated in the Project Record Drawings.

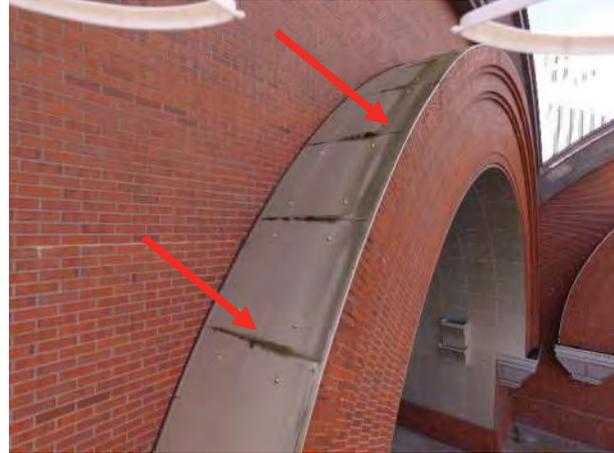
**Photo No. 74** - View of large North Elevation archway top as observed from BET&R's drone near the main entry. Note the moss growth promoted by the large open butt joints in the decorative aluminum panel cladding system.

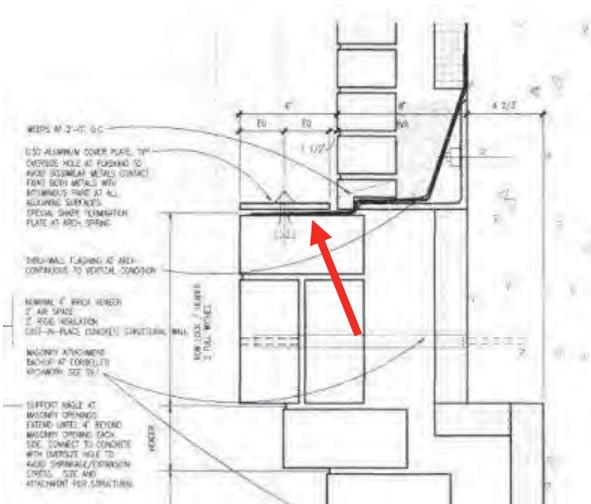
**Photo No. 75** - Depicts portion of detail A-8.1/4 that depicts through veneer flashing at brick ledger angle and extends under the decorative aluminum cladding panel. The as-built condition does not match the detail as drawn.

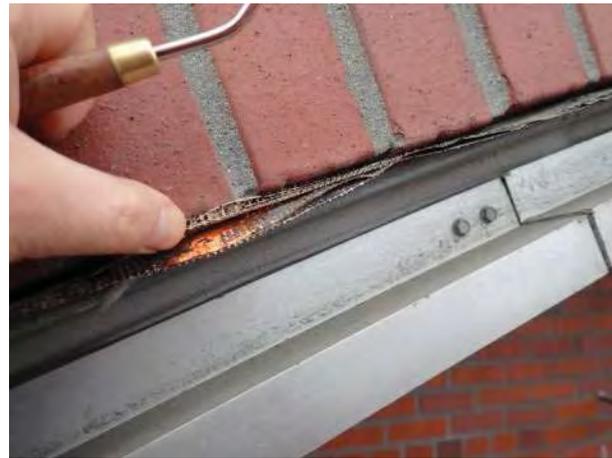
**Photo No. 80** - BET&R observed a hybrid laminated flexible flashing product at that this specific detail, as depicted in photo. The laminated flashing material appears to be similar to York Flash Vent product with a flexible copper core laminated to flexible reinforced membrane. This joint also is in need of corrective actions.

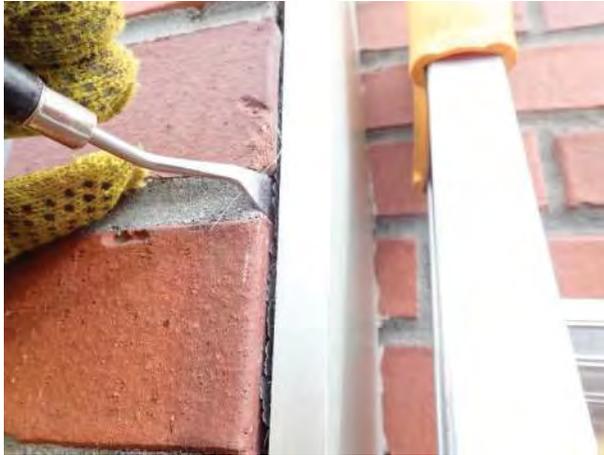
**Photo No. 81** - View of what appears to be the edge of the flexible flashing, just visible under the decorative aluminum archway cladding panels. The membrane has degraded and embrittled from having been exposed to UV, weather, and water. Due to the unfinished and deficiently constructed joint, the material is no longer functioning as a through-veneer flashing.

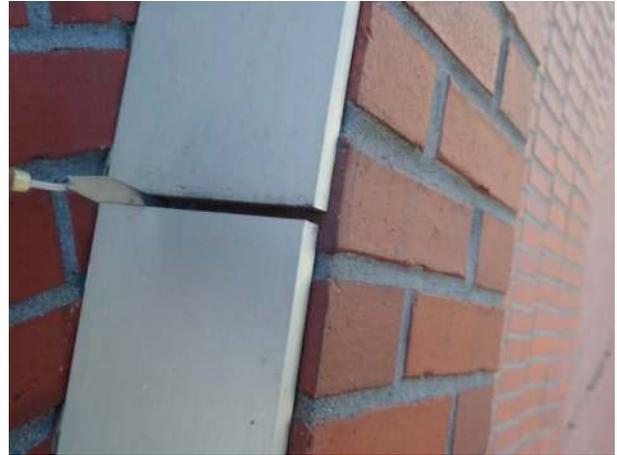
**Photo No. 82** - Depicts open decorative aluminum panel-to-panel joint, approximately 5/8" wide, open to water entry to the head of the brick arch. Note flexible flashing was not observed at this location under the decorative aluminum panels, so water and freeze-thaw degradation of portions the brick masonry may occur over time.

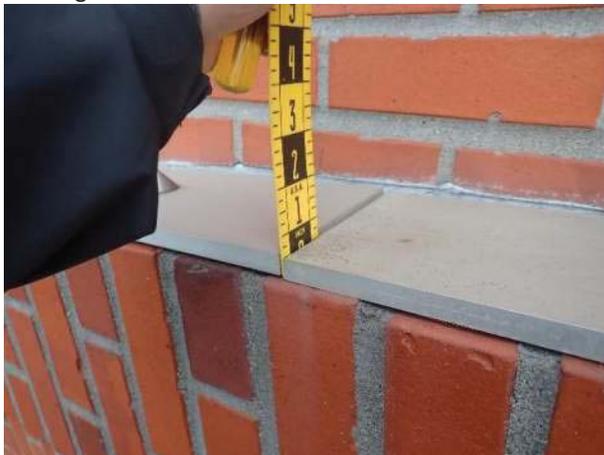
**Photo No. 83** - Depicts open decorative aluminum panel-to-panel joint, approximately 1/2" deep, open to water migration to the head of the brick arch. Note that flexible flashing, nor an underlying back-up metal flashing that could and should have lapped out over the outer edge of the brick to protect the masonry from freeze-thaw damage, was not observed all along this area under the decorative aluminum panels.

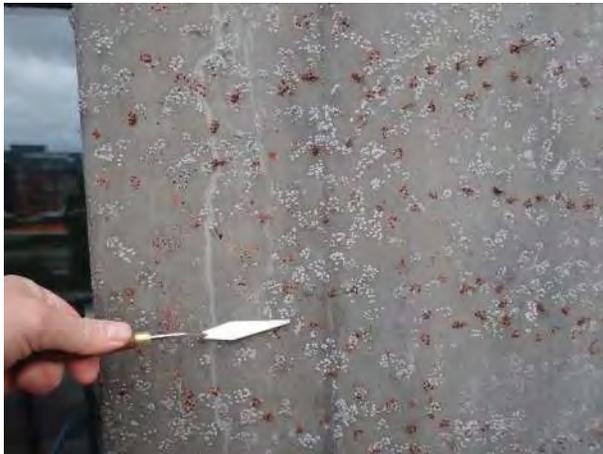
**Photo No. 85** - View of biological growth and staining observed on the exposed concrete walls at the East Elevation likely from crawling vines on that side of the Building.

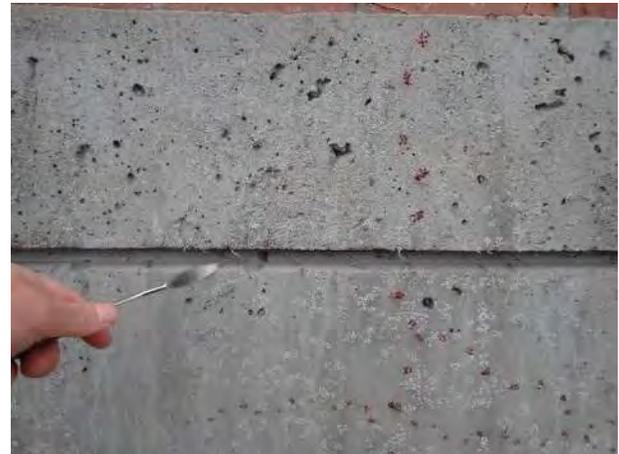
**Photo No. 86** - View of “bug holes” and rock pockets, which were not sacked & patched during original construction, are visible and holding some organic growth as observed at the CIP walls. This condition is not necessarily problematic provided the concrete receives an appropriate cleaning and proper application water repellent (including within the voids) at regular intervals as the concrete ages. If the wall were thoroughly cleaned, the voids could be grouted/filled with an appropriate color-matching cementitious grout or repair material if desired.

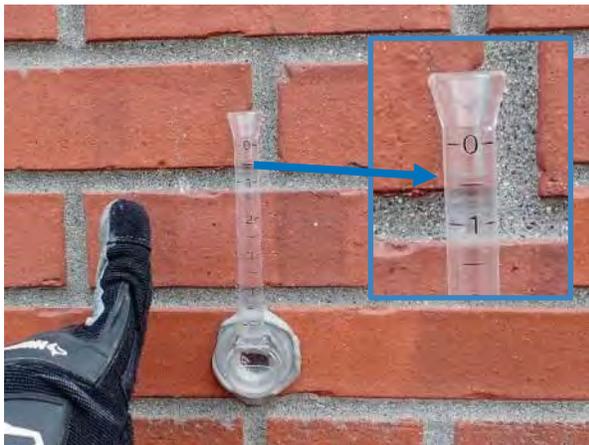
**Photo No. 91** - Depicts close-up of the specimen on the West Elevation that exhibited among the most moisture penetration at 0.5 after the 30-minute test. While this does indicate good water-penetration resistance, the increased absorption will lead to an increased rate of water-related degradation and absorption unless remediation steps are taken to further protect the masonry substrate.

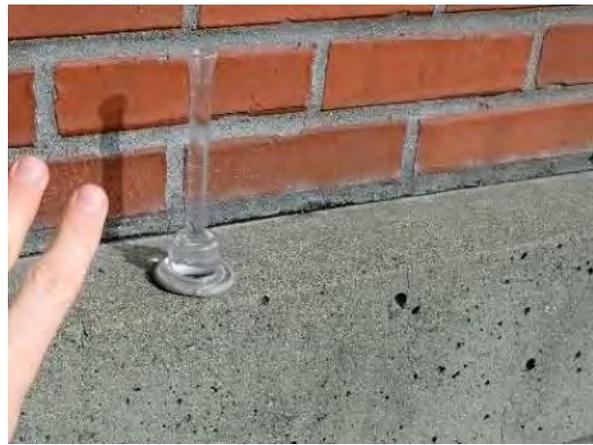
**Photo No. 92** - Depicts testing conducted at the horizontal surface of the concrete foundation wall at the South Elevation of the building. This area was chosen due to the proximity of relatively moist-appearing mortar at the interface with the concrete. The small amount of moisture absorption exhibited at this location (0.2 after 30 minutes) indicates relatively high moisture penetration resistance, even in an area where water might be expected to pool and degrade the concrete in an accelerated manor.

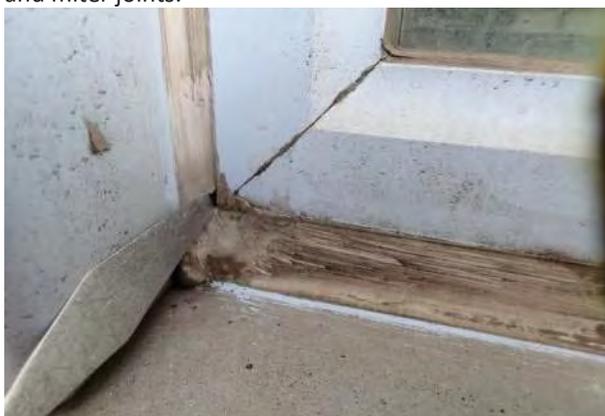
**Photo No. 97** - View of small sealant failure at jamb-to-sill intersection. Although minor locations of failed sealant were observed, the majority of the sealant appears to be in serviceable conditions.

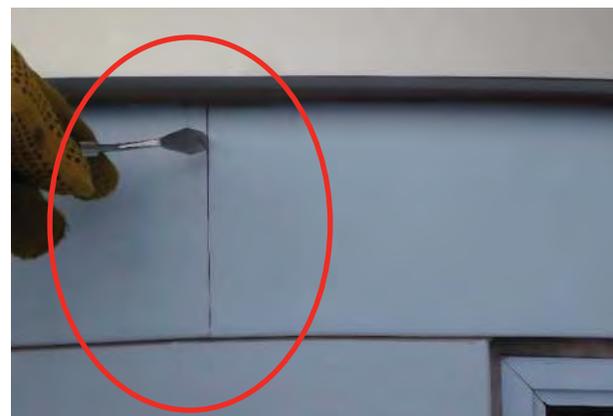
**Photo No. 98** - View of open .125-inch thick aluminum panel joinery associated with storefront window systems observed at the West Elevation arched windows. Careful tactile probing suggested a backer plate is present, as detected behind the open joint.

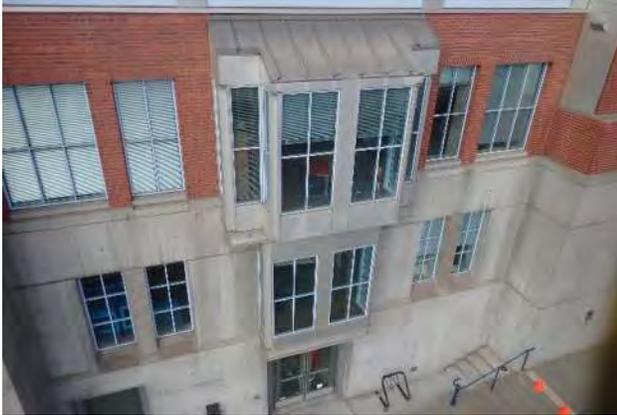
**Photo No. 99** - Overview of protruding window bay at the East Elevation, which is a reported area of fairly intense condensation issues with respect to the aluminum framed window system.

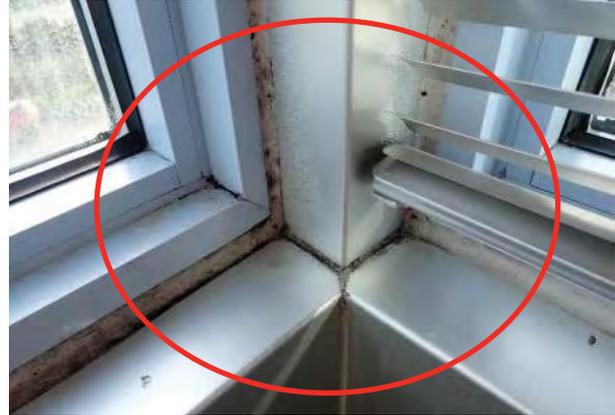
**Photo No. 100** - View of black and dark-colored fungal growth (e.g., mold) stained silicone sealant joints at the interior, as well as water droplets on the aluminum frame due to condensation forming on aluminum frame.

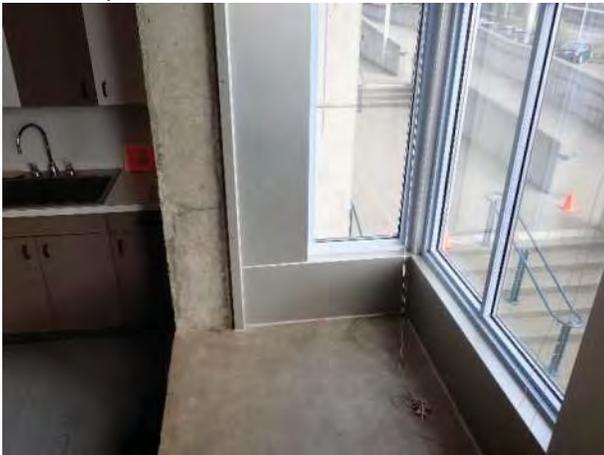
**Photo No. 101** - View of interior of Bay Window at East Elevation, and location of residual moisture staining at the interior likely from the reported repetitive condensation occurring at these units.

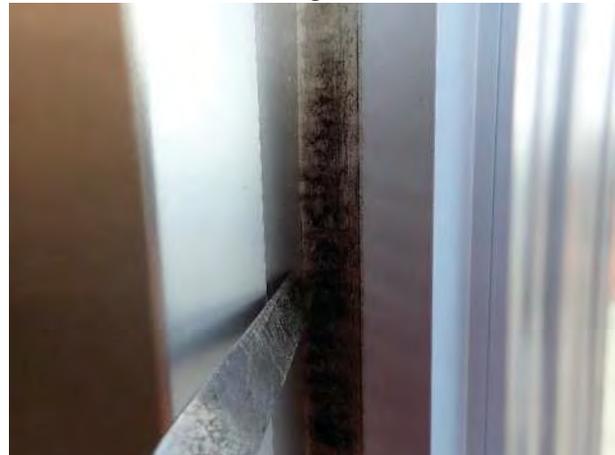
**Photo No. 102** - View of interior sealant joint showing signs of repeated wetting and drying, likely from condensation, as evidenced by the dark-colored fungal (e.g., mold) visible on the silicone sealant.

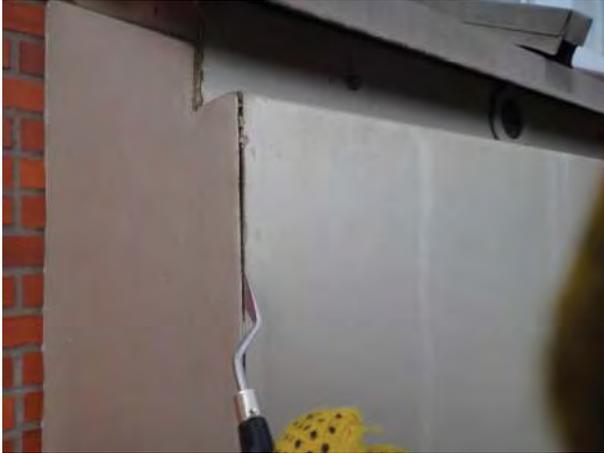
**Photo No. 103** - View of open .125-inch thick aluminum panel end-joinery associated with storefront window systems, as observed at the East Elevation window bay.

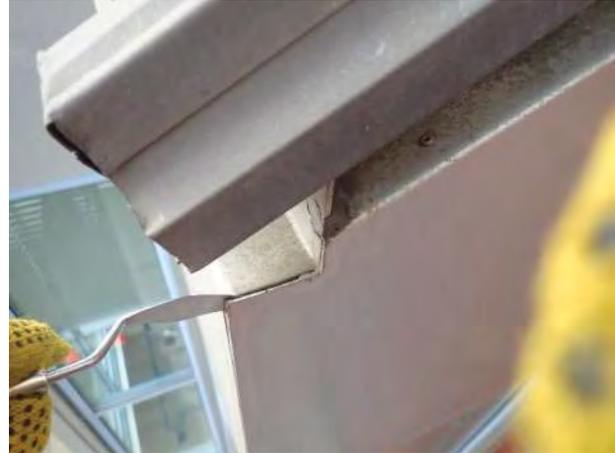
**Photo No. 104** - View of open .125-inch thick aluminum panel corner joinery associated with storefront window systems observed at the East Elevation window bay.

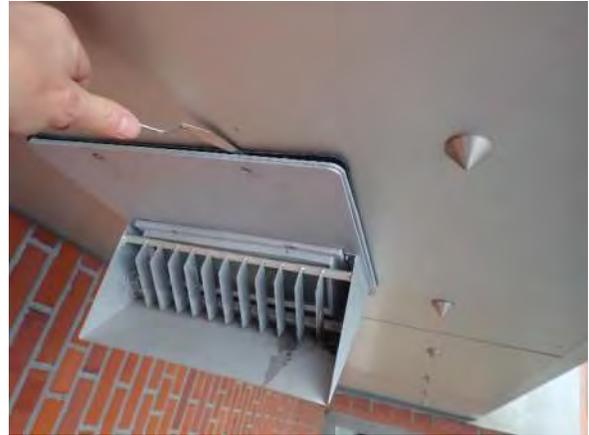
**Photo No. 118** - View of displaced light fixture in need of attention.
