WASHINGTON STATE HISTORICAL SOCIETY

2026 Supplemental Capital Budget Request

CAPITAL PRESERVATION

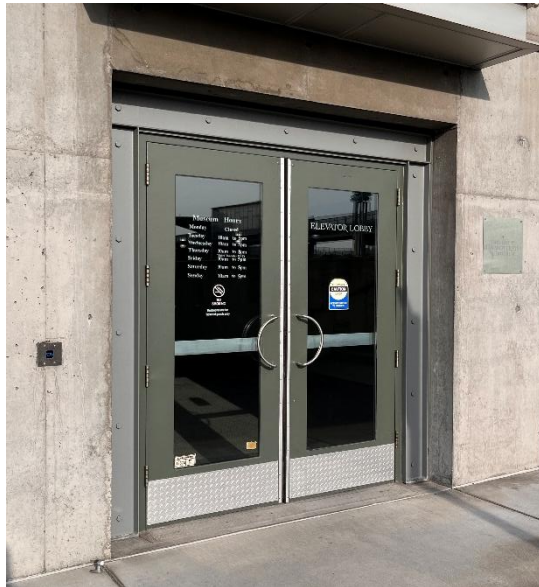
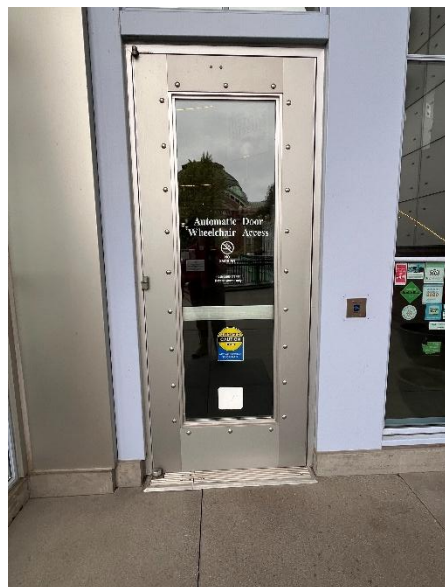
1. **Permanent signage:** The main level entrance and ground level accessible entrance should bear the International Symbol of Accessibility (figure 1). Another option would be a more universal sign that includes images of a parent with a stroller and a person using a cane along with the International Symbol of Accessibility (figure 2). This option also includes a built-in doorbell that can be used to call staff when the door is locked before opening hours.

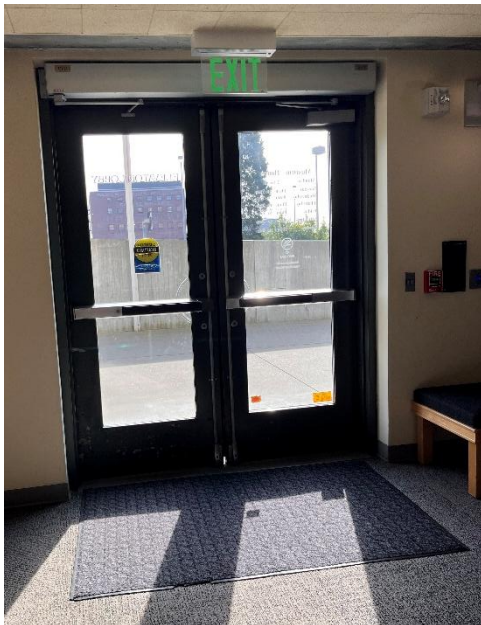
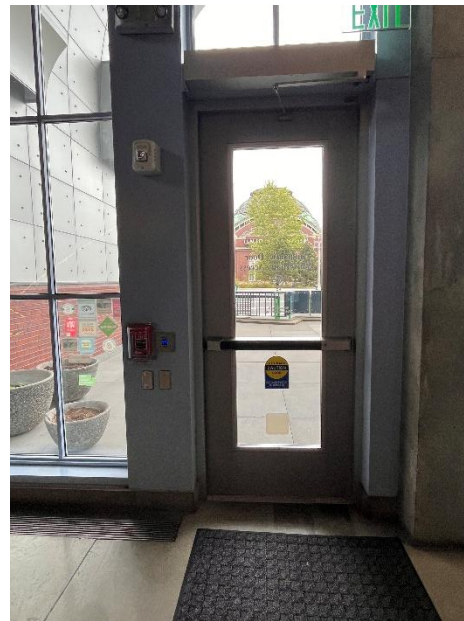
- 2. Walk-off Mats:** Walk-off mats located at the main level and ground level accessible entrances into the museum. These could become a tripping hazard for those with mobility challenges. Consider adding an alternative texture or material these entrances a more permanent way to reduce fall risks and capture outdoor materials.

Integrated walk-off matting that can be embedded in front of both accessible entrances (like the integrated walk-off matting in the vestibule area of the main entrance) could be considered during future renovations.

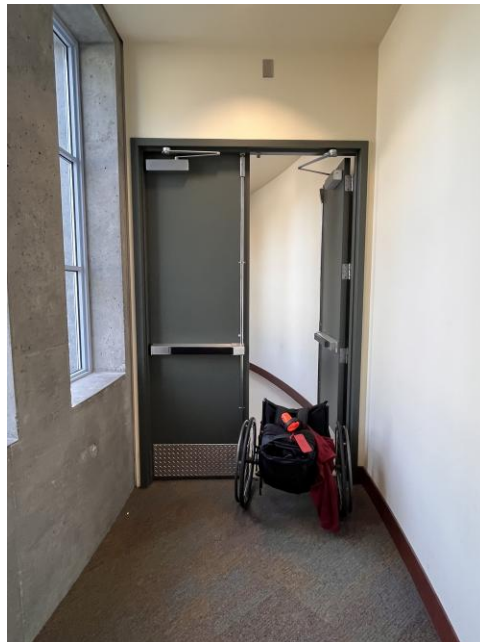
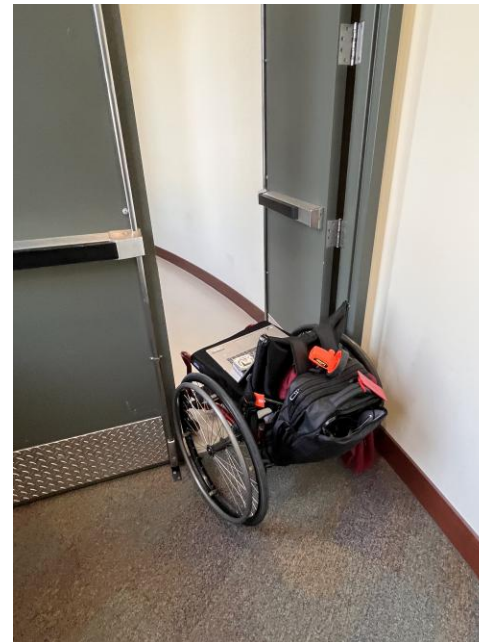
- 3. Doorway to Public Spaces is at least 32 inches wide/doors are easy to open:** Outer doors to the auditorium from the restroom area are only 27.5 inches when a single door is open so both doors need to be open to allow wheelchair access (consider adding automatic door openers that open both doors at once to this entry to allow easier access for all).

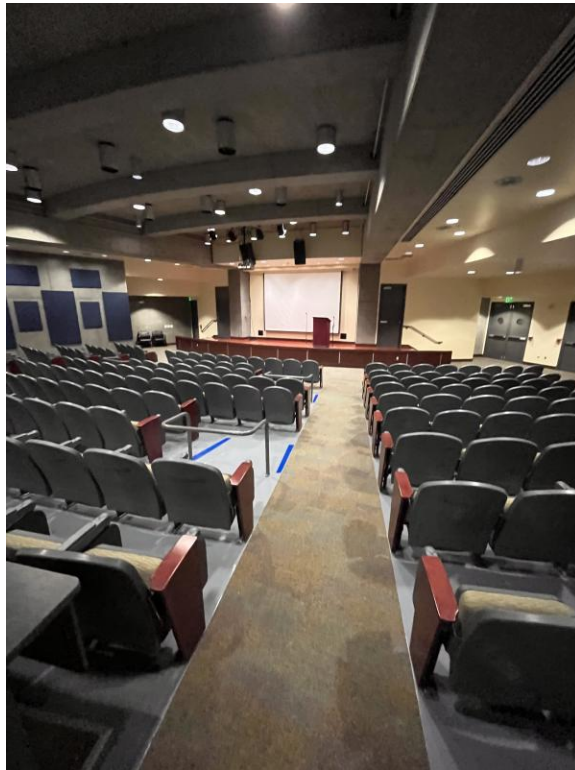
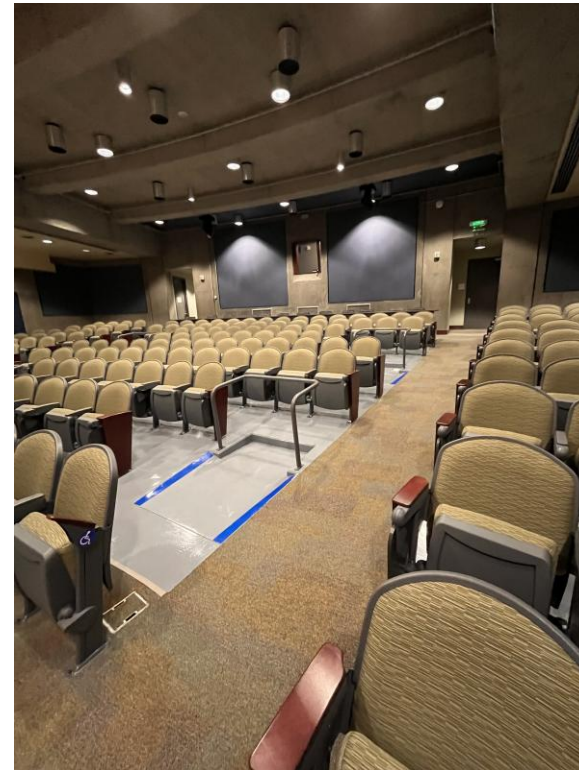
4. Are the seats and rows clearly numbered and easy to locate: The auditorium has a wide variety of accessible seating options, but there is no seating or row numbering. This could be updated when permanent signage issues are addressed.

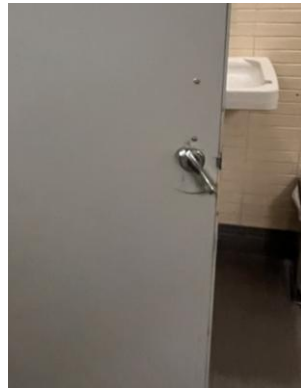
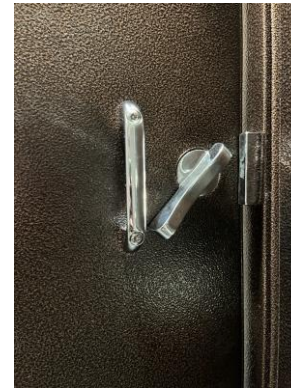
5. Stall door operable with a closed fist, inside and out: These doors can be opened from the outside of the stall with a handle but once in the stall pulling the door closed could be tricky. Consider adding handles on the inner side of the door to help assist in pulling the door from the inside. An example is shown below, current restroom inside door in the photo on the left and example of additional handle on the inside of the door in the photo on the right.

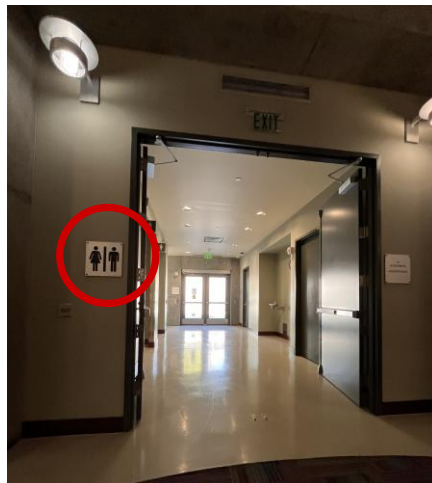
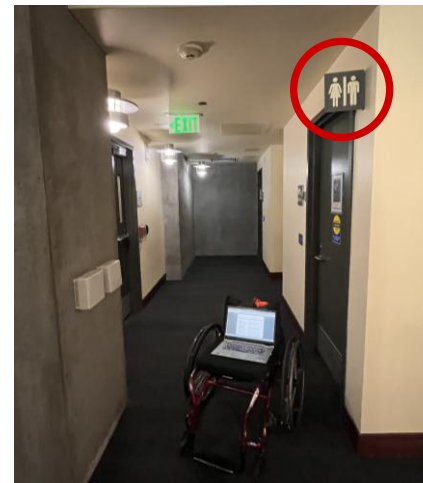
6. Accessible restrooms identified with appropriate permanent signage: Some restroom signage does not identify accessible restrooms. This could be updated when permanent signage issues are addressed.

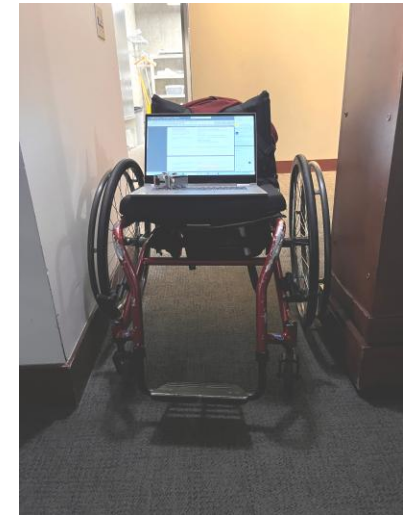
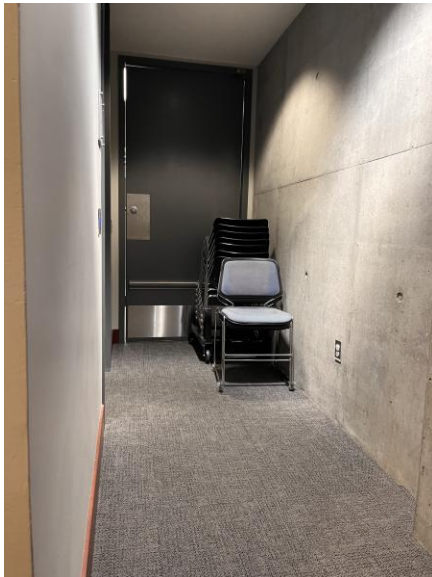
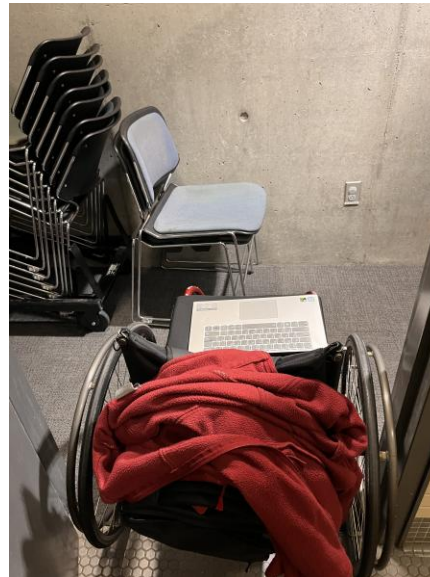
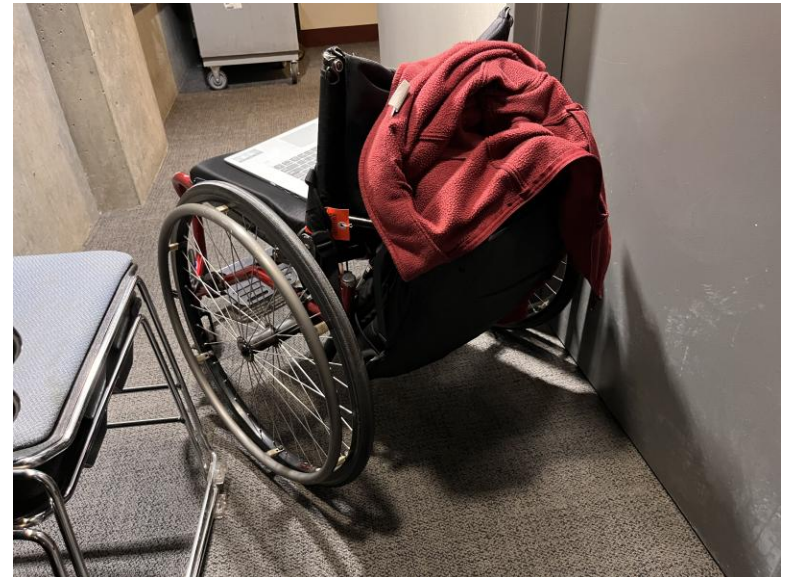
7. Are accessible route to restrooms clear of movable items: The route to the restrooms on the 4th floor can be very tight due to movable furniture that is used to block the main meeting area from the main hall where restrooms are located. The image to the right shows how tight this space is for someone using a mobility device. Try to maintain a 36-inch clear pathway from the main meeting area to the main hall where the restrooms are located.

The hallways that access each restroom on the 4th floor have a maximum width of 4 feet which can be tight to navigate in a mobility device. Make sure that movable elements like chairs or carts are placed out of access around restroom doors, especially on the men's room side. The images below show how tight it is for someone using a wheelchair to enter/exit the men's restroom.

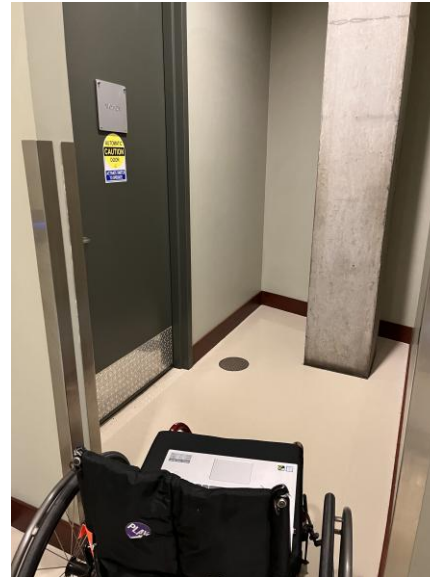
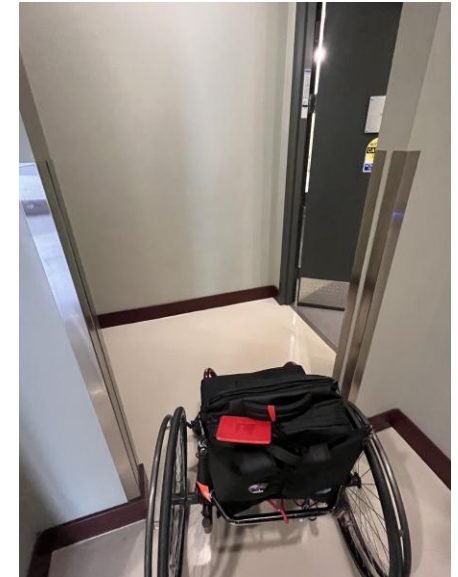
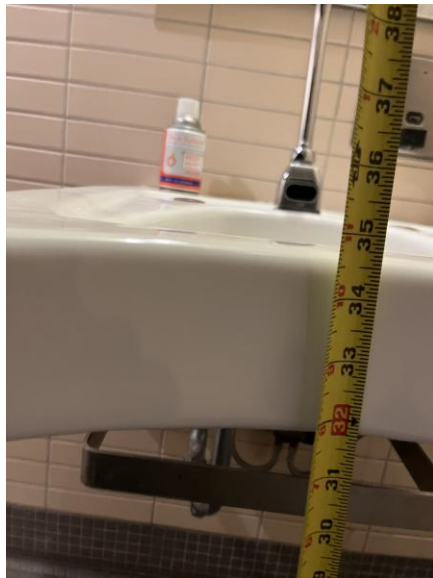
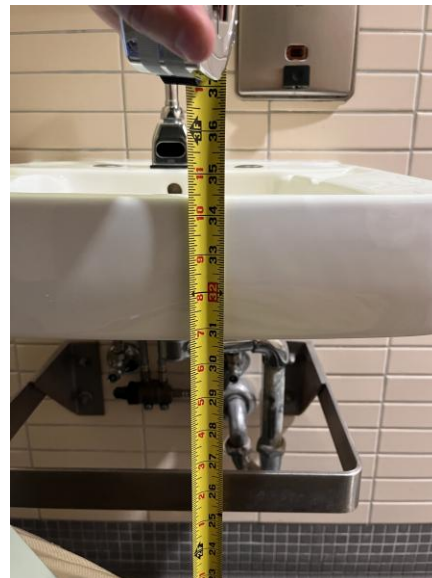
7. Are accessible route to restrooms clear of movable items:

The restroom entry halls to the 2nd floor restroom start quite wide but then narrow to 36 inches. This happens at the entry to the men's and women's restrooms on this floor (see images right). The next time renovations are made to the museum consider widening these two entry points if possible so that they are the maximum width of the hallways.

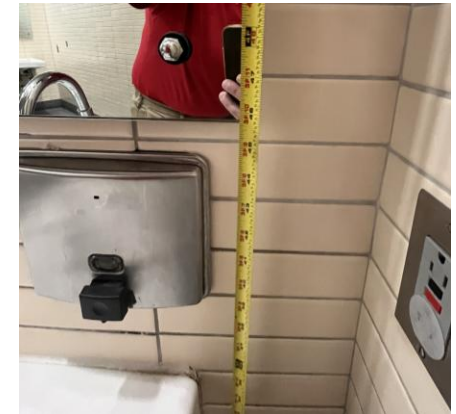
8. Lavatory rim higher than 34 inches: 4th floor women's (left image) and men's lavatory rims (right image) are higher than 34-inches, both measuring 34.5 inches. The clearance under these sinks for knee clearance measures higher than 29-inches requirement so these sinks could be lowered by $\frac{1}{2}$ - 1 inch to meet the upper rim high requirements and still meet the under-sink knee requirements of 29 inch minimum.

9. Bottom edges of mirrors are no higher than 40 inches: None of the mirrors in the restrooms meet this standard because the soap dispenser is in the way. All restrooms have the same design. The bottom of all mirrors is 46 inches from the ground. The next time the museum does renovations they should consider adding soap dispensers integrated into the sinks (the sinks appear to have this built into their design) and lower all mirrors so that the bottom of the mirror is at 40 inches.

10. If there are six or more stalls, is there also a 36-inch-wide stall with an outward swinging door and parallel grab bars: The 2nd floor women – no stall meets this standard. Determine if there is a stall that meets this dimension where an outward swinging door and parallel grab bars could be added.

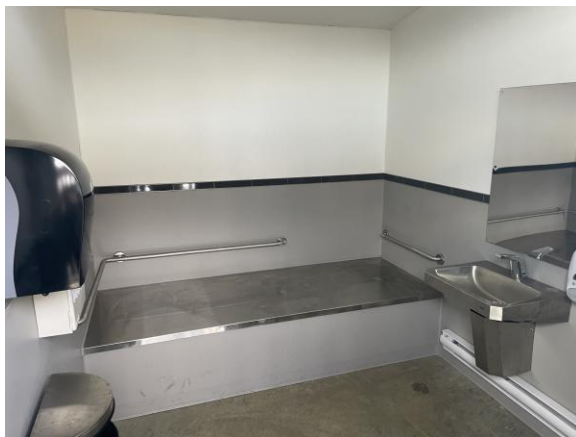
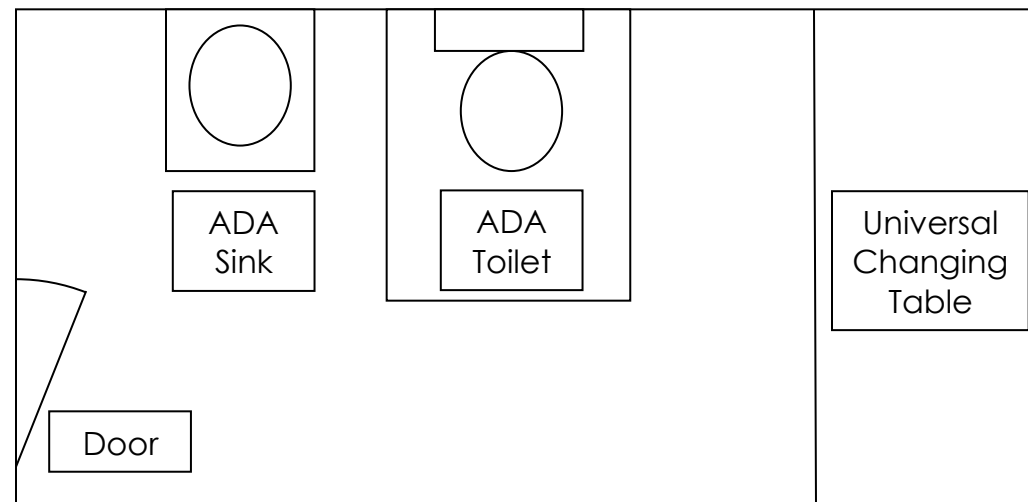
11. Universal Changing Table: One of the unisex restrooms could be updated to include a universal changing table. This could allow families with larger children who need to be changed with accessible changing option. The image shows an example from an outdoor restroom. The sketch is a possible layout for the unisex restroom without the window. A more specific design could be created if desired. The next time the museum does renovations consider making this upgrade.

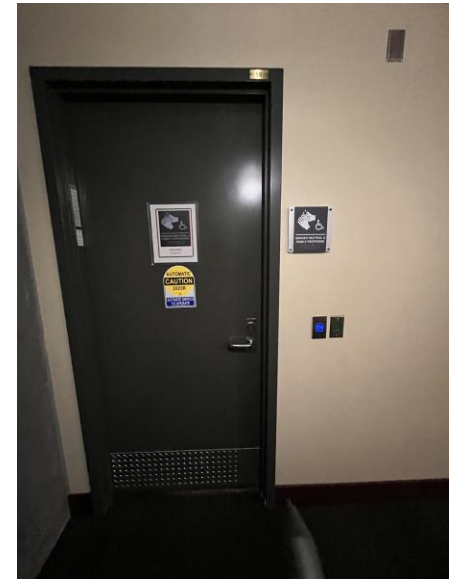
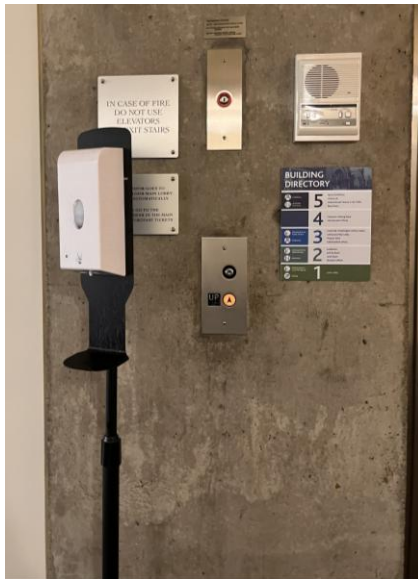
12. Restroom doors opening into the hallway: None of the restrooms meet this standard (image right) and I have never had restrooms in other public buildings meet this standard either. Ensure that these doors meet the building code in your region.

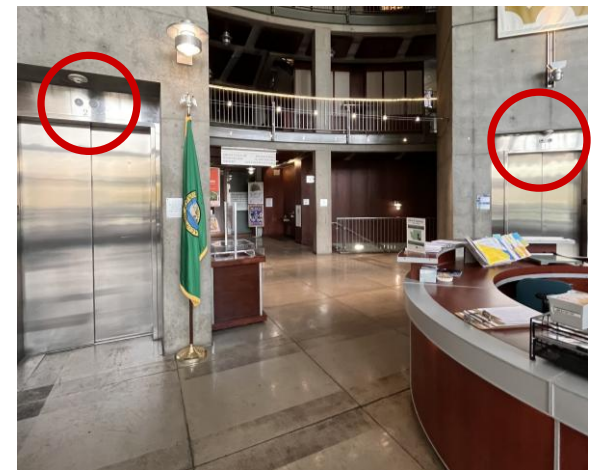
13. Obstruction around the elevator: Watch placement flags (image left) and other items that might block signage at the elevators. This could be part of a weekly checklist around maintaining accessibility in the museum.

14. Signage identifying elevator cars: The labeling system (image right) of CAR 1 and CAR 2 is inconsistent from floor to floor and lacks good contrast. This could be updated when permanent signage issues are addressed.

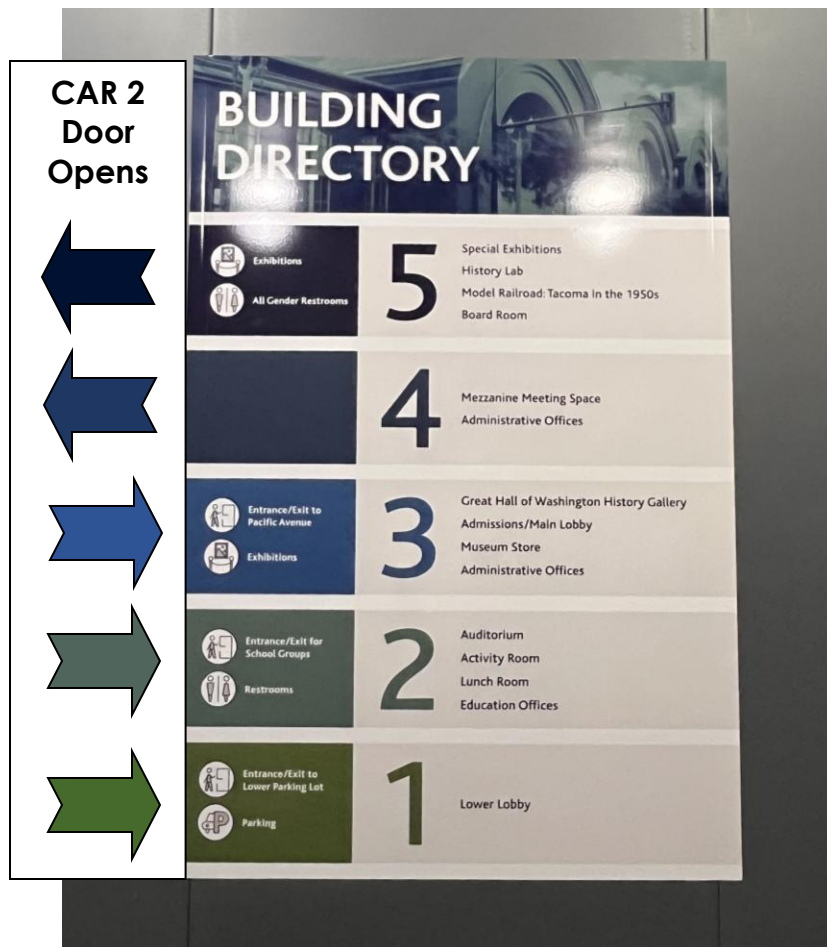
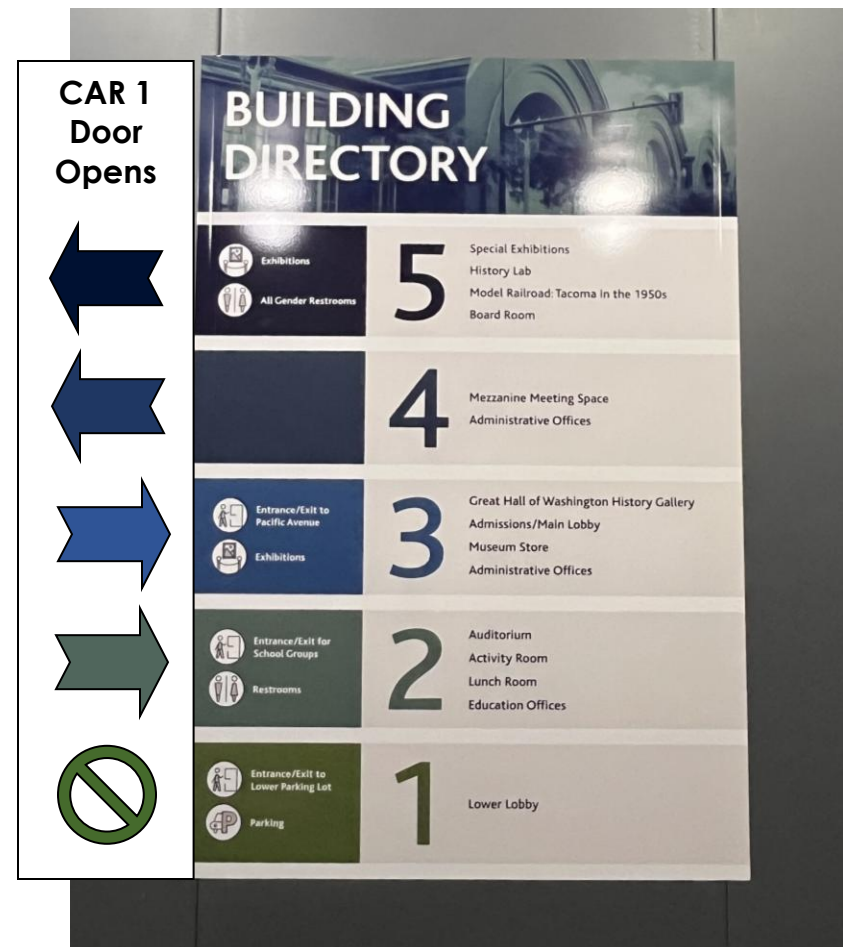
15. Floor Signage in elevator: The museum has well-designed signage in the elevators to help visitors know what is on each floor of the museum. Adding signage to identify which door opens on each floor would add to the ease of use for visitors. This could be an additional strip that has an arrow that points to which door will open on which floor. It could follow the same color-coded pattern of the sign. If an elevator does not go to all floors a different symbol could be used to indicate no access on that floor in that elevator.

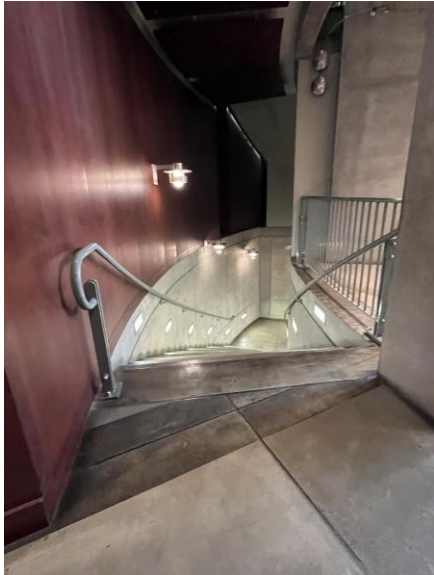
16. Continuous rails on both sides of the stairs: The landing on the stairs that go from the 3rd to 2nd floor does not have a railing (image right), which could lead to issues for those with limited mobility who choose to use the stairs. The next time the museum does renovations consider adding a railing along this landing to make the railing continuous on this side of the landing.

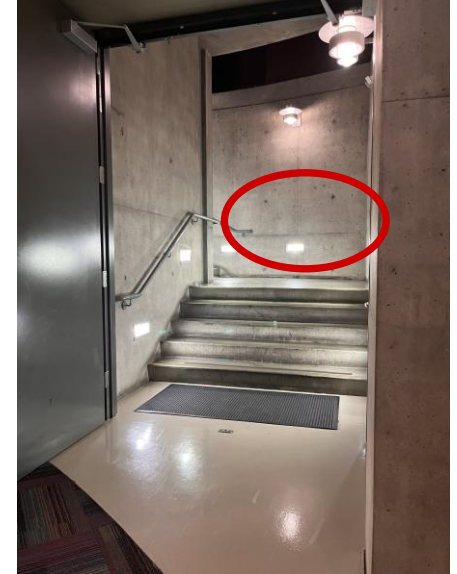
17. Non-slip surface on stairs: Stairs going from the 3rd to 2nd floor are polished concrete and could get slippery when wet (image left). The next time the museum does renovations consider resurfacing these with non-slip material.

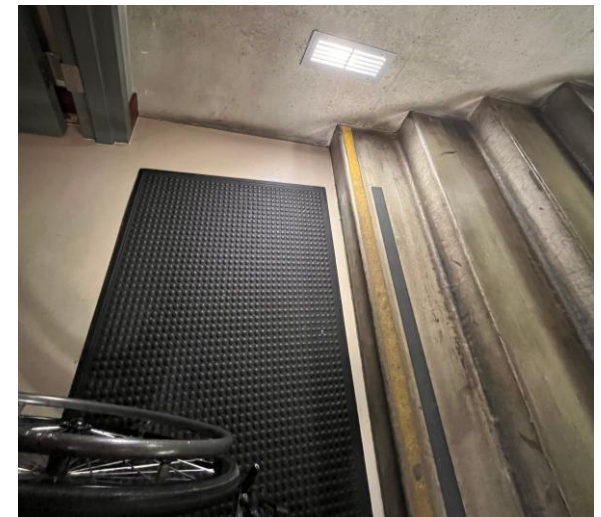
18. At the top of the stairs, are there tactile and high contrast warning strip: Most of the stairs meet this requirement. The top of the concrete stairs on the 3rd floor coming from the 2nd floor do not meet this requirement (image above left). The stairs and floor are polished concrete so color contrast is lacking. Consider adding a tactile strip and color contrast strip at the top of these stairs similar to what is located at the bottom of these stairs (image right).

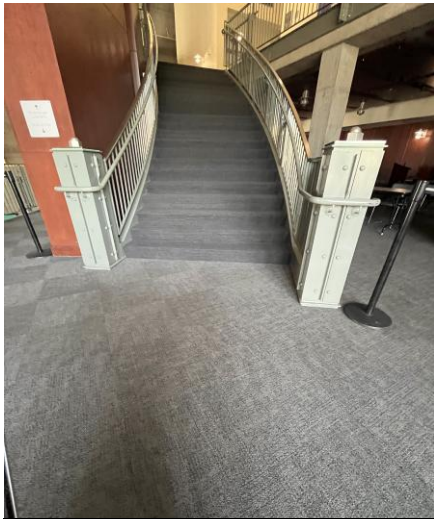
5th to 4th floor stairs

18. At the top of the stairs, are there tactile and high contrast warning strip: The carpeting on the 4th floor does not have good contrast with the stairs going to the 5th or 3rd floors. The next time the museum does renovations consider replacing the 4th floor carpet so that it has good color contrast with the carpet on both sets of stairs. The 5th floor carpet provides a good example of carpet contrast.

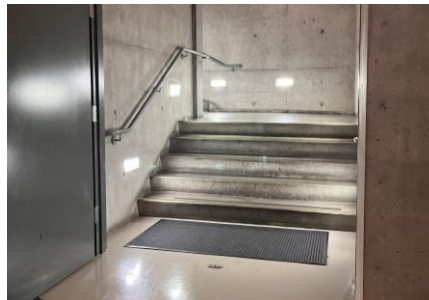
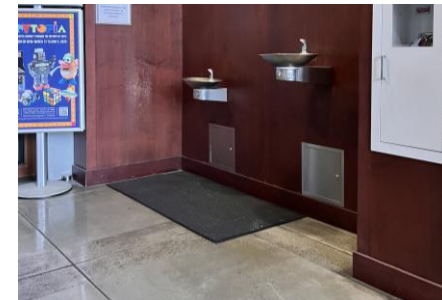
19. Walk-off mat is a trip hazard: Walk-off mats at the 3rd floor drinking fountain and at the base of the stairs at 2nd level are possible tripping hazards. The next time the museum does renovations consider changing these walk-off mats with an alternative texture or material to absorb water. In the meantime, ensure that these are checked regularly by staff to prevent tripping and falling.
