Washington State Patrol

2022 Supplemental Request

Subject: Washington State Patrol 2022 Supplemental Capital Budget Request

SPRINKLER SYSTEM ASSESSMENT

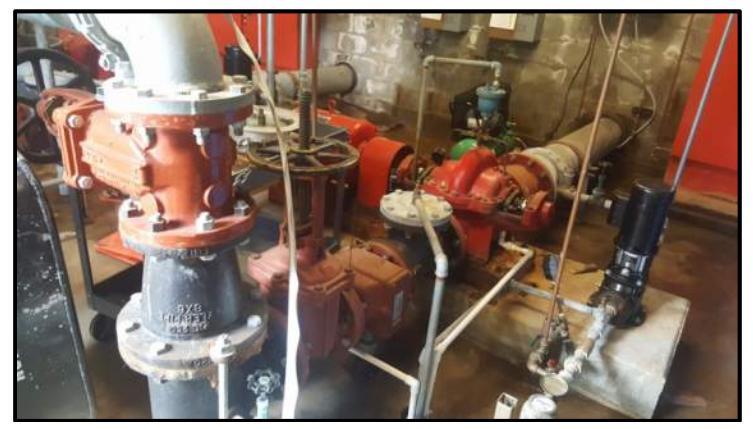
Figure 1 – Existing Fire Pumps at Outbuilding

The outbuilding has wood roof and lacks automatic sprinkler protection. Outbuilding conditions are not code compliant. Additionally, there is evidence of standing water in fire pump room, suggesting inadequate floor drainage. See Figure 1 – Existing Fire Pumps at Outbuilding.

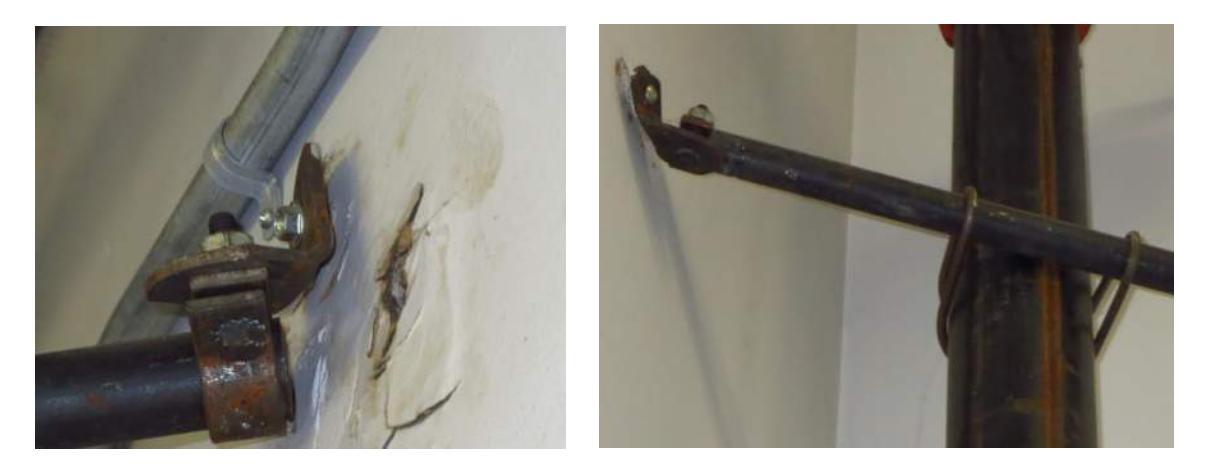
Additionally, earthquake sway bracing was observed to deficient based on current standards, which would be expected as the system was installed in 1993. Riser bracing wall attachments were observed to be separating from the walls of all three systems as shown below in Figure 1:

Figure 1. Administration Building and Vehicle Inspection Building Riser Braces. The photo on the left is the attachment of the Administration Building riser sway bracing and the photo on the right is the Vehicle Inspection Building riser brace. Both braces appear to have pulled from their attachment to the wall.

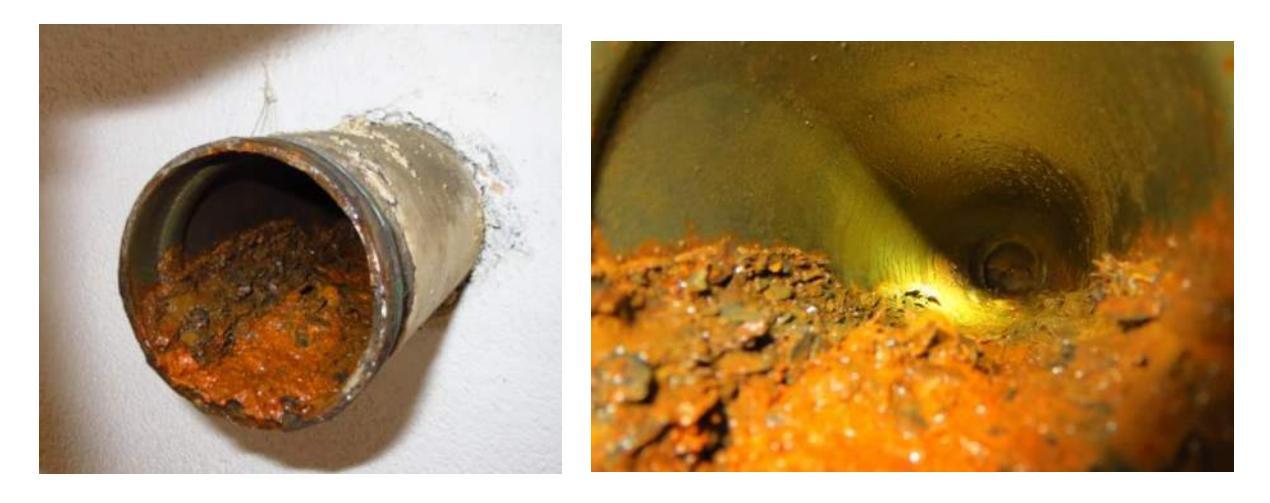
Figure 2. Administration Building Dry System. Both photos above are of the interior of the feed main supplying the south entrance canopy. This piping exhibited moderate sludge, scale, and scale build up on the bottom half of the pipe, indicative of water ponding due to poor drainage.

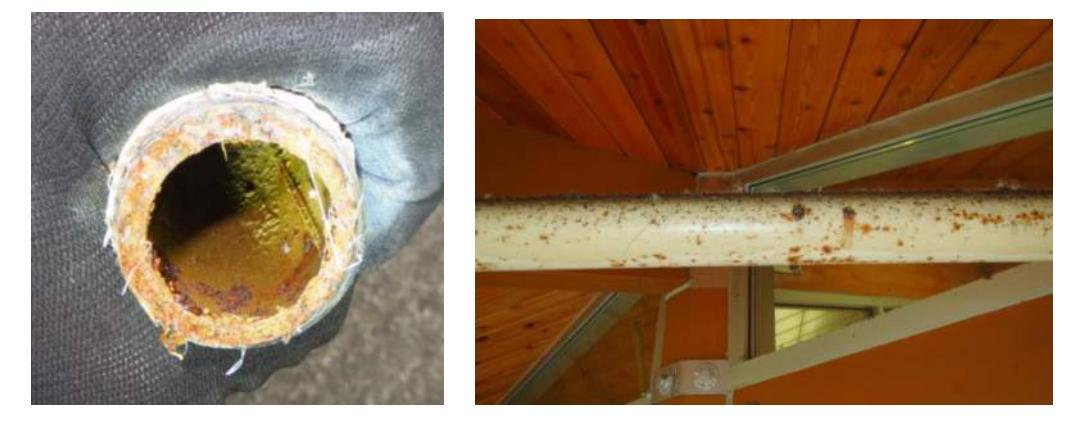
A sprinkler riser nipple was removed at the front entrance and examined. The 1-inch riser nipple was found to be in good condition with minor oxidation of the interior of the piping, as shown below in Figure 3. The exterior of the piping exhibited rust spots, however, these were observed to be around the perimeter of the piping as is typical of exterior rust as opposed to interior corrosion through the pipe wall thickness. In addition, this piping is Schedule 40 piping. The greater thickness of the smaller diameter piping (Schedule 40) means there is a lower risk of pipe failure compared to the larger diameter Schedule 10 piping.

Figure 3. Administration Building Dry System. The photo on the left is the interior of a riser nipple supplying a sprinkler head covering the exterior canopy of the main north entrance and exhibits only minor rust. The photo on the left is the exterior branch line exhibiting minor exterior corrosion.

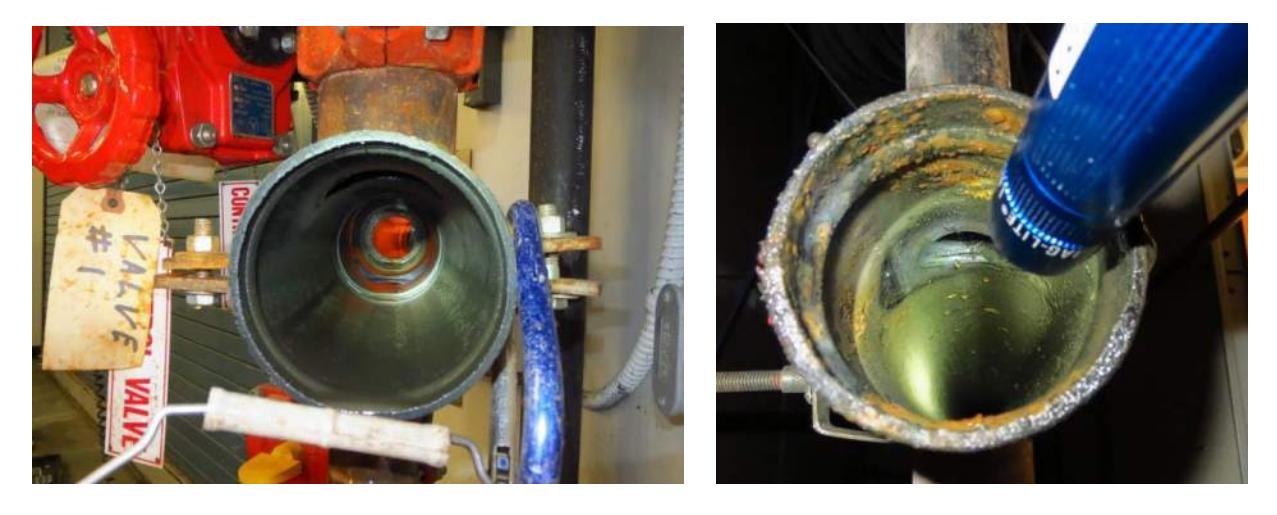
The 4-inch wet system covering the administration building was then investigated beginning at the riser manifold. The system was drained and the end cap of the riser manifold was removed. The piping was observed to be in excellent condition with no indications of rust. A 1-inch branch line in the rooftop Mechanical Room 201 was then inspected by separating the branch line at an elbow. No indication of corrosion was observed. A sprinkler head in the Motorcycle Storage Room 140 was removed and found to exhibit no indications of corrosion. Finally, a 2½-inch end cap was removed from the Crime Lab coffee room and inspected. This portion of the system is in the original 1992 building. This piping was also found to be in very good condition with only minor points of rust (See Figure 4).

Figure 4. Administration Building Wet System. The photo on the left is the main riser manifold and exhibits no corrosion. The photo on the right is of the original 1992 cross main in the Crime Lab and exhibits minor rust spots on the interior.

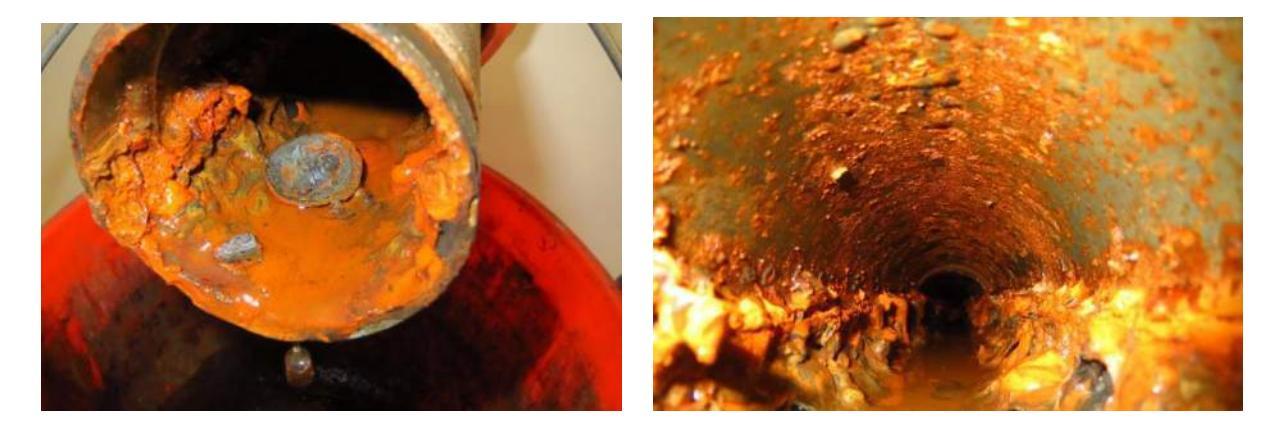
A 3½-inch feed main along the south wall of the main inspection bay was accessed by removing a grooved elbow fitting and the interior of the pipe was found to have extensive corrosion. The extent of deposits could obstruct a sprinkler head from flowing properly. This system should be considered impaired until flushing and/or replacement of piping is conducted. Water was observed ponding in the bottom of the pipe, indicating insufficient pipe slope to drain. Rust was observed for the entire circumference of the piping and including visible tubercles as shown in Figure 5, below.

Figure 5. Vehicle Inspection Building Dry System. *The photos above are of the 3½-inch feed main in the drive-through vehicle inspection bay. Both photos exhibit significant corrosion.*

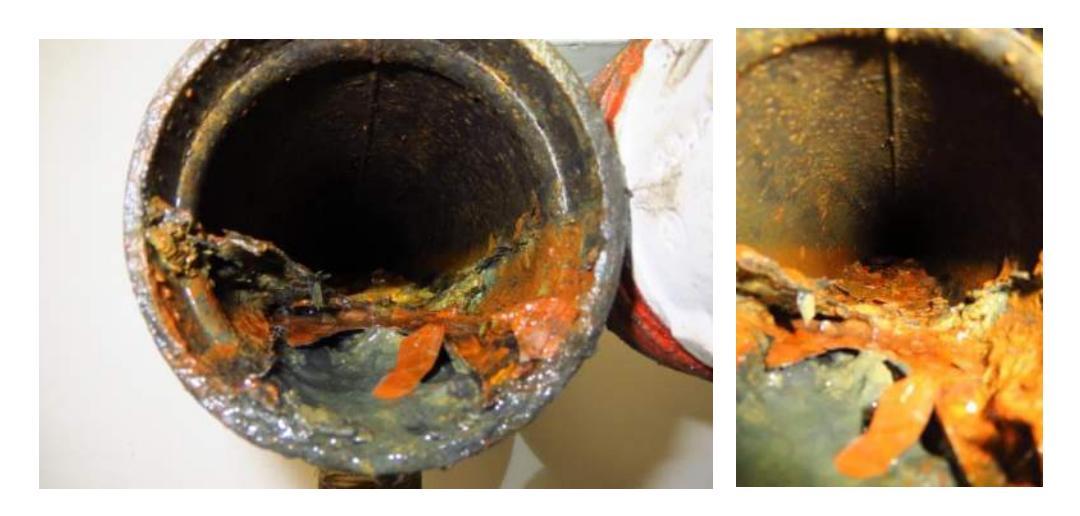
Due to the significant corrosion encountered, an additional inspection point was accessed. A 2½-inch grooved elbow in a small inspection bay was removed to access the feed main. This portion of the piping is fitted with a manual drain. The interior of the pipe was found to have extensive corrosion. The extent of deposits could obstruct a sprinkler head from flowing properly. This system should be considered impaired until flushing and/or replacement of piping is conducted. Water was observed ponding in the bottom of the pipe, indicating insufficient pipe slope to drain. Rust was primarily observed for the bottom half of the pipe, with scale and visible tubercles occurring in the bottom 1/3rd of the piping as shown in Figure 6 on the following page.

Figure 6. Vehicle Inspection Building Dry System. The photos above are of the 2½-inch feed main in the small inspection bay. Both photos exhibit significant corrosion.

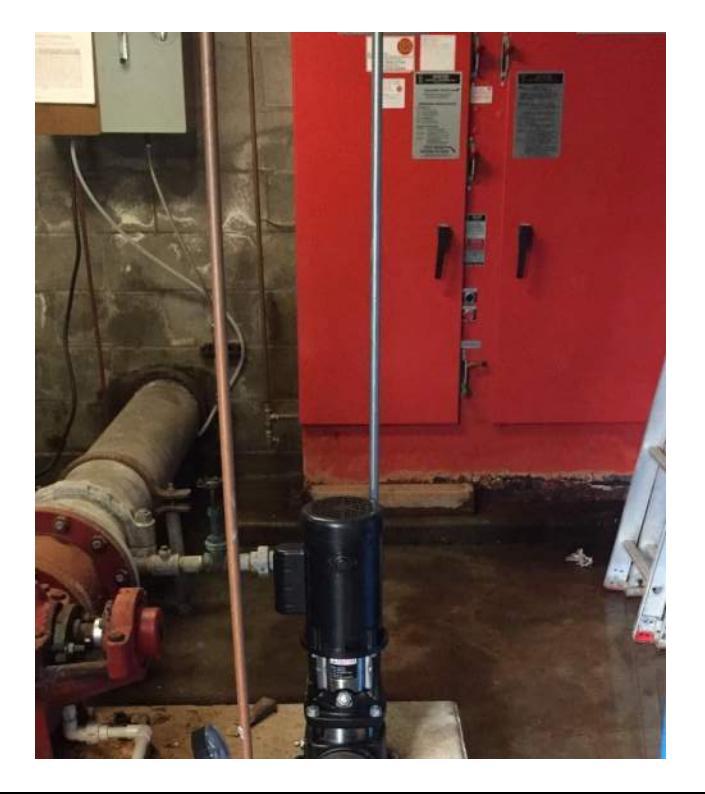
The fire pump room is not equipped with adequate floor drainage as standing water was observed on the floor (See Figure 8 below). Additionally, this room has a wood roof and is not protected with automatic sprinkler protection. Both conditions are not code compliant.

Figure 8. Fire Pump Room. Standing water was observed in the fire pump room, due to the lack of required floor drains. Additionally, significant corrosion of the base of both fire alarm control panels and fire pump supports was observed.
