2022 PROJECT PROPOSAL CHECKLIST
2023-25 Biennium Four-year Higher Education Scoring Process

INSTITUTION	CAMPUS LOCATION
360 - University of Washington	Seattle Campus
PROJECT TITLE	FPMT UNIQUE FACILITY ID # (OR NA)
CBPS: Infrastructure Renewal	NA
PROJECT CATEGORY	PROJECT SUBCATEGORY
Infrastructure	Major
PROPOSAL IS	
New or Updated Proposal (for scoring)	Resubmitted Proposal (retain prior score)
<input checked="" type="checkbox"/> New proposal <input type="checkbox"/> Resubmittal to be scored (more than 2 biennia old or significantly changed)	<input type="checkbox"/> Resubmittal from 2019-21 biennium <input type="checkbox"/> Resubmittal from 2021-23 biennium
CONTACT	PHONE NUMBER
John Wetzel	206-616-5924

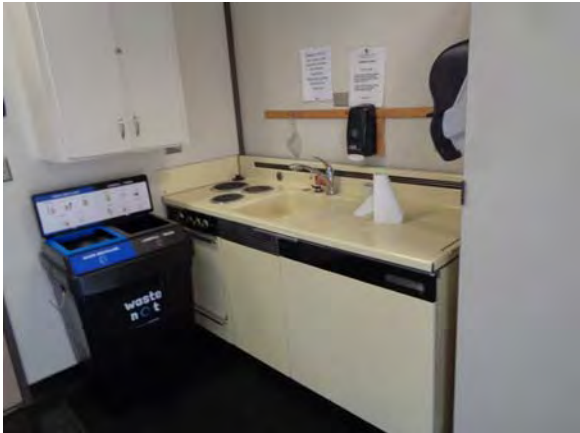
001034a 2/28/2019
Kitchenette with nonaccessible sink
Third floor, room 386A

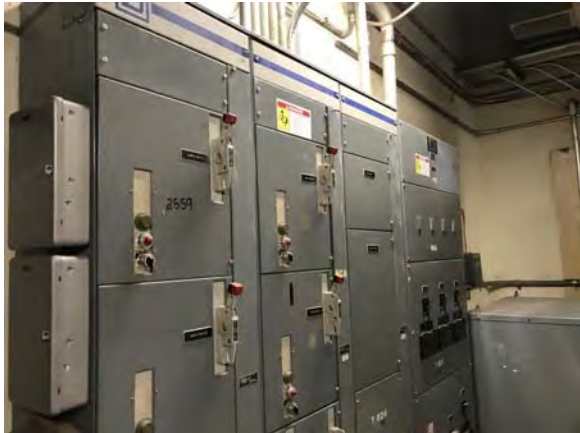
001034e 2/28/2019
Motor control center
Room ME0108

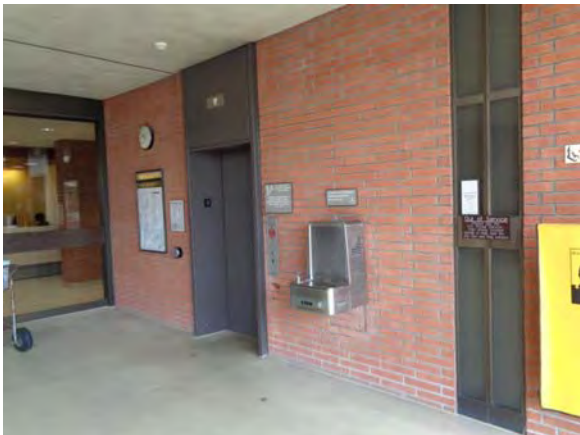
001035a 2/28/2019
Single-level drinking fountain
Third floor, east walkway

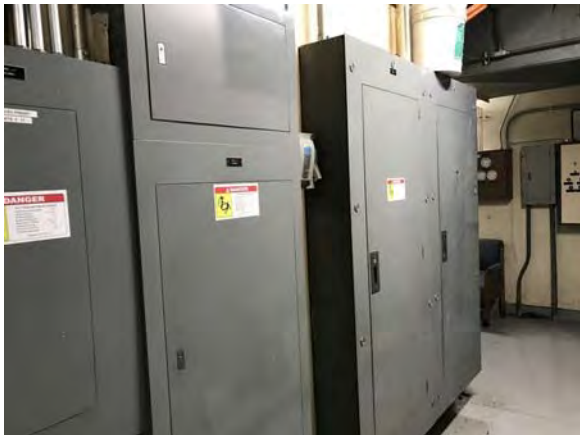
001035e 2/28/2019
Local panelboards
Room 130

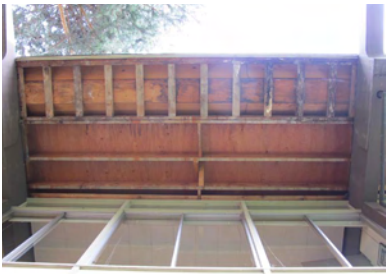
Figure 2.2

2.1 WEST ELEVATION

The northwest corner exhibits significant deterioration likely resulting in structural compromise. Temporary reinforcement has been installed in an effort to mitigate potential collapse.

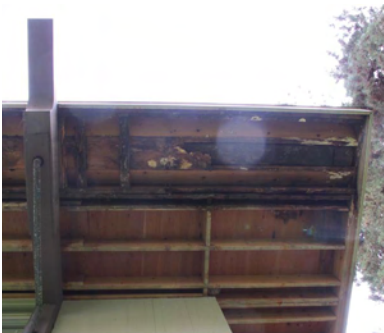
Figure 2.10

2.9 WEST ELEVATION

Deterioration present along underside of gutter and in soffit framing members. Plywood deteriorated. General framing shows evidence of deterioration.

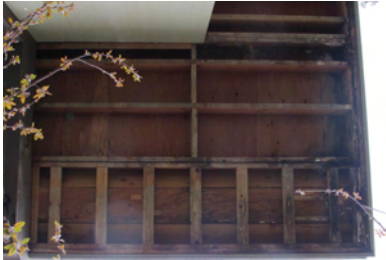
Figure 2.11

2.10 WEST ELEVATION

The southwest corner exhibits significant deterioration in plywood sheathing, general framing and soffit members. Structure may be compromised.

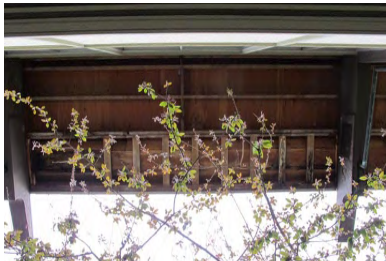
Figure 2.12

2.11 EAST ELEVATION

The southeast corner exhibits significant deterioration in plywood sheathing, general framing and soffit members. Structure may be compromised.

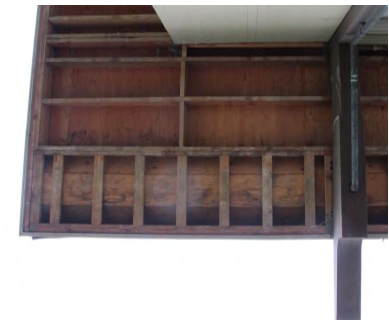
Figure 2.20

2.19 EAST ELEVATION

Deterioration present along underside of gutter and in soffit framing members. Plywood deteriorated. General framing shows evidence of deterioration.

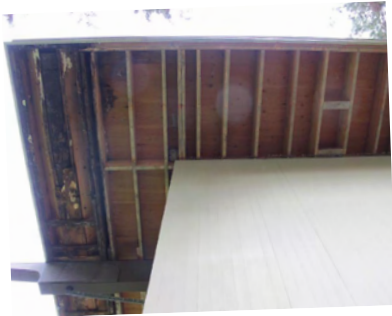
Figure 3.1

2.20 EAST ELEVATION

The northeast corner exhibits moderate to significant deterioration in plywood sheathing, general framing and soffit members. Structure may be compromised.
