2022 PROJECT PROPOSAL CHECKLIST
2023-25 Biennium Four-year Higher Education Scoring Process

INSTITUTION	CAMPUS LOCATION
365 - Washington State University	Pullman, WA
PROJECT TITLE	OFM/CBS Project #
Eastlick / Abelson Hall Renovation - CBPS	40000362
PROJECT CATEGORY	FPMT UNIQUE FACILITY ID # (OR NA)
Renovation - Major	A08581, A09794, A04256
PROPOSAL IS	
New or Updated Proposal (for scoring)	Resubmitted Proposal (retain prior score)
<input checked="" type="checkbox"/> New proposal <input type="checkbox"/> Resubmittal to be scored (more than 2 biennia old or significantly changed)	<input type="checkbox"/> Resubmittal from 2018 (2019-21 biennium) <input type="checkbox"/> Resubmittal from 2020 (2021-23 biennium)
CONTACT	PHONE NUMBER
Kate Kamerrer	509-335-9314

INSTITUTION	CAMPUS
Washington State University	Pullman
PROJECT TITLE	
Eastlick / Abelson Hall Renovations - CBPS

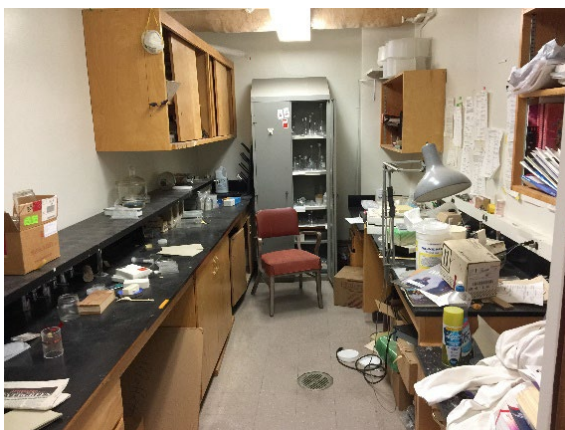
Figure 1 - Heald Hall Research Lab

By improving existing under-utilized spaces in Eastlick and Abelson Halls, these renovations will allow programs to move out of Heald Hall, a 58-year-old building with original systems that has never undergone a major remodel. As a result, Heald Hall is currently in managed decline due to failing infrastructure, obsolete building systems, aged furnishings, and inflexible layouts, making it entirely inadequate for contemporary teaching and research.

See **Figure 1** and **Figure 2** for examples of the outdated teaching and research space within Heald Hall.

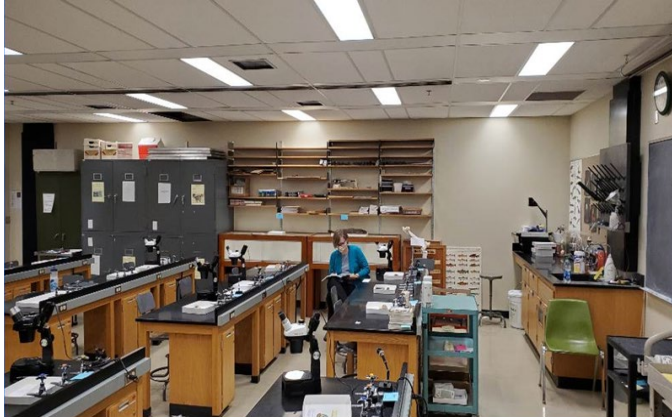
Figure 5 - Unrenovated Eastlick Teaching Lab

In addition, Heald has highly outdated and failing infrastructure; including electrical, water, data, and mechanical systems which increasingly cannot support modern laboratory equipment. Water in Heald Hall, for example, is not potable, and even the most basic equipment such as sinks are worn well beyond repair, thus threatening the ability to conduct cutting-edge, environmentally sensitive research.

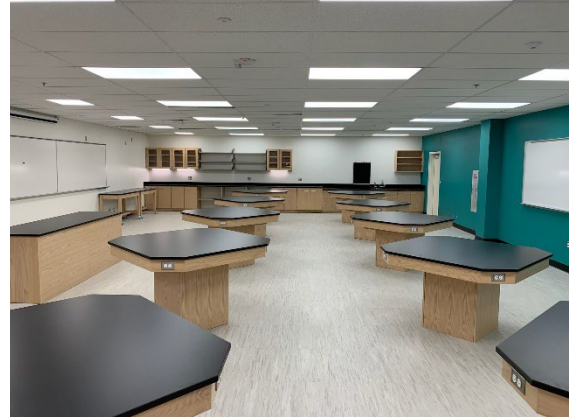
Figure 6 - New Eastlick Teaching Lab

By contrast, the modern, flexible instructional and research lab space in Abelson, Eastlick, and the new Pullman Sciences Building enabled by these renovation projects will provide a place to innovate and collaborate in a functional lab environment that meets current health and safety standards. Reconfiguring spaces in Abelson and Eastlick Halls will increase efficiency and remove barriers, encouraging collaboration and sharing of resources. These renovations will significantly improve space utilization and energy efficiency while also significantly improving teaching and research environments.
