2022 PROJECT PROPOSAL CHECKLIST
2023-25 Biennium Four-year Higher Education Scoring Process

INSTITUTION	CAMPUS LOCATION
365 - Washington State University	Pullman, WA
PROJECT TITLE	OFM/CBS Project #
New Engineering Student Success Building	40000342
PROJECT CATEGORY	FPMT UNIQUE FACILITY ID # (OR NA)
Replacement - Major	NA
PROPOSAL IS	
New or Updated Proposal (for scoring)	Resubmitted Proposal (retain prior score)
<input checked="" type="checkbox"/> New proposal <input type="checkbox"/> Resubmittal to be scored (more than 2 biennia old or significantly changed)	<input type="checkbox"/> Resubmittal from 2018 (2019-21 biennium) <input type="checkbox"/> Resubmittal from 2020 (2021-23 biennium)
CONTACT	PHONE NUMBER
Kate Kamerrer	509-335-9314

INSTITUTION	CAMPUS
Washington State University	Pullman, WA
PROJECT TITLE	
New Engineering Student Success Building

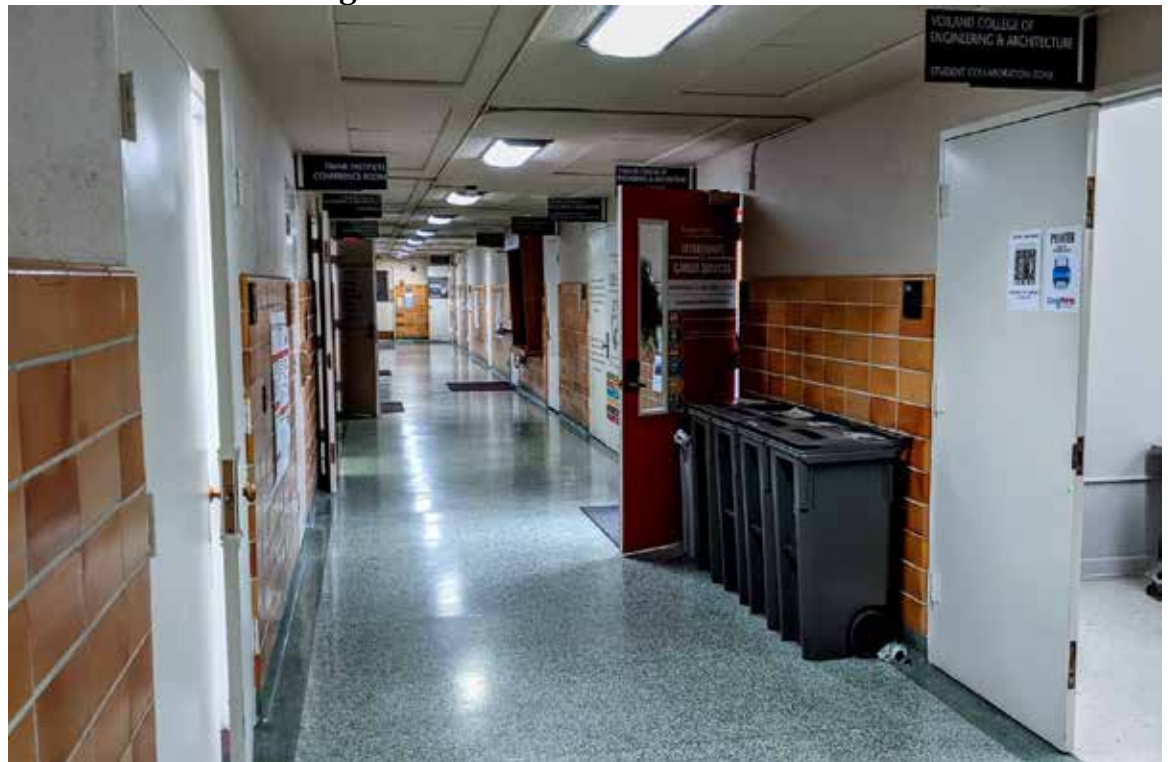
Figure 1 - Washington State University, Dana Hall- 1st Floor Hallway

- Life Safety:
 - NFPA 72, Sections 18.4.1 and 18.4.3 – visual and audible fire alarm notifications will be addressed with this project.
 - Access Card Swipe – Door hardware will include card swipe access with electronic lock down capabilities necessary for an active shooter response.
 - IBC 2018 Chapter 10 – Means of Egress - Exit paths will be located and sized appropriately and continuous with no obstructions.
 - IBC 2018 Sec 1005.7.1 Doors – when fully opened shall not reduce the required width more than 7 inches. See **Figure 1** below.

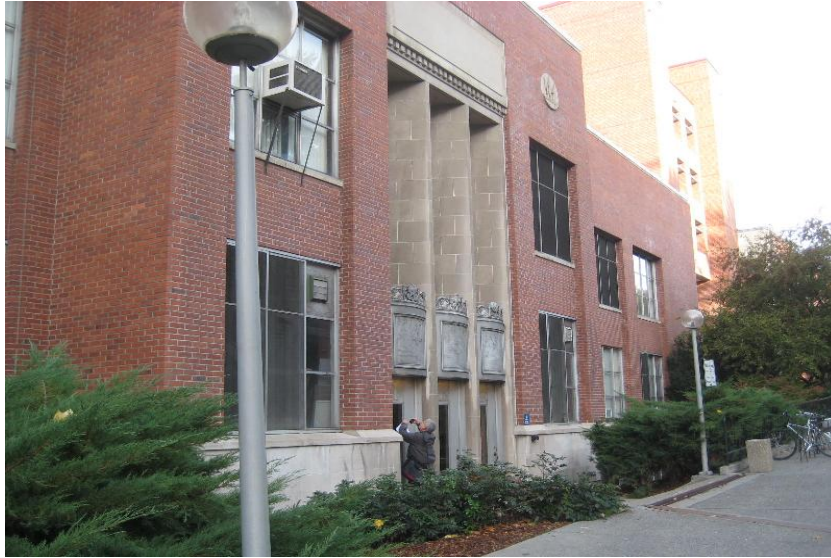
DANA HALL

System Name	Description
A - Substructure-Concrete Footings	Concrete spread column footings.
A - Substructure-Foundation Wall and Footings 12-Ft - Full Basement	Full basement wall and foundation with a 12-Ft. height to include strip footing, underdrains, foundation wall and damp proofing.
A - Substructure-Structural Slab on Grade - Non-Industrial	The building substructure includes a non-industrial type structural slab on grade.
B10 - Superstructure-Multi-	Multi-story concrete floor structure with reinforced cast in place concrete floor slab and beams supported by concrete bearing walls and columns.
