ANDERSON HALL

ANDERSON HALL: A LANDMARK AND A LEGACY

Resource Conservation Program Audit Report: Anderson Hall

Facility Number: 1351

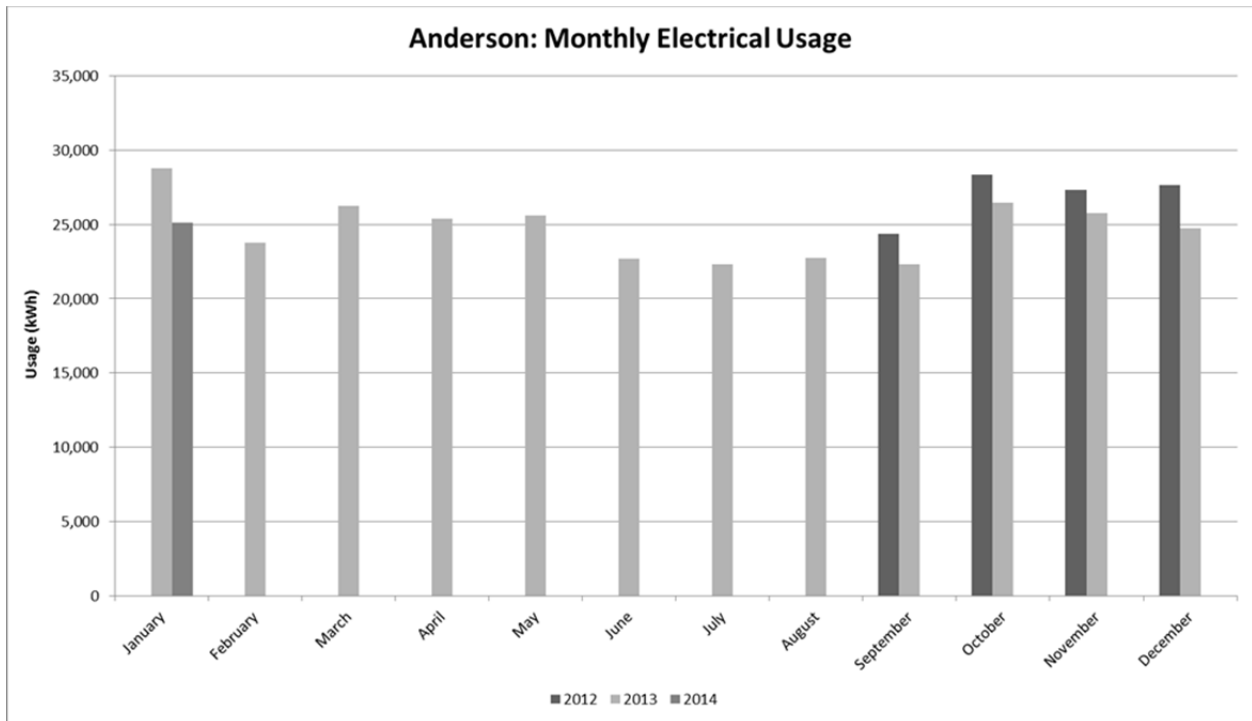
Figure 1: Monthly Electrical Usage

Figure 1 shows the monthly electricity usage. The data is compiled from the building-level submeter.

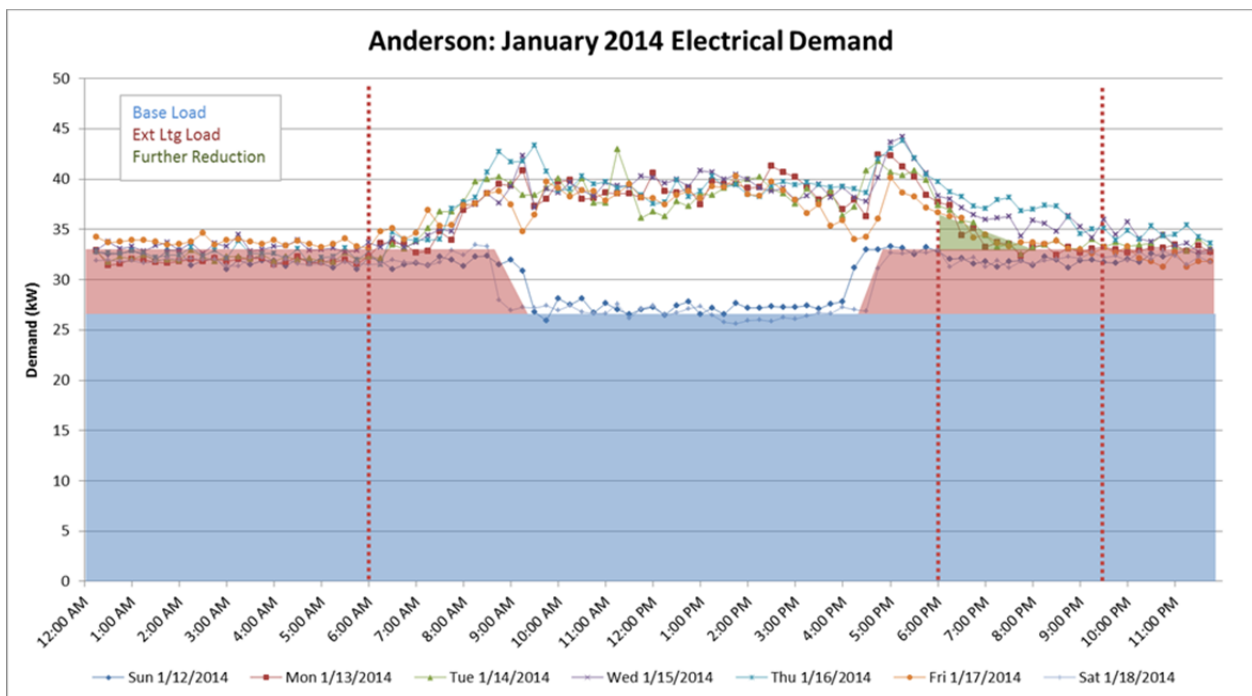
Figure 2: January 2014 Electrical Demand

Weekend loads tend to have a flat demand curve indicating no weekend occupancy. HVAC systems should be shut down during this period.

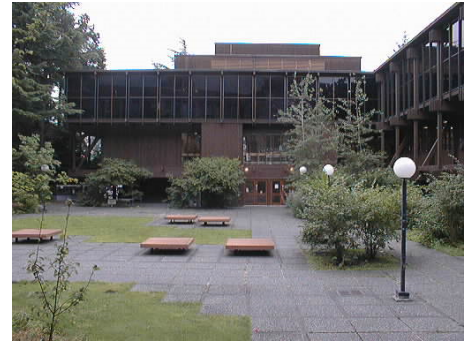
The concrete paving in the court yard at the south of the building is beginning to settle in an uneven manner, and wooden dividers are being replaced with concrete fill. The result is some tripping hazard and an aesthetic that is beginning to look bad.

Consider replacing the entire plaza paving at time of major building renewal.

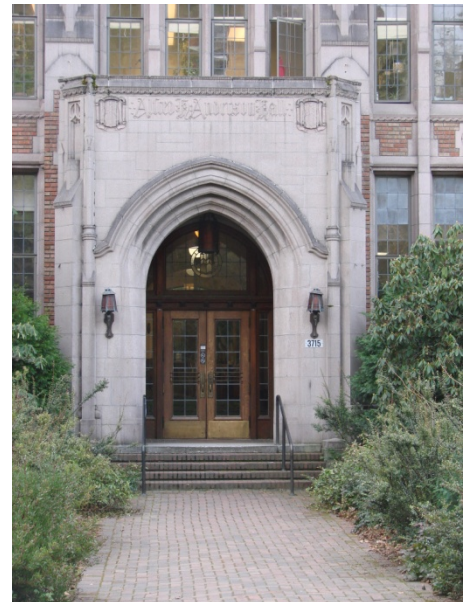
**Landscape: *Planting, Edging.*****Background/ Problem:**

Landscaping close to the building is mature, and in some cases are too close to the building. This prevents masonry walls from drying out efficiently.

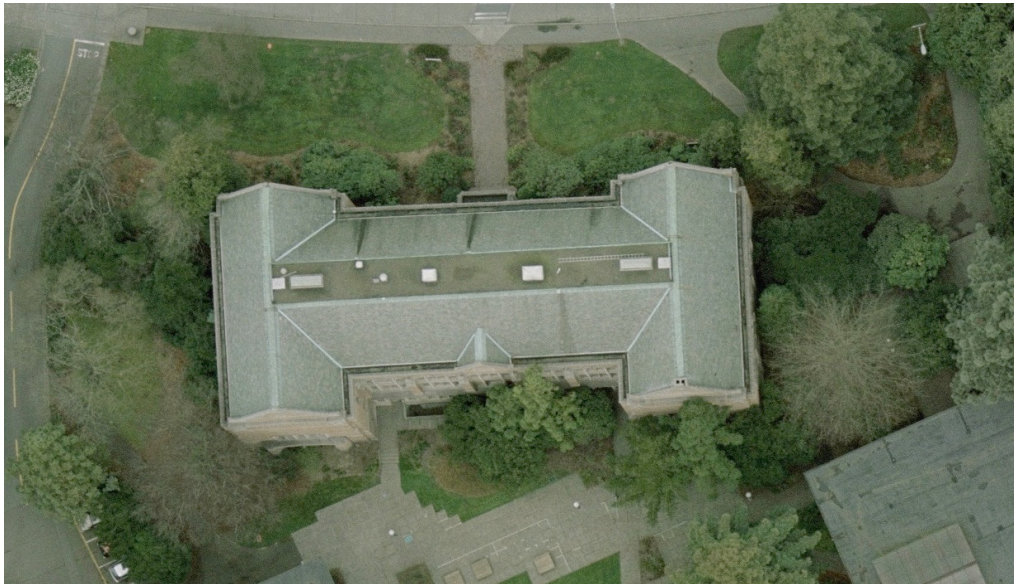
Civil:**General:****Tunnel**

This building is located on the lower campus (LC) tunnel system. Access to the tunnel is by way of a door in the basement mechanical room on the south side of the building. The 7-foot high 6-foot wide tunnel passage runs south from Anderson across the courtyard to Bloedel and then east to LC-8-1 which is near Winkenwerder. From LC-8-1 the tunnel extends northward to LC-8 which is the main lower campus branch. Most of this main LC tunnel was built in 1947 with the extension to Anderson /Bloedel/Winkenwerder built around 1970 with the construction of Bloedel Hall. (See Structural sections for more information on tunnels under the building footprint)

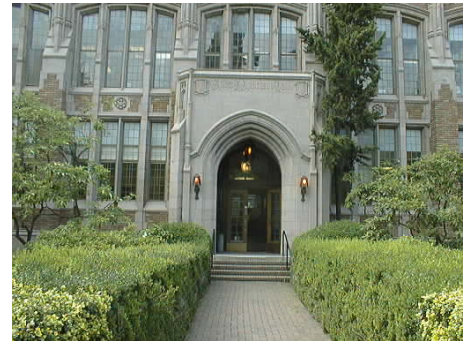
General:

This building is a three-story over crawl space, concrete structure with brick and cast stone cladding. Windows are single glazed and leaded, framed in steel sash, all set in cast stone surrounds. There is a steep-sloped roof with slate shingles, and a narrow flat area that was once a skylight now covered with a built-up roof. Roof ridges are still trimmed with ornamental copper cresting.

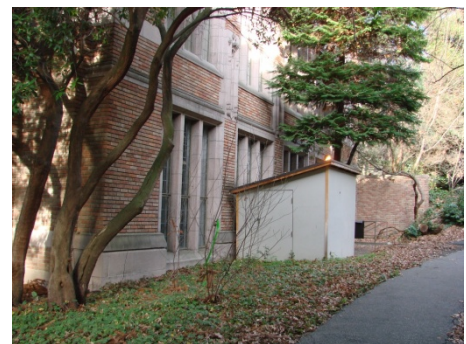
In the tunnels/trenches below the Ground Floor there is an ongoing issue with water infiltration and mold/mildew. A fan was added on the east side of the building to ventilate the areas and reduce the moisture. Some remedial cleaning was done however the entire area was not addressed.

Determine the source of water infiltration and mitigate. Clean and seal the tunnel/trench system.

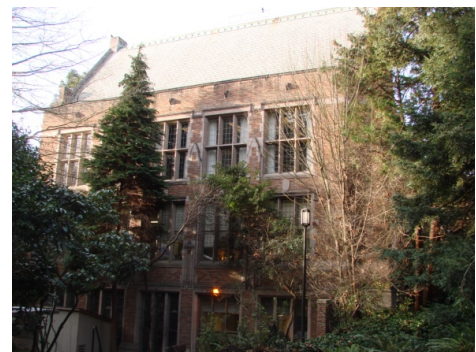
Exterior walls are of multi-wythe masonry consisting of a brick veneer with grey to pink cast stone window surrounds, tracery and decorative elements all built around a concrete frame. There is a history of water leaks from the roof gutter at the upper story east wall. This leak has resulted in damage to interior walls and finishes. This problem was partially corrected in the winter of 1999-00 by University masons and roofers.

Monitor the location of this historic leak and make additional repairs until the building renewal program is begun. At that time, determine the exact source of the leak and make permanent repairs.

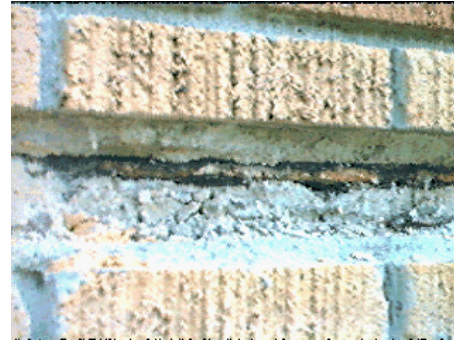
During the repairs of 1990, the masons also performed a masonry renewal consisting of cleaning, tuck pointing and sealing of the entire building façade. During that renewal, temporary repairs were made to rusty ledger angles and to cast stone elements where damage was severe.

Continue scheduled maintenance. The 99-00 masonry renewal did not attempt to restore the all elements of the façade and additional restoration can be expected. Perform detailed survey to determine extent of deterioration of the façade elements and design remedial measures.

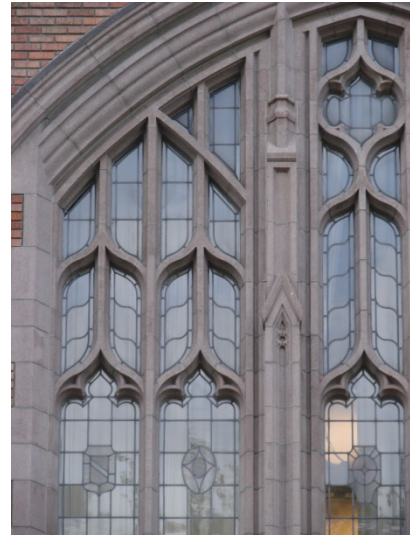
Windows are original, leaded single glazed, steel sash units set into cast stone tracery and surrounds. Operating sash are casement type with brass latches and restraining arms. These windows are generally in good condition, but are not weather tight or insulated.

Continue scheduled maintenance and replace windows at time of building renewal.

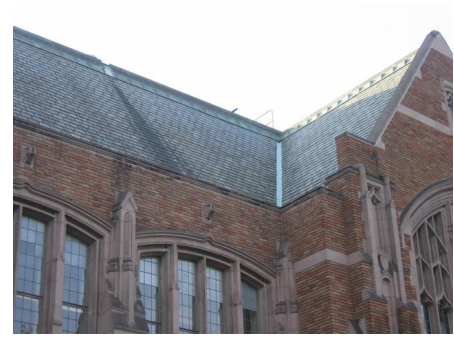
The main roof consists of a steep slope section covered with slate shingles, a top flat portion covered with built-up and gravel roofing, and copper gutters coated with an aluminum emulsion. The flat BUR is in fair to poor condition. The slate roof is in good condition with some atmospheric dirt. There is no fall protection system in place.

Continue scheduled maintenance and replace roof systems in a major building renovation. In the meantime, the slate roof may be cleaned to improve appearance.

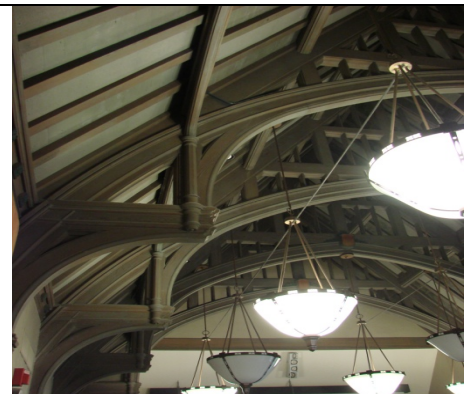
Ceilings are a combination of painted concrete, glued on ACT and suspended ACP. All are in generally good to fair condition. The large seminar rooms have vaulted ornate carved wood ceilings in good condition.

Continue scheduled maintenance and replace most ceilings in a major renovation. The vaulted ornate carved wood ceilings may be historically significant. They are recommended to be retained and refinished.
