2020 PROJECT PROPOSAL CHECKLIST
2021-23 Biennium Four-year Higher Education Scoring Process

WSU INSTITUTION	CAMPUS LOCATION
365 - Washington State University	Pullman
PROJECT TITLE	FPMT UNIQUE FACILITY ID # (OR NA)
Johnson Hall Demolition	A00267
PROJECT CATEGORY	PROJECT SUBCATEGORY
Replacement	Standalone
PROPOSAL IS	
New or Updated Proposal (for scoring)	Resubmitted Proposal (retain prior score)
<input checked="" type="checkbox"/> New proposal <input type="checkbox"/> Resubmittal to be scored (more than 2 biennia old or significantly changed)	<input type="checkbox"/> Resubmittal from 2017-19 biennium <input type="checkbox"/> Resubmittal from 2019-21 biennium
CONTACT	PHONE NUMBER
Jason Baerlocher	509-335-9012

Problem Statement - Washington State University requests \$8,000,000 in the 2021-23 Capital Budget for the demolition of Johnson Hall on the Pullman campus to capitalize on the rare appropriation of federal funds to replace the aged building with a new 105,000 square foot state-of-the-art research facility.

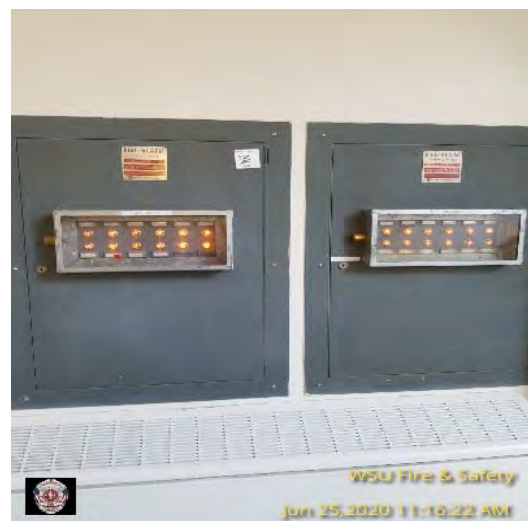
Figure 2 - Johnson Hall Fire Alarm Panel

Johnson Hall contains many critical building systems that have past their useful life and are in need replacement. Examples include:

- Air Handling Units
- Primary Electrical Service
- Building Electrical Distribution
- Cooling Tower
- Building Controls and IT Infrastructure
- Mechanical Distribution System
- Elevators
- 500 ton chiller (currently not operational)
- Building Envelope (windows, cladding, doors)
- Fire Alarm System (Figure 2)

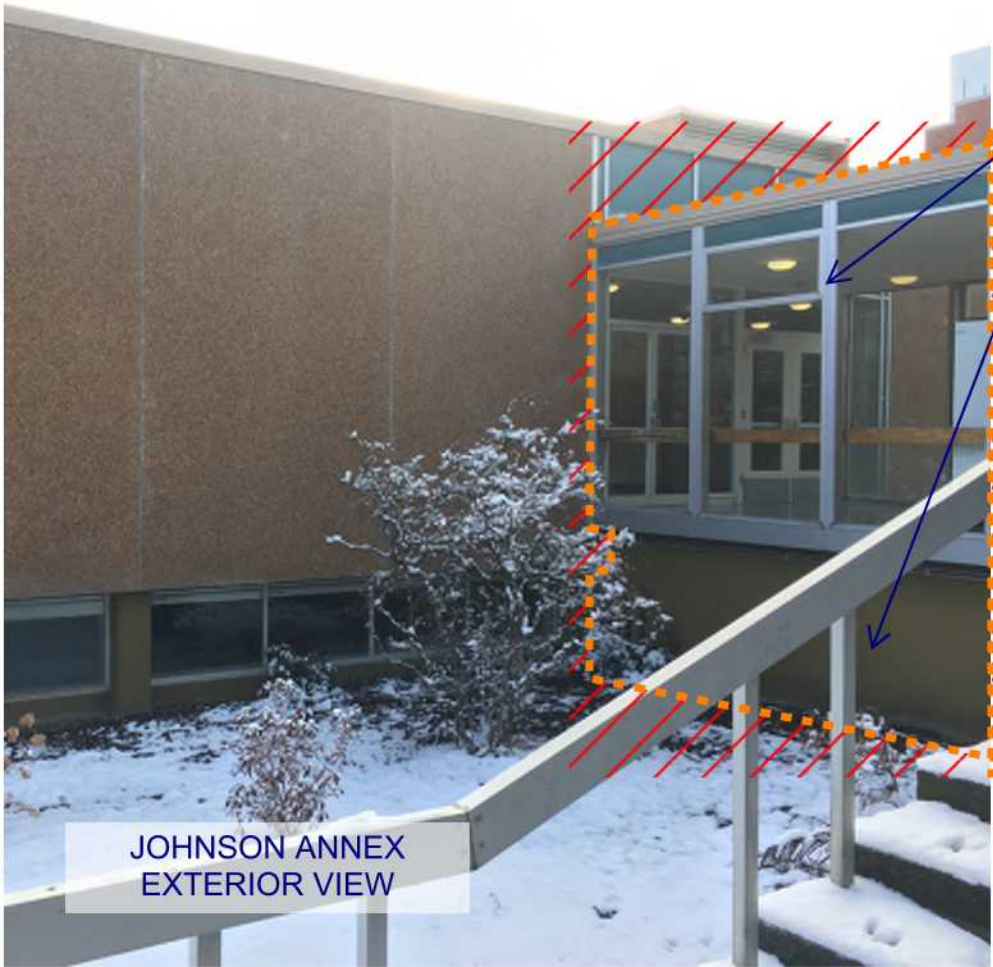
JOHNSON ANNEX
EXTERIOR VIEW

DEMOLISH GROUND LEVEL, AND
LEVEL 1 OF JOHNSON ANNEX
CONNECTION.

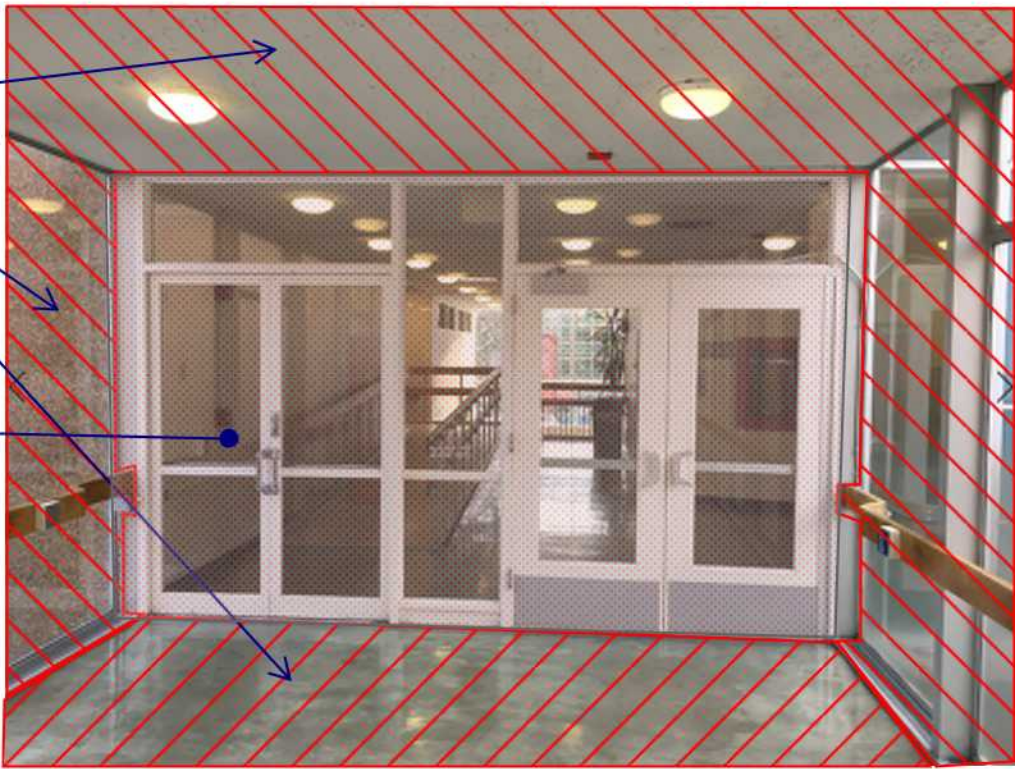
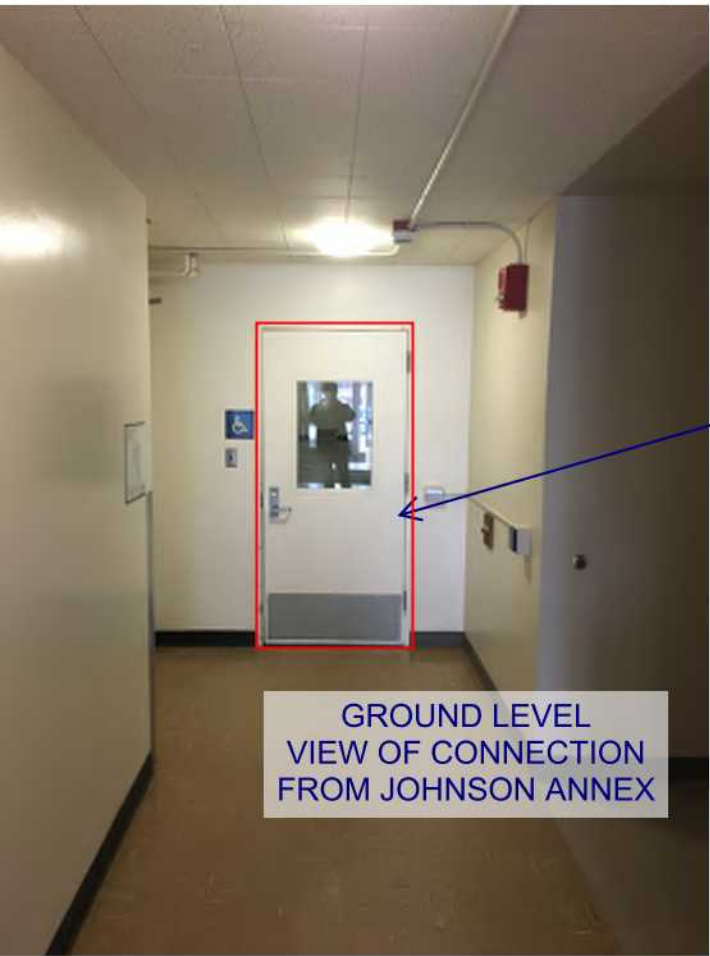
GROUND LEVEL
VIEW OF CONNECTION
FROM JOHNSON ANNEX

DEMOLISH JOHNSON
ANNEX CONNECTION.

-REMOVE DOOR.
-INFILL OPENING WITH
INSULATED METAL STUD WALL.

NEW CAST IN PLACE WALL.
WATERPROOFING AT
BELOW GRADE PORTIONS
OF WALL. EXPOSED
CONCRETE AT ABOVE
GRADE PORITONS.

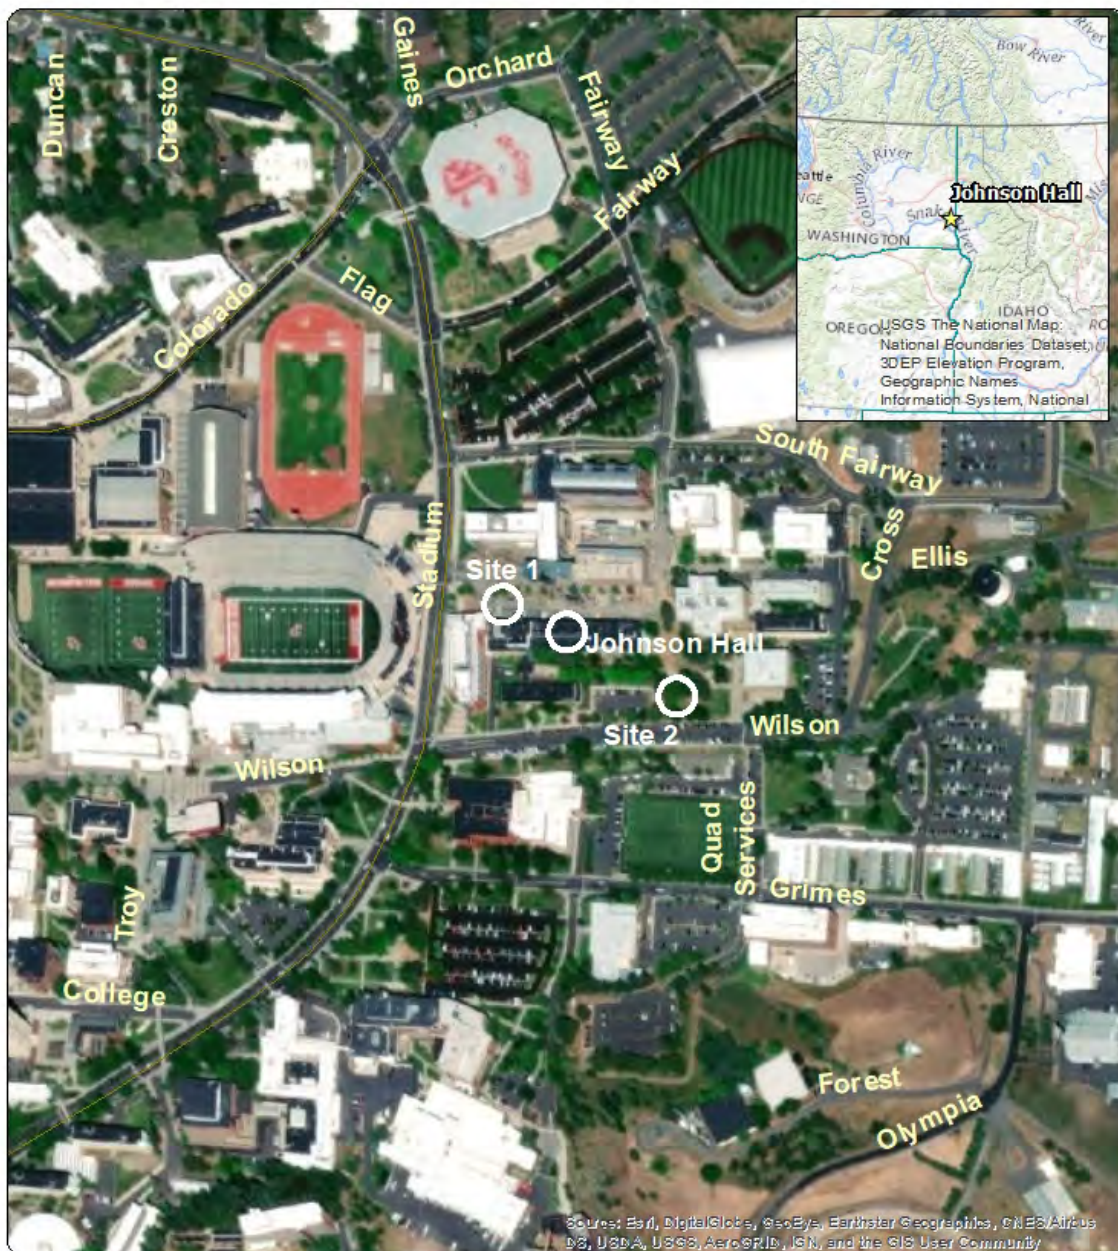
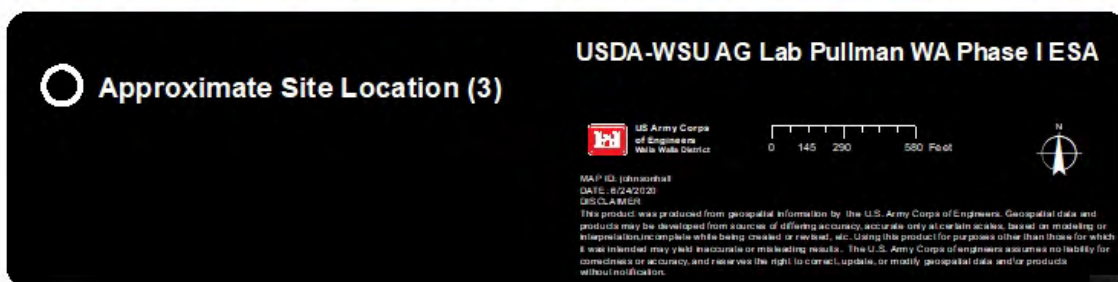
Figure 1. Location of the Subject Property. The Subject Property consists of Site 1, Site 2, and Johnson Hall.
