# MAGNUSON HEALTH SCIENCES (T-WING) RENOVATION PHASE II

This audit reflects the status of existing building systems, components and infrastructure for **Magnuson Health Sciences Center T-Wing** and includes known maintenance and/or operational issues related to those systems, along with a rating of their general condition. Also included are preliminary recommendations for addressing the issues noted.

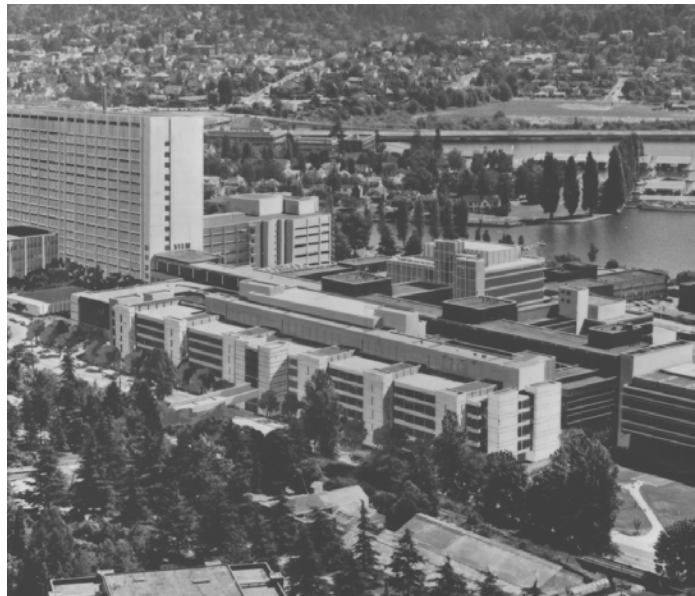
**T-Wing** was designed by Naramore Bain Brady & Johanson (nbbj) in 1970 and construction completed in 1972. The building has a concrete and steel framed structure. The exterior is clad with architectural precast concrete wall panels and single glazed windows with aluminum frames. Penthouses are stucco exterior over steel framing.

T-Wing consists of seven floors with a basement. The building is divided into 3 separate structures with 2 seismic joints that extend North-South through the building. The building is also isolated from the original Health Science Center by a continuous seismic joint.

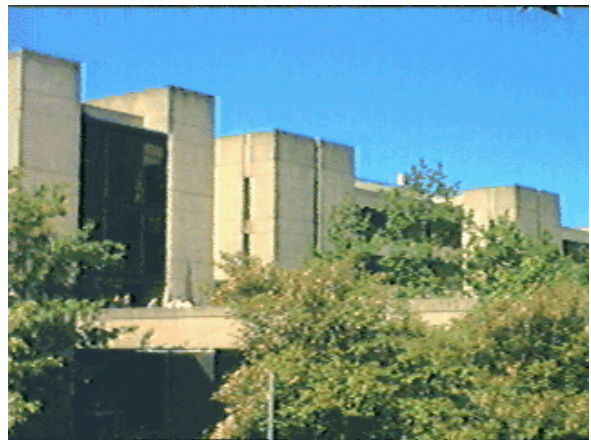
The façade is CIP and precast concrete panels. Over time, rain and air-borne solids stain the concrete, especially near the tops of walls. Sealant in panel joints has a general life expectancy of 15-years, and this building is past due for new sealant.

Clean exterior concrete surfaces and apply a penetrating sealer. Replace sealant at panel joints within 5-years.

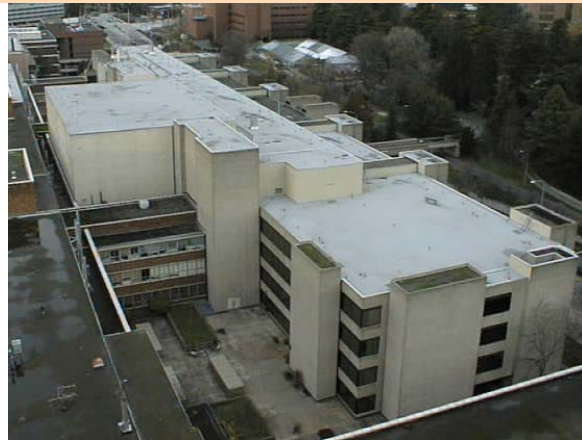
The roof is modified bitumen with a white granulated cap sheet. The upper roof was replaced in 1999. The lower roofs were replaced in 2004.

Stainless steel flashing and copings were added during the two roofing projects.

Roofing and flashings are in good condition.

Maintain scheduled maintenance for useful life of the roofs.
