CAPITAL PROJECTS PROPOSAL 2021-2023

**Psychology Building
Renovation | Stand-alone**

August 15, 2020

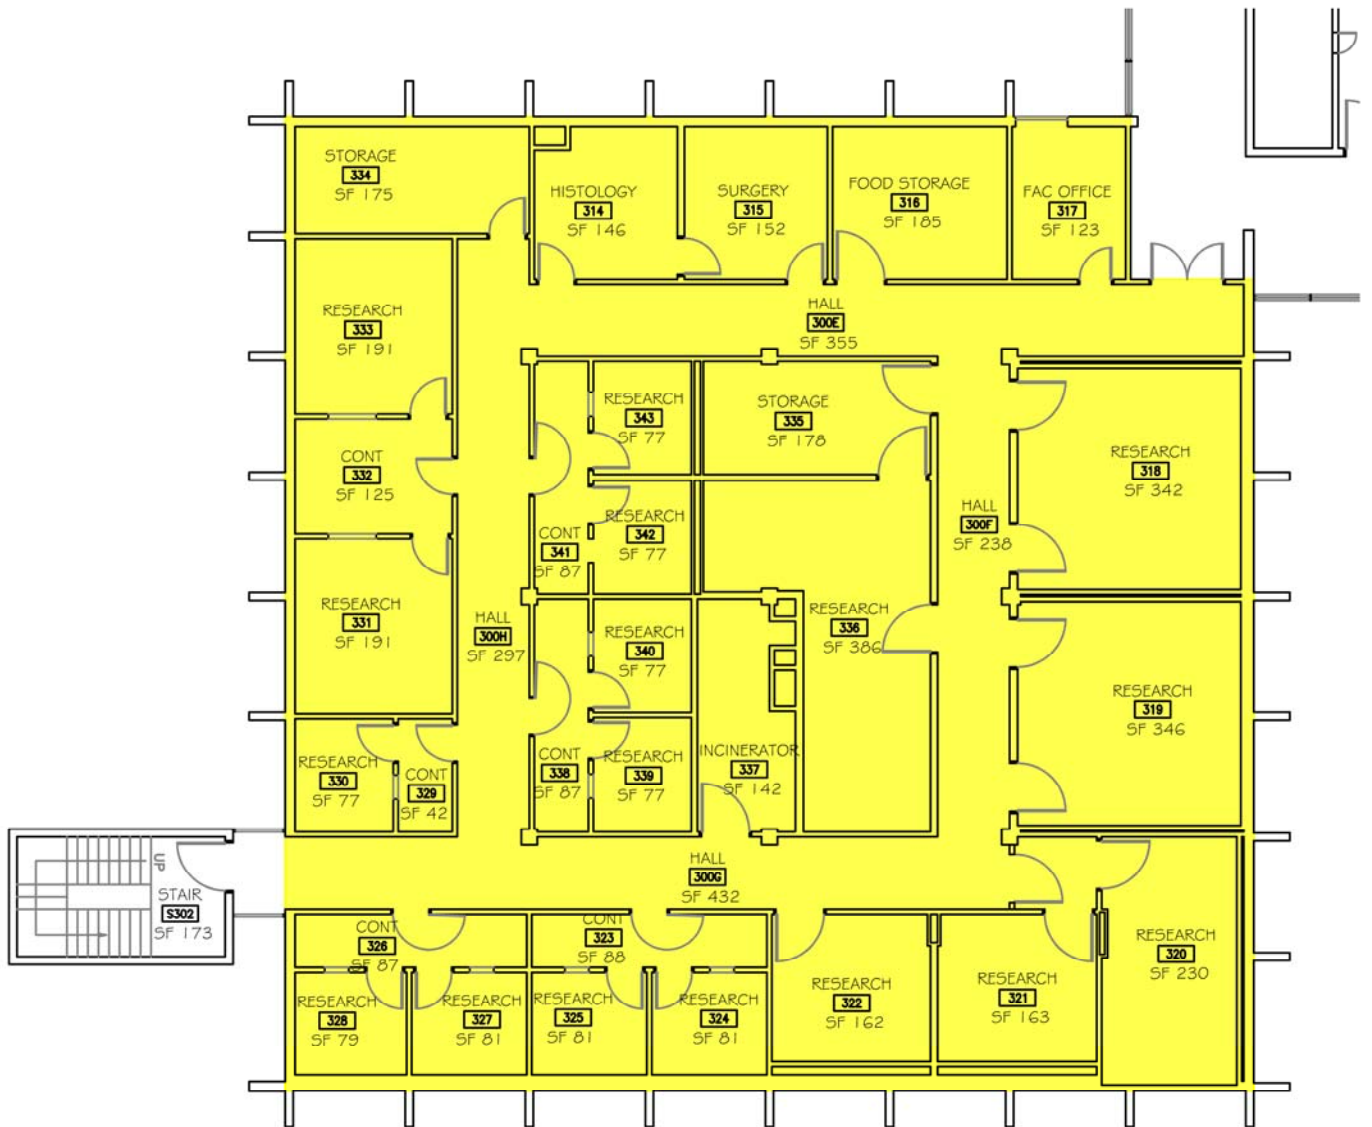
APPENDIX G

Psychology Building – Third Floor Plan – SW (Chimp Area)

FORMER CHIMPANZEE WING AT PSYCHOLOGY BUILDING.

SQUARE FOOTAGE: 6408 SF

PSYCHOLOGY BUILDING THIRD FLOOR - SW Wing

A key factor driving the need for renovation is the use of the building to house chimpanzees between 1981 and 1992. The north wing of the third floor of the building housed five chimpanzees within the Chimpanzee and Human Communication Institute (CHCI). Sewage, air handling, and other systems were contaminated and corroded by the extreme demands associated with caring for the chimpanzees. The integrity of the floor structure has been compromised due to the saturation of chimpanzee urine; highly acidic urine compromised the integrity of reinforcing steel in the concrete floor. The entire building’s air-handling systems were clogged with chimpanzee dander and hair. Resulting health and safety concerns caused the south-west wing of the third floor to be completely closed off and it has been unusable since 1993. **Appendix G** shows the extent of the affected floor plan.

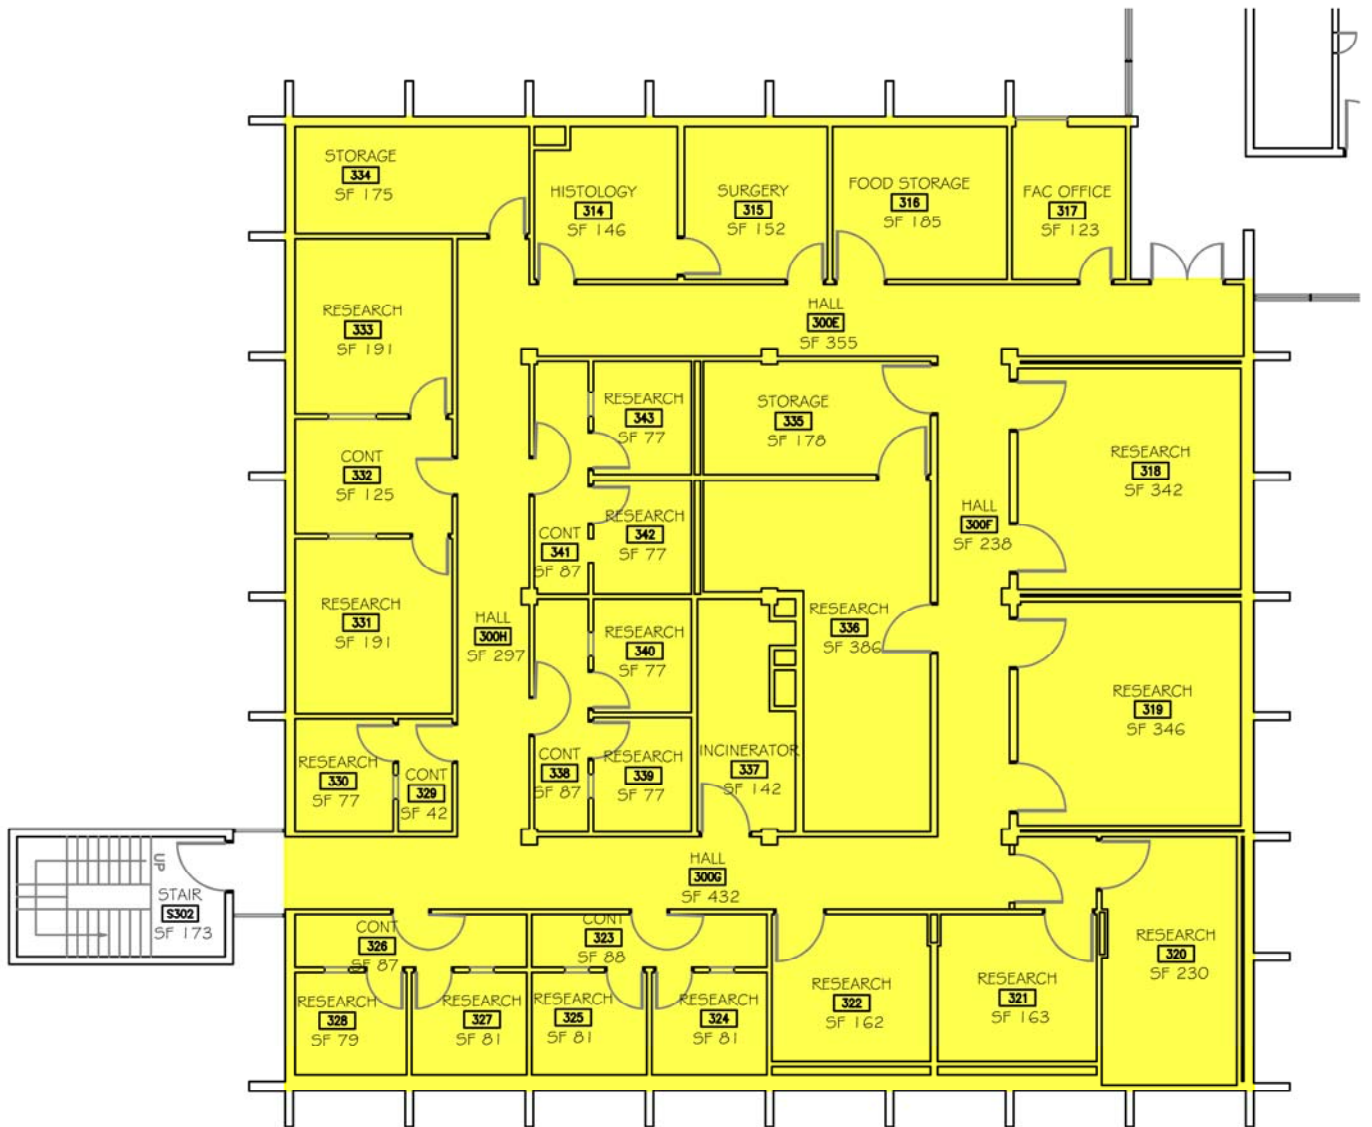
APPENDIX G

Psychology Building – Third Floor Plan – SW (Chimp Area)

FORMER CHIMPANZEE WING AT PSYCHOLOGY BUILDING.

SQUARE FOOTAGE: 6408 SF

PSYCHOLOGY BUILDING THIRD FLOOR - SW Wing
