Washington State Patrol

2022 Supplemental Request

Subject: Washington State Patrol 2022 Supplemental Capital Budget Request

SPRINKLER SYSTEM ASSESSMENT

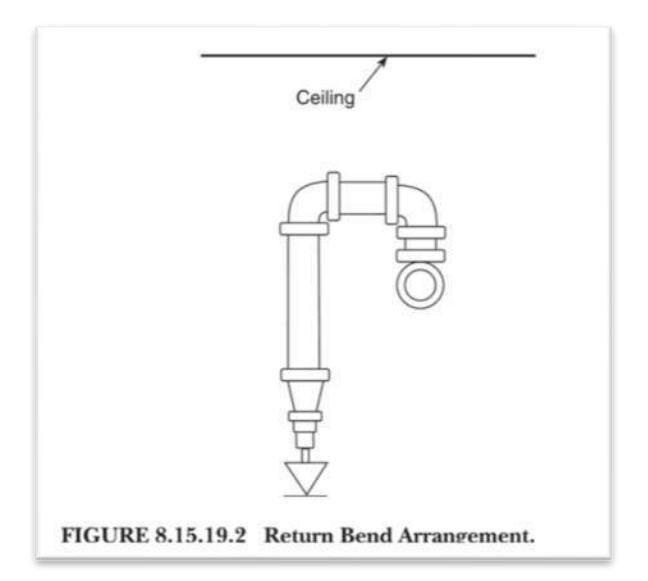
Additional deficiencies in the sprinkler protection for the Vehicle Inspection Building includes the use of direct-drop pendent sprinkler heads for the office space. These sprinkler drops do not incorporate a return bend arrangement required for raw water sources as shown in Figure 7 below. As such, accumulation of water and debris can occur within the drop. The extent of such was not investigated. Pendent sprinkler heads beneath the exterior trailer bay on the east end of the building were observed to have varying degrees of corrosion and are in need of replacement.

Figure 7. Return Bend Arrangement. *NFPA 13 Figure 8.15.19.2 demonstrating a return bend arrangement.*
