AGENCY 390: WASHINGTON STATE HISTORICAL SOCIETY  
BI23 CAPITAL BUDGET REQUEST

**390 - Washington State Historical Society  
Ten Year Capital Plan by Project Class  
2021-23 Biennium**

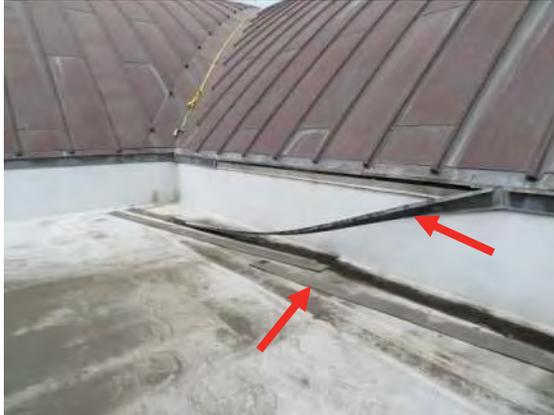
The sheet metal flashings at the steep-slope-to-low-slope roof intersection, and at all sheet metal roof system eave edges, appears to be generally inadequately secured and these flashings have become either fully or partially detached in several locations, apparently during wind events and through thermal expansion and contraction. Key sheet metal components in the flashing assembly appear not to have been mechanically fastened, and properly cleated and clipped for thorough securement at the time of construction. Several locations examined do not appear cleated nor clipped, and instead appear to be only held in place predominantly through compression-type (e.g., crimped) forces. For example, the perimeter eave flashing fits between the hemmed downslope edge of the overlying roof panels and the hemmed edge of the underlying perimeter flashing, and appears to rely on compression from the overlying metal panel clips to remain in place, which is not prudent nor desired during wind events and/or during the temperature swings that can occur during the cool/cold winters of the Pacific Northwest that turn into warm springs and hot summers, which result in relatively significant thermal induce contraction and expansion movements of sheet metal components. Please see photos and field sketch below for more detail information regarding this deficient condition.

**Photo No. 2** - Photo depicts overview of location at the west side of the building where sheet metal flashings (perimeter eave flashing and transition counterflashing) at the metal steep-slope-to-low-slope membrane roof systems. The flashings have become partially, and in locations fully, detached from the building. Following the survey BET&R bundled the loose components up and tied them down to a weighted stanchion base to mitigate blow-off potential. This item must be promptly addressed with additional temporary ballast by facility maintenances soon as possible as these loose flashings could be an urgent life safety hazard issue if winds blow them from the roof onto the public below. As soon as the loose flashings have been temporarily secured, then these deficient as-built flashings should be re-detailed for retrofit with different and additional mechanical attachment for long-term securement.

**Please Note:** BET&R would be glad to work with SSWA, whereby BET&R could promptly prepare a written scope of work, while simultaneously working with SSWA to prepare detail drawings, in prompt collaborative efforts to expedite and facilitate a retrofit project, which could then be bid, and then upon award of the work, the necessary work should be executed by a qualified local sheet metal roofing and flashing contractor.

**Preliminary Recommendation:** BET&R recommends that a retrofit of the sheet metal flashing at the draining eave edge of the steep-slope roof area be undertaken as soon as possible. The perimeter eave flashing should be mechanically secured to meet code wind uplift requirements, and industry sheet metal securement standards, in order to provide long-term weatherproof (e.g., wind resistant) and watershedding performance.

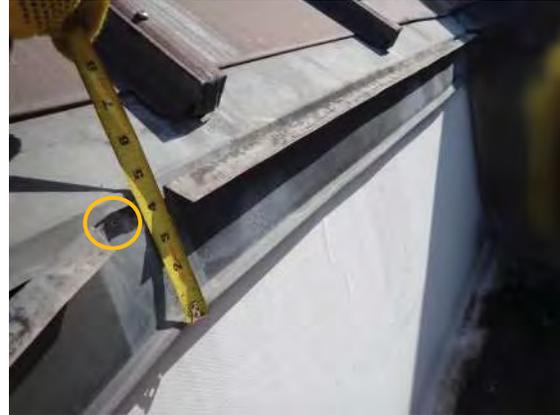
**Photo No. 3** - It appears the perimeter eave flashing attachment is reliant on compression between the overlying metal panel clips and the underlying perimeter flashing. The perimeter eave flashing has become detached from the building in this location and the counterflashing is now only partially attached. Rivets (yellow circled location) appear to have been placed at only each end of the ~10-foot lengths of sheet metal counterflashing, most likely just installed during construction for temporary holding convenience. These rivets appear to be the sole source of mechanical attachment and are not adequate means for securement of this sheet metal flashing assembly. **Please Note:** These flashings also require urgent retrofit in order to avoid a public safety hazard if winds were to blow them off from the building during a potential upcoming wind event. BET&R would be glad to work to prepare a written scope of work and/or detail drawings and work in collaboration with SSWA in prompt efforts to facilitate a retrofit project, which could then be bid by quality-oriented local sheet metal shops, and then upon award of the retrofit project the necessary work should be executed by a qualified local sheet metal roofing and flashing contractor.

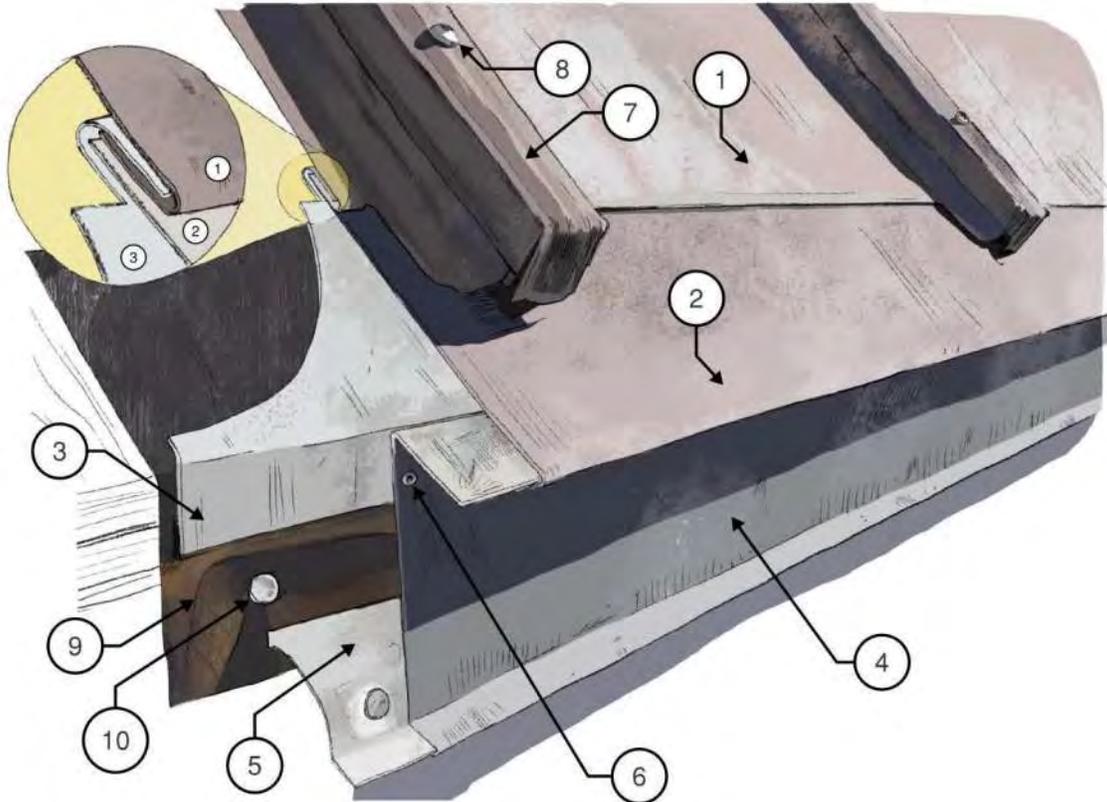
**Figure No. 2.** Field Sketch of the sheet metal at draining eave edge. Please note: Some components have been depicted layered, cut-back, expanded, or augmented for clarity. **1.** Lead-coated copper roof panels; **2.** Perimeter Eave Apron/Flashing, this component was observed fully detached at one location on the west side of the steep-slope roof area; **3.** Underlying perimeter flashing; **4.** Combination Apron-flashing Cleat & Fascia Counterflashing, this component was observed both partially and fully detached at one location on the west side of the steep-slope roof area, it was also disengaged from the underlying drip-edge cleat (5) in the same and numerous other locations; **5.** Cleat; **6.** Convenience Rivet, observed one at either end of the end of the partially detached 10-foot Apron-cleat & Fascia Counterflashing piece; **7.** Lead-coated Copper Clip Batten; **8.** Stainless-Steel Screw Fastener; **9.** Self-Adhering Underlayment (Grace Ultra), where the overlying sheet metal pieces were detached the Grace Ultra showed signs of oxidization/discoloration and degradation from prolonged UV exposure; **10.** Round-head roofing nail observed fastening the Cleat to underlying substrate and also appearing to secure the underlayment in places.

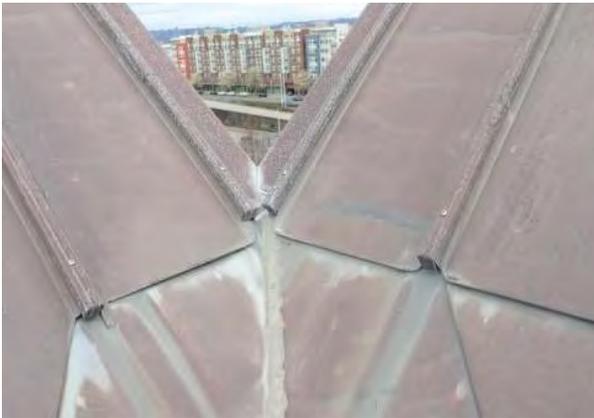
Aged and embrittled sealant was observed at the inside corner intersection of the sheet metal coping flashing above the North Plaza Deck adjacent the Museum's main entry. Streaking from water tracking down the sheet metal cornice and visibly wet and stained brick masonry was observed from the ground at this location, indicating that water flow was uncontrolled at the apex of the roof edge and sheet metal cornice. Visual and tactile observation from the roof at this location revealed aged and embrittled sealant at laps of the sheet metal coping flashing. It appears that water running down the slope of the barrel roof at the rake edge of these two adjoining steep-slope roof areas may not drain entirely to the low-slope roof area as designed. The water appears to be then be forced out over the roof edge and down the face of the cornice.

**Photo No. 4** - Depicts the intersection of the steep-slope roof perimeters and specifically the rake edge roof panels at the intersecting sheet metal roof areas. The sealant applied at the laps of these sheet metal roof panels and flashing components has degraded and reached the end of its useful service life.

**Preliminary Recommendation:** *Degraded and aged sealant joints should be carefully removed, the joints cleaned, primed and prepared; and then, new high-performance sealants (i.e., non-skinning butyl in concealed joints and silicone in exposed joints) need to be correctly specified and detailed by an experienced and knowledgeable sheet metal roofing consulting firm, working collaboratively with SSWA. Utilizing those prepared project documents, the full-scope of this metal-roof-related sealant work can be appropriately bid by sheet metal experienced contractors and then properly installed by the selected contractor, so as these sealant joints will perform successfully for the long-term.*

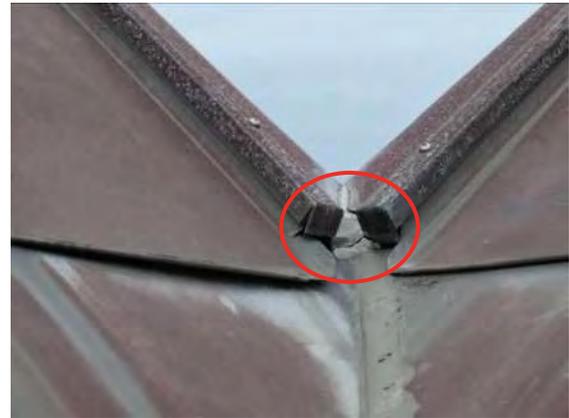
**Photo No. 5** - Depicts close view of aged, degraded, and failing sealant at the roof panel intersection above the north courtyard.

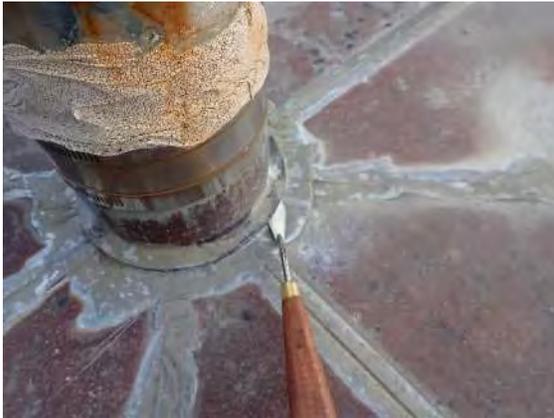
Numerous solder joints at the lead-coated copper roof panels around the fall protection anchors and near the apex of the barrel roofs have broken open and need correction prior to 2020 fall and winter rains, winter-snow, freezing temperatures, ice and ice-melt. The majority of these broken solder joints were observed at lower-sloped, high traffic areas at the apex of the sheet metal standing seam roof system.

**Photo No. 6** - Depicts broken solder joints at the sheet metal flashing around a fall protection anchor at the apex of the steep-slope roof area, which needs to be repaired and flashed over.

**Preliminary Recommendation:** *BET&R recommends carefully removing all loose and damaged solder where damaged joints have broken open, then the joints can be cleaned, prepared, re-tinned, and correctly soldered. All solder joints should be probed and those that need attention marked to re-work and corrective-action repair or retrofit. The installation of new solder joints, at all failed solder joints, are recommended to be performed by a qualified sheet metal Contractor, that employs experienced craftsmen capable of successfully soldering lead-coated copper panels. After corrections of the solder joints adjacent the fall protection anchors, those joints should be flashed over with a new 16 ounce soft copper flashing collars, or a 4lb. lead flashing collar, or can be over-flashed with PMMA liquid applied flashing, fully reinforced with polyester-fleece to form a new flashing boot, installed at the fall protection anchors.*

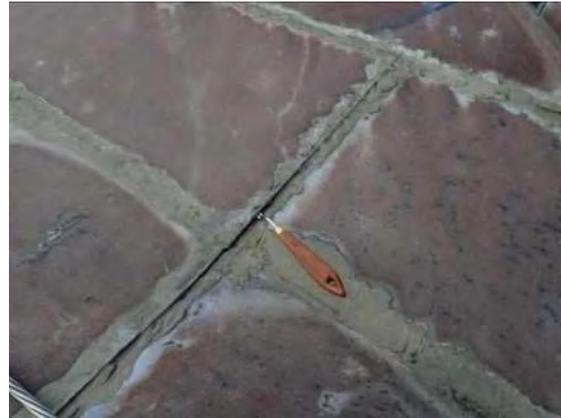
**Photo No. 7** - Depicts probe inserted into a broken solder joint near the apex of the sheet metal roof area, this location was in a more heavily trafficked portion of the roof area and may have been caused by repeated roof maintenance traffic applying pressure to the solder joint, rather than stepping over and past the joint.

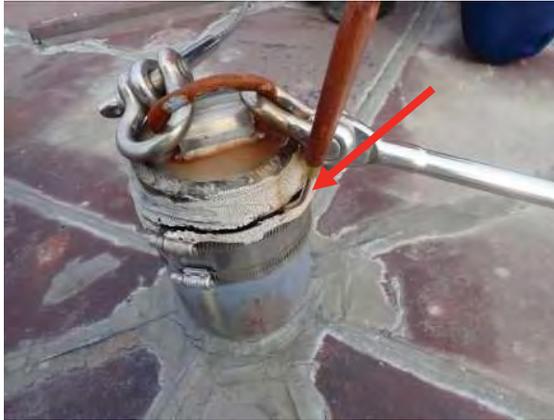
The sealant applied at the three (3) fall protection anchors above the sheet metal flashing collars and stainless steel clamping bands is weathered, sun degraded, crazed, and at the end of its useful service life. The sealant at all three fall protection anchors is embrittled, and the southernmost safety anchor location is the most heavily crazed, embrittled, cracked, and degraded, but all are in need of retrofit.

**Photo No. 8** - Depicts a round-nosed probe inserted into a cracked and failed sealant joint at the fall protection anchor at the south end of the steep-slope roof area.

**Preliminary Recommendation:** BET&R recommends carefully removing all aged and degraded sealant joints, thoroughly cleaning of the lead flashing-to-anchor post intersection, and then installation of a PMMA primer and a new PMMA resinous liquid applied and fully-fleece reinforced flashing collar, applied to overlap the existing lead flashing, that should be by a qualified roofing contractor in coordination with the roofing panel Manufacturer to ensure that the existing warranty is maintained.

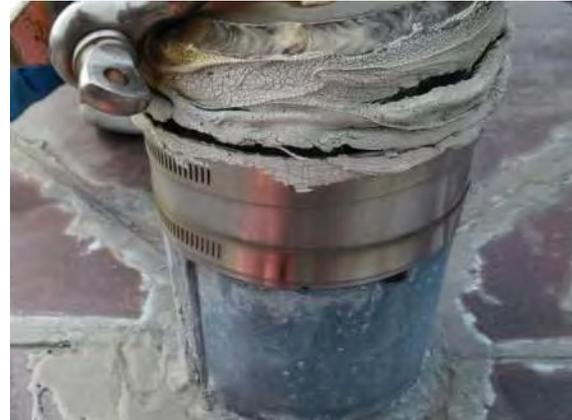
**Photo No. 9** - Depicts weathered, degraded, crazed and cracked sealant joint at a fall protection anchor on the steep-slope roof area.

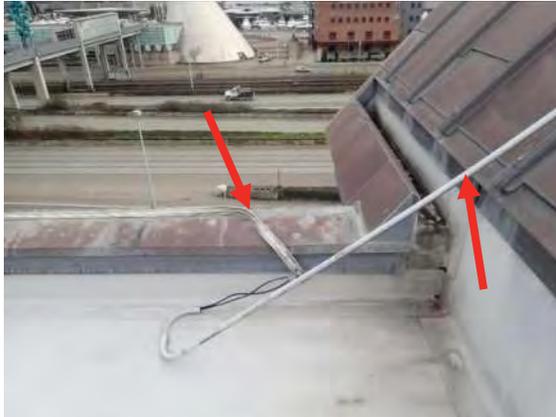
The thin strip of electrified bird deterrent installed at the perimeter of the building's main roof area is displaced and incompletely adhered in numerous locations. Additionally, the sealant used to adhere the metal strip to the sheet metal parapet is degraded and has disbonded from the sheet metal in numerous places. Contacts and connections apparently used to electrify the bird deterrent were also observed to be displaced in several locations. Further displacement and detachment of portions of the bird deterrent system may be expected, due to manner in which it was installed, and will pose a hazard if the system or system components detached from the roof and fell or are blown onto adjacent pedestrian or traffic areas below.

**Photo No. 10** - Photo depicts displaced and progressively detaching electrified bird deterrent strips and loose and damaged plastic conduit at the steep-slope-to-low-slope transition at the northeast corner of the building. The bird deterrent system should be repaired, secured, or removed soon.

**Preliminary Recommendation:** *BET&R recommends the careful removal of all degraded sealant adhesive, damaged plastic conduit, and damaged bird deterrent components, followed by replacement with new, more robust components, and they should be thoroughly secured for the long term, by a qualified contractor, and to meet the roofing panel Manufacturer's requirements so as not to affect the roof warranty.*

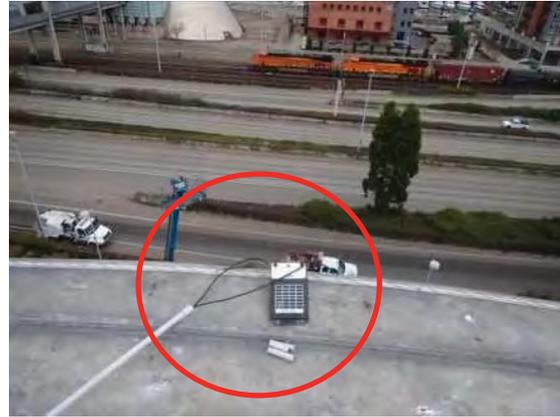
**Photo No. 11** - Photo depicts loose electrical equipment and components at the apex of the steep-slope barrel roof area on the east side of the building. The bird deterrent system should be repaired, secured, or removed soon.

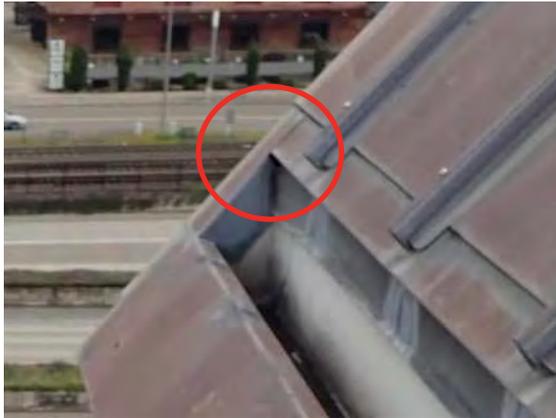
Improperly tabbed and sealed joints on the vertical face of the sheet metal flashing at the membrane gutter-to-steep slope roof area transition have resulted gaps in the sheet metal flashing and left the top edge of the low-slope roof membrane exposed to wind-driven rain and weather in locations. This condition was observed at the inside corner of the sheet metal roof perimeter flashing, and is in need of a backer rod and sealant closure.

**Photo No. 12** - Photo depicts opening at the sheet metal eave edge flashing-to-membrane gutter intersection. The unsealed termination of the roofing membrane was observed to be exposed at this opening, which is in need of correction.

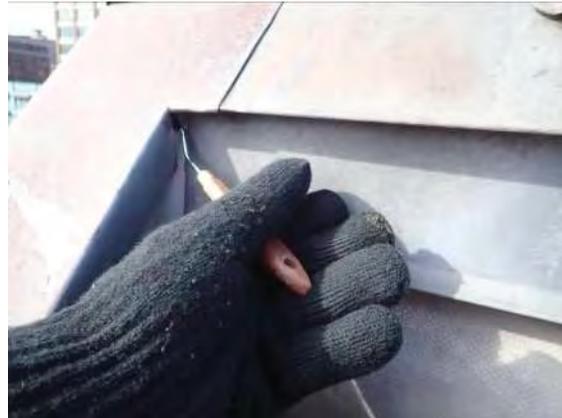
**Photo No. 13** - Photo depicts a tactile probe inserted into an opening at the sheet metal eave edge flashing-to-membrane-lined gutter intersection. This condition was observed in the majority of the areas accessed and appears to be a typical condition – all of which are in need of backer rod and sealant and properly formed, fit, and secured sheet metal corner closures.

**Preliminary Recommendation:** *BET&R recommends the installation of closed-cell foam backer rod, Dow silicon sealant, then properly formed and secured sheet metal corner closures to close off these open and weather exposed conditions. This type of repair is recommended to be detailed in a drawing, generated by a knowledgeable and experience repair designer, so that the repair can be properly installed by a qualified contractor and integrated into the existing steep-slope roof system in a weathertight and watershedding manner.*

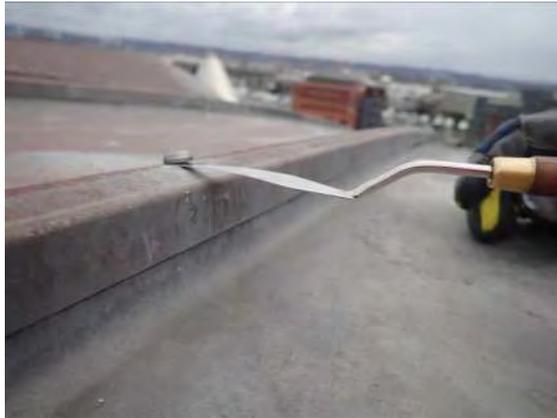
The stainless-steel fasteners that secure the lead-coated copper batten caps to the machined panel clips of the metal roof are loose in locations. The proper installation of these fasteners is critical to properly securing the sheet metal battens and preventing displacement and wind blow-off. Allowing loose fasteners to go unattended to may be anticipated to lead to the displacement or detachment of the sheet metal batten and cause a life safety risk during an upcoming wind event.

**Photo No. 14** - Photo depicts roof technologist's tactile probe inserted between the head of the loose stainless steel screw fastener and the lead-coated copper roof panel seam battens at the apex of the steep-slope barrel roof area on the southern (i.e., windward) portion of the building.

**Preliminary Recommendation:** BET&R recommends having BET&R work with SSWA and the roofing panel Manufacturer to arrive at a mutually agreed upon, prudent and long-term corrective action detail for retrofitting of these loose roof batten conditions. All loose fasteners should be temporarily and properly torqued tight per the roofing Manufacturer requirements, in effort to maintain the roof warranty.

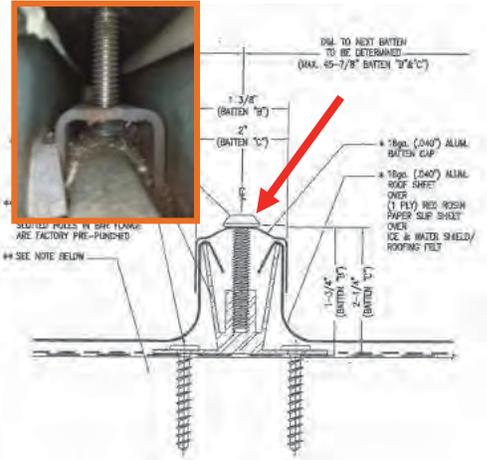
**Photo No. 15** - Excerpt from Overly Manufacturing shop drawings depicts general arrangement of the roof system panel and batten securement. The machine screws were observed to be loose in select locations, as indicated with red arrow. Inset photo depicts example actual in-situ batten seam clip and machine screw threaded shank.

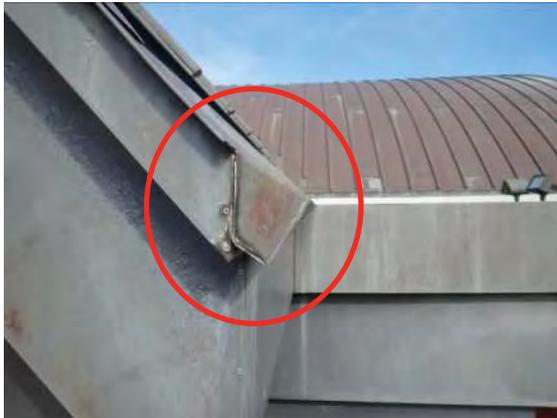
The sealant at the sheet metal rake edge metal flashing and the exterior face of the sheet metal gutter flashing is cracked, disbonded, degraded, and at the end of its useful service life.

**Photo No. 16** - Photo depicts aged and failed sealant joint at the roof's perimeter rake edge flashing-to-sheet metal gutter flashing intersection.

**Preliminary Recommendation:** *BET&R recommends the careful removal of aged and degraded sealant, cleaning of the intersecting joint, and the installation of new high performance gutter seal or silicon sealant, which can be installed by a qualified sheet metal roofing or gutter specialty contractor to correct this condition for the long-term.*

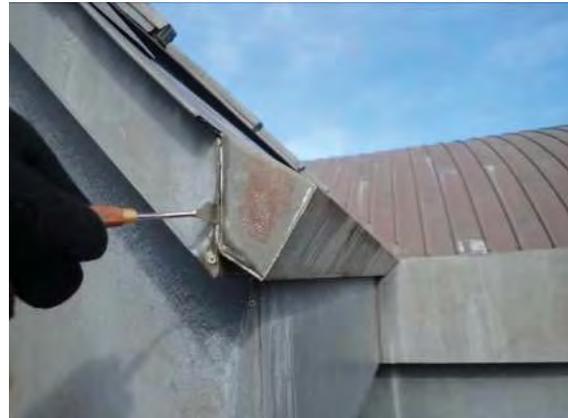
**Photo No. 17** - Photo depicts roof technologist's flat metal probe carefully inserted into the failed and open sealant at the sealant-dependent sheet rake edge-to-sheet metal gutter flashing intersection. Due to anticipated rain water runoff migrating into these open joints, BET&R recommends including this failed detail in to an upcoming roofing and flashing repair & retrofit project, which BET&R would be glad to assist SSWA and the Museum to design and see to completion this year as needed.

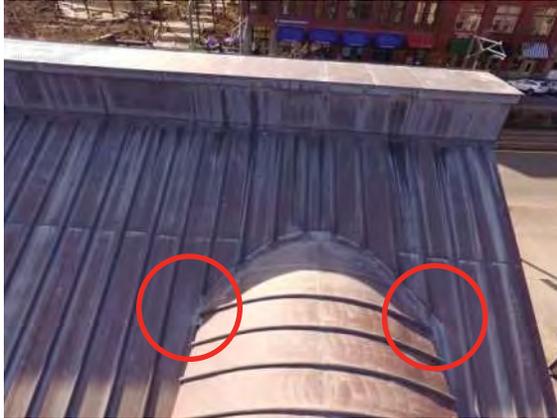
At the intersection of the sheet metal flashing at the upslope apex of the barrel-shaped roof of the small dormer on the north end of the Anthem Café adjacent to the building's Main Roof Area, BET&R observed open sheet metal joints and degraded sealant. Moisture and signs of prior moisture intrusion were discovered downslope of this location indicating that the deficiencies observed at the Dormer's apex flashing-to-main roof intersection, located just above the dormer roof, are allowing water into the roof system.

**Photo No. 18** - Photo depicts overview of the apex flashing at the dormer roof-to-main roof transition at the east side of the Anthem Café portion of the facility.

**Preliminary Recommendation:** BET&R recommends the removal and replacement of all aged and degraded sealant joints as soon as possible, and the well thought out re-design of this apex flashing-to-Upper Main Roof intersections in order to properly plan the retrofit of this apex sheet metal flashing at the dormer-to-main field of roof intersection by an experienced sheet metal roofing and flashing contractor. This detail, along with numerous other flashings and transitions at the building/facility are recommended to be properly retrofit – before winter rains cause more leakage into the roof system -- and before frost and freezing weather cause more issues and keep skilled tradespersons off the steep-slope sheet metal roof system due to potential for slipping and injury.

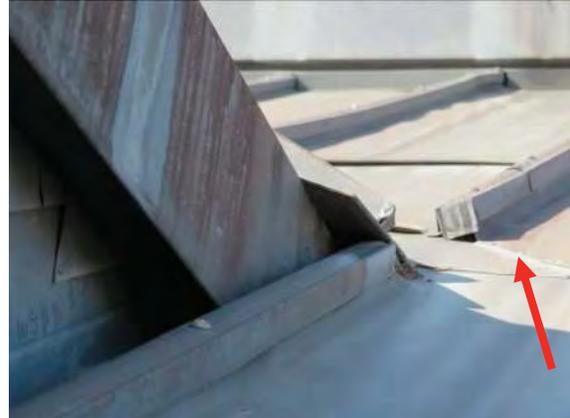
**Photo No. 19** - Depicts close view from a different angle of the sheet metal apex flashing-to-main roof area transition. Water was observed behind and beneath the sheet metal roofing and flashing downslope of this location, indicating that this vulnerable intersection is allowing moisture into the roof system.

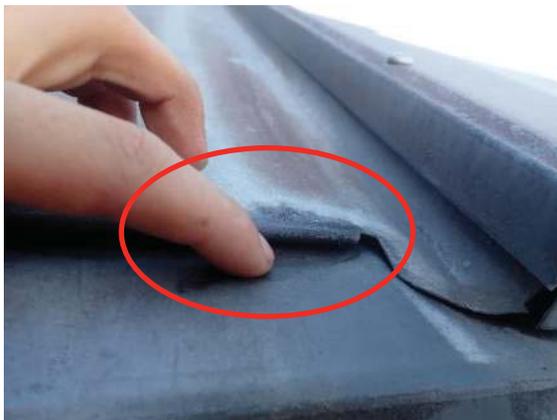
**Photo No. 20** - Photo where staining and moisture was visible, apparently exuding out from between sheet metal components immediately down-slope of the problematic dormer-to-main field of roof intersection.

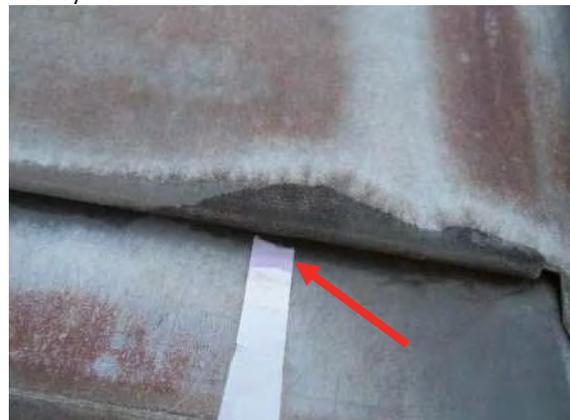
**Photo No. 21** - Water-finding paper indicates that moisture is present, emanating from this sheet metal intersection. The upslope deficient detailed conditions should also be included in an upcoming roof repair and retrofit project, so that they can be carefully re-designed and retrofit to keep wind-driven rain and water from entering the roof for long-term successful performance of the roof system.

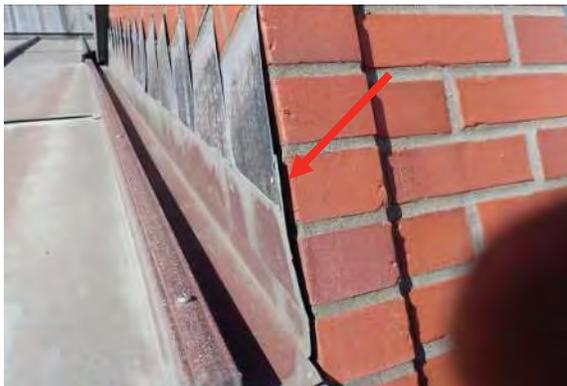
The sheet metal roof-to-wall flashing at the rising wall of the dormer, on the north end of the Anthem Café main roof are open and improperly terminated at the eave edge, at the roof-to-wall base flashing, and at the stepped counterflashing. The roof-to-wall's sheet metal flashing does not wrap or extend out beyond the dormer's brick veneer cladding via a diverter flashing bend, nor is the eave termination of the metal roof panels and the overlying stepped counterflashing closed and/or sealed with sealant. The intermediate roof-to-wall sheet metal flashing lacks a diverter flashing extension flange, which should be retrofit to "kick" water out away from this vulnerable roof-to-masonry transition. The roof system is exposed to wind driven rain at this roof-to-wall intersection, which is not properly closed off. And, the masonry wall is exposed to drainage water runoff from the roof at this incompletely detailed roof-to-wall location. Wet and stained brick was observed adjacent the deficient sheet metal flashing at this roof-to-wall transition/location.

**Photo No. 22** - Photo depicts weather-exposed opening between the sheet metal roof-to-rising wall flashing that extends up onto the brick veneer at the South Elevation of the Anthem Café Dormer. Incompletely terminated and unclosed sheet metal components, and the lack of a diverter flashing leaves this area vulnerable to wind-driven rain, and snow- and ice-melt moisture intrusion.

**Preliminary Recommendation:** BET&R recommends retrofit design of this roof-to-wall intersection, and part of the retrofit should be the installation of sheet metal diverter flashings to promote rain water to drain to the gutter and to keep roof water runoff as well as snow- and ice-melt water from contacting and getting into the brick masonry wall assembly. BET&R also recommends installation of additional sheet metal closure components and proper modulus butyl sealant tape to properly close these currently deficiently detailed roof-to-wall conditions, which are and have been avenues for moisture intrusion into the masonry cladding and into the roof system, which in time will cause leakage into the building.

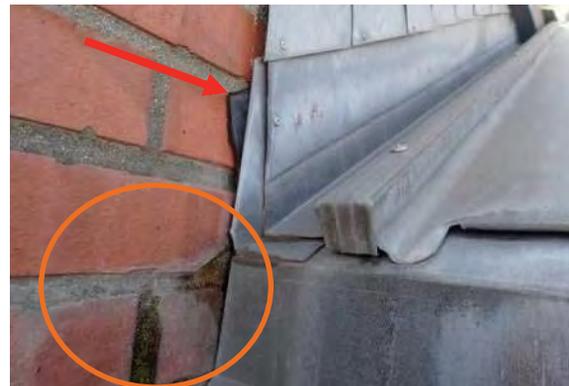
**Photo No. 23** - Photo depicts opening between the sheet metal roof-to-rising wall flashing and the brick veneer at the North Elevation of the Anthem Café Dormer. A small portion of the underlying self-adhering ice and water protection membrane is visible at the incomplete termination of the sheet metal roof-to-rising wall flashing (arrow). Water was also observed to be on the brick behind the flashing at this location (circle); these roof-to-wall transition flashings need to be retrofit.

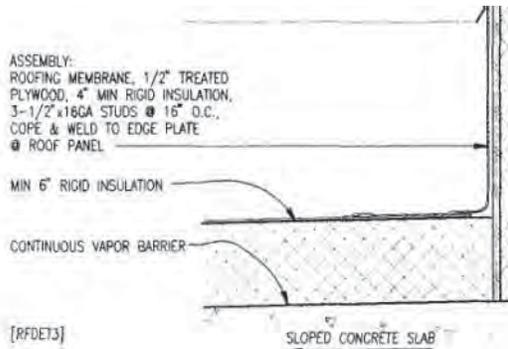
**Photo No. 24** - Excerpt from Project Record Drawings indicates that the low-slope roof assembly consists of a sloped concrete deck, a vapor barrier, 6-inches of rigid insulation, and the mechanically attached roof membrane. However, BET&R discovered that the vapor barrier did not appear to exist and that the insulation was actually 4-inches thick rather than 6-inches thick.

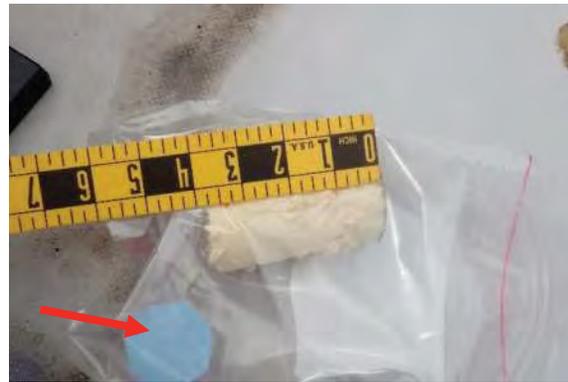
**Photo No. 25** - Depicts the roof test cut sample extracted during this 2020 site visit, which revealed: One 4-inch-thick layer of mechanically-attached, organic/inorganic paper-faced polyisocyanurate roof insulation that is covered by a weathered, aged, chalky, and embrittled, single-ply Hypalon roof membrane, as was once manufactured in the U.S. by JP Stevens (See arrow indicating light-blue backside of roof membrane, the color utilized solely by JP Stevens on their Hypalon roof membranes).

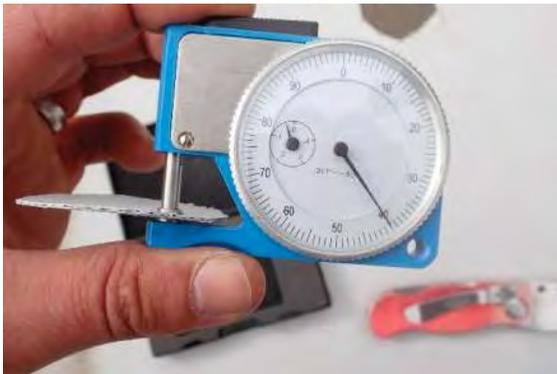
**Photo No. 26** - The existing JP Stevens single-ply Hypalon roof membrane was noted to be a 40-mil (0.04-inch) thick single-ply, reinforced with a polyester-fabric scrim.

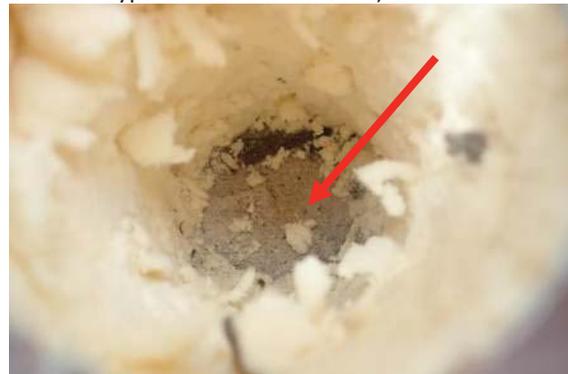
**Photo No. 27** - Depicts existing concrete roof deck observed at test opening. No vapor retarder was observed at the area of the test opening. The black material, located just above the red arrow down in the test opening, is the bottom-side recycled-cardboard facer of the single-layer of rigid-roof insulation.

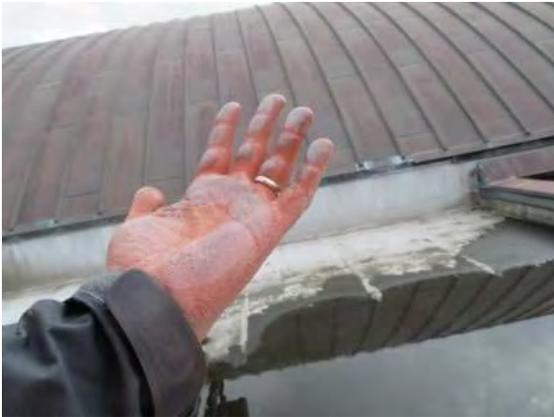
As observed during BET&R's on-roof survey and conditions assessment, the surface of the roof membrane is significantly oxidized, faded, and is "chalky" to the touch, indicating degradation to the skyward-facing surface of the Hypalon single-ply roof membrane. The skyward-facing surface functions as the primary weathering surface and the primary waterproof layer of the laminated membrane. In addition, while roof insulation and the underlying roof deck at the test cut location were generally dry, spot moisture meter testing indicates that, due to the degradation of the primary waterproofing layer at the top surface of the membrane, moisture has begun to penetrate to the roof membrane's internal polyester fabric-reinforcing scrim of the membrane.

**Photo No. 28** - Chalky residue visible on BET&R's Survey Technician's hand after light hand pressure was placed on the existing Hypalon roof membrane. In general, the oxidized chalky surface indicates that the primary top surface of the roof membrane is aged and weathered.

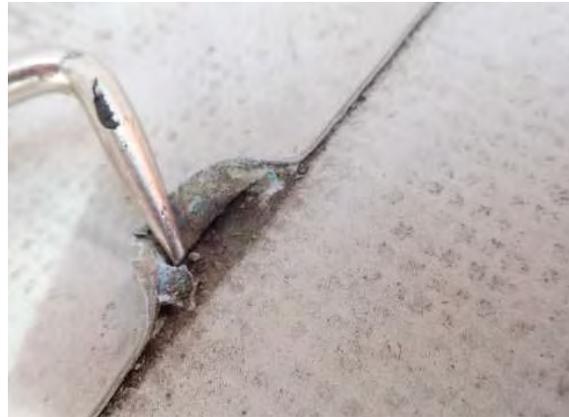
**Photo No. 29** - Depicts open and disbonding membrane seam at the southeast corner roof area. Disbonding, or partially disbonded seams were observed in a few select locations, primarily at the west side of the southeast corner roof area.

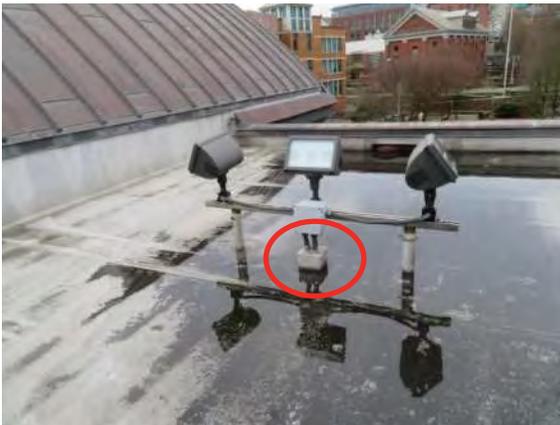
There is debris build-up and ponding water on portions of the low-slope roofs, which is not desired with only a single-ply roof membrane as the primary roof covering on these eight (8) low-slope roof areas. And, the "pitch pans" filled with pourable sealant to form penetration "flashings" for the ganged-electrical conduit penetrations are aged and the sealant filler has shrunk and disbonded, leaving the penetration flashings and the adjacent roof system vulnerable to moisture intrusion.

**Photo No. 30** - Circle indicates the "pitch pan" type penetration flashing typically present at electrical penetrations at the low-slope roof area. Note that the pan is located in a significant ponding area. One such pourable sealant penetration pocket was observed at each of the eight (8) low-slope roof areas.

**Preliminary Recommendation:** BET&R recommends the careful removal of all loose and degraded sealant and the installation of new properly configured flashing boots at all roof penetrations as part of a reroofing project for summer of 2020 or at latest 2021.

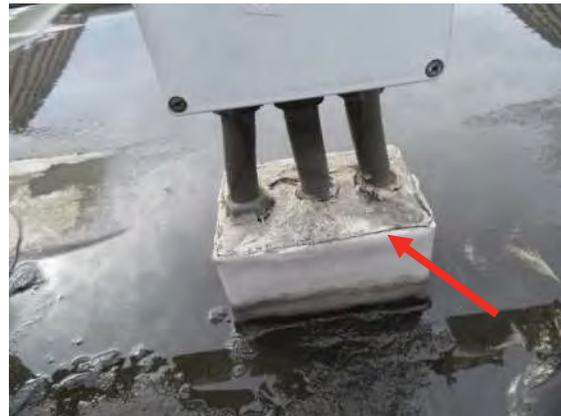
**Photo No. 31** - The pourable sealant installed as the electrical-conduit penetrations' "flashings" was observed to be aged, failing, and in numerous areas cracking and shrinking away from the perimeter of the pitch-pan, leaving the area vulnerable to moisture intrusion.

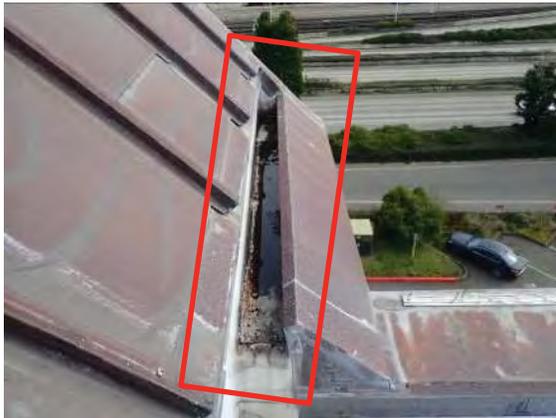
Besides the deficiency of ponding water on the low-slope roofs, which is not desired, the membrane-lined gutters built into the barrel roof eave edge, which drain into the low-slope roof areas, were observed to be generally either minimally sloped to drain back to the low-slope roof area, or even reverse sloped, retaining water, and in some cases supporting extensive vegetative growth that also hampers drainage. In addition, the sheet metal closure flashing detail at these built-in gutter conditions does not appear to incorporate a proper “kick-in” projecting flashing and appears to allow water exiting the end of the gutter to drain down onto the top of the adjacent parapet and potentially over the roof edge and down the exterior face of the cornice and wall. This defect should be retrofit with more thoroughly thought-out design detailing, so that during the upcoming reroofing these deficient details are retrofit and installed correctly.

**Photo No. 32** - Photo depicts water ponding within an exemplar membrane-lined built-in gutter adjacent a low-slope roof area. As the water level indicates, the gutter is improperly sloped -- sloping away from the draining end rather than towards the gutter exit.

**Preliminary Recommendation:** BET&R recommends the immediate careful removal of all vegetative growth and biological debris at the low-slope membrane roofs and in the built-in gutters. The augmentation of more positive slope on the low-slope roof areas, and more positive slope in the gutters and the installation of “kick-in” sheet metal flashings, should be included as part of the upcoming reroofing design for the upcoming Reroofing Project.

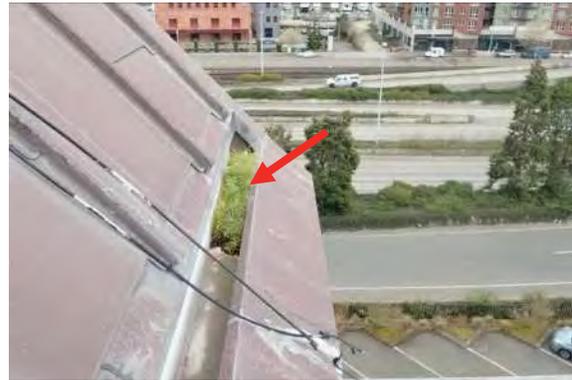
**Photo No. 33** - Extensive vegetative growth was observed at several of the membrane-lined built-in gutters, apparently supported by the moisture available due to the gutters' improper slope.

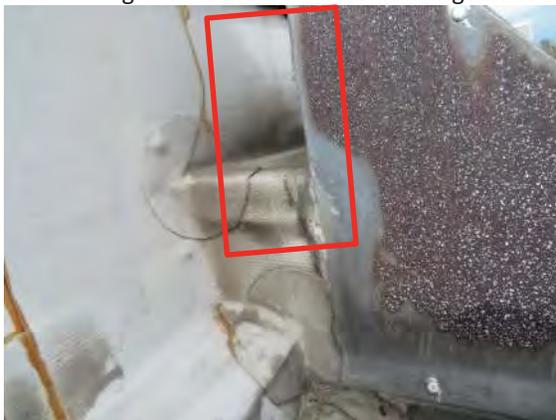
**Photo No. 34** - Photo depicts area where either a sloped “kick in” flashing should be installed, or better yet a re-sloping of the gutter trough during the upcoming reroofing so as to direct water away from the vulnerable parapet-to-gutter termination intersection.

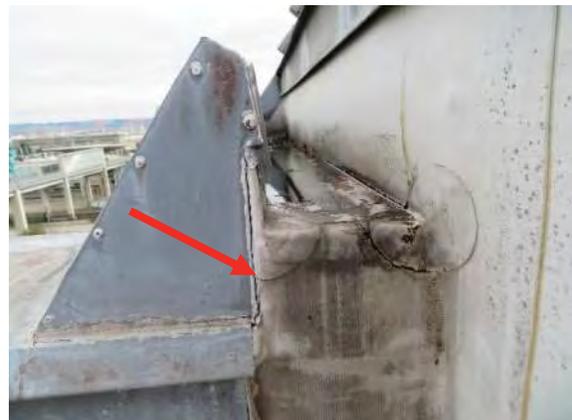
**Photo No. 35** - Arrow indicates vulnerable and open intersection between existing membrane gutter liner and the sheet metal end-closure flashing. Water appears to be able to drain out of the end of the gutter and intrude into this open and unsealed transition. These details should be corrected via their redesign by a roofing-experienced and knowledge roof consultant, assisting the architect, for the upcoming reroofing project design phase.

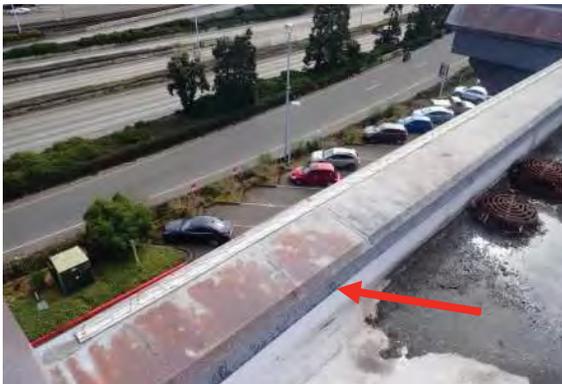
The existing sheet metal counterflashing along roof edge parapets at the low-slope roof areas was observed to be loose, easily detached, and in some cases, has already detached from the rising wall. This deficiency appears to be due to two primary conditions:

- 1) The counterflashing’s hold-down cleat appears to be secured to the parapet wall’s plywood sheathing with only smooth-shanked nails, which have very minimal pull-out resistance and were observed to be pulling free in numerous locations; and,
- 2) The counterflashing’s hem was not fully engaged with the parapet’s sheet metal wall cleat, nor was the counterflashing fully engaged with the hem of the parapet’s overlying sheet metal coping cap.

**Photo No. 36** - Red arrow indicates the sheet metal, counterflashing which engages into the roof-side hem of the parapet’s sheet metal coping flashing. The hem was observed to be unevenly engaged at numerous locations, and in some cases had been attempted to be secured with rivets.

**Preliminary Recommendation:** BET&R recommends the immediate short-term or emergency-type securement of the parapet walls’ sheet metal coping/cap flashing utilizing hex-head or modified-truss head screw fasteners, of appropriate length and diameter for secure and weatherproof anchorage into the substrate below. Each screw is recommended to be fit with a dome-shaped washer laminated to an EPDM-rubber gasket for secure and weatherproof mechanical attachment. The screw fasteners should be fastened through the sheet metal coping, through the cleat, and counterflashing, into the underlying sound plywood sheathing substrate, and into the underlying framing where feasible, so as to meet wind-uplift requirements for this Code designated minimum of 115 mph wind-design zone, and roofing and sheet metal industry standards. These new screw fasteners may be effectively spaced at approximately 12-inches on-center, for efficient emergency securement of these subject existing sheet metal components, by driving the screws along the inboard (e.g., the roof-side) flange of the coping. Also, the

*proper redesign of this deficiently constructed original coping and counterflashing detail, and their proper securement for the long-term, should include a re-shaped and differently attached sheet metal continuous cleat, as well as that of the sheet metal counterflashing, both of which should be part of the upcoming reroofing and reflashng Project.*

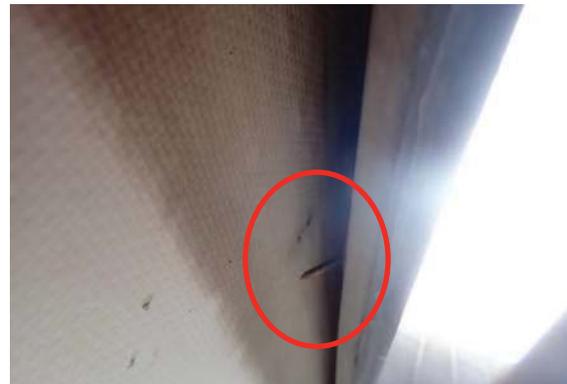
**Photo No. 37** - The lower portion of the sheet metal counterflashing was apparently intended to be secured via engagement into/with a concealed stainless steel continuous cleat. BET&R observed that at numerous locations the cleat was either not effectively engaged with the counterflashing’s hem, or the cleat was itself displaced due to insufficient securement with smooth-shanked copper nails (circled), or both.

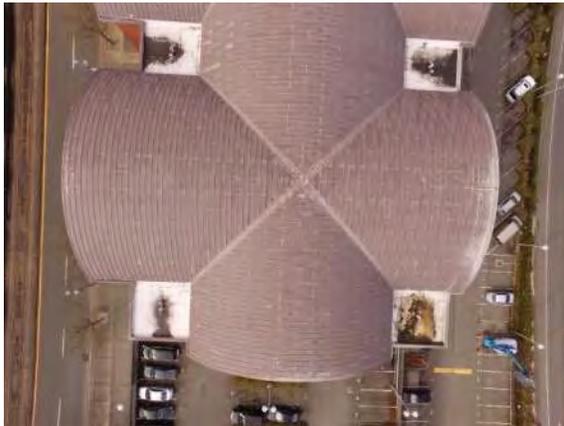
Extensive debris, including vegetative growth, silt, and detritus, were observed at all low-slope roof areas. These debris have collected to such an extent that they are affecting the drainage of the roof, both due to clogging and obstructing of the primary drain bowl, and also due to the organic debris and silt buildup lowering the effective slope of the roof. As noted above, extensive ponding, in some cases covering the majority of the low-slope roof area, was observed at all low-slope roof areas.

**Photo No. 38** - Drone overview of the South Portion of the Museum's Main Roof illustrates extensive areas of ponding and staining observed on the low-slope roof areas, partly due to clogging of the roof-side drain strainers.

**Preliminary Recommendation:** *BET&R recommends immediate, careful, and thorough cleaning of each of the low-slope roof areas, and their roof drains and drain strainers, to facilitate drainage of each of the low-slope roofs as well as the Main Upper Roof Areas. This immediate drain cleaning should help to limit some of the ponding water, which dangerously accumulates on the low-slope roofs. These low-slope roofs, if drainage is further impeded, will potentially contribute to roof overloading, if drains were to become further clogged, which could potentially result in a collapse or a partial collapse of these low-slope roofs due to the contributory drainage of the large Upper Main Sheet Metal Roofed Areas.*

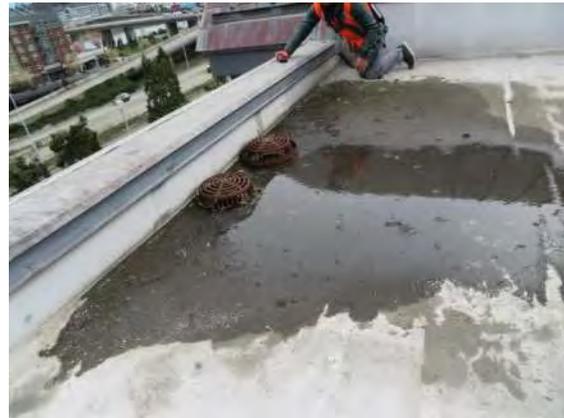
**Photo No. 39** - Photo depicts significant buildup of silt and organic debris, as was typically observed at low-slope roof areas.

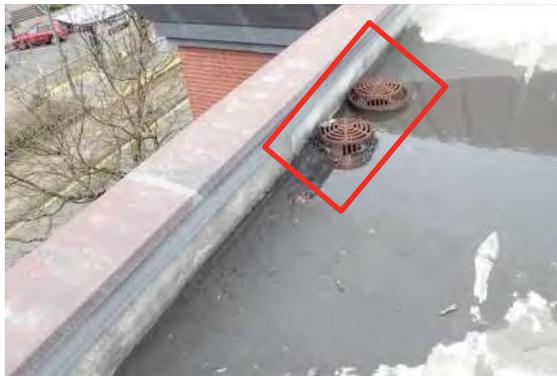
The existing primary and secondary (i.e., overflow) roof drains at the low-slope roof areas were observed to be plumbed into the decorative sheet metal cornice, where the drain leaders both daylight into the same exterior wall-mounted decorative sheet metal collector box and flow into the same exterior downspout. This does not allow the overflow to function as required by Code. As these drains are currently plumbed, in the event one or more of the primary drains is clogged or becomes clogged, the overflow, which is only outfitted with a 2-inch drain, should activate, but there will be no indication to building maintenance personnel that the primary drain is clogged, as the water will continue to flow unseen into the collector box. This incorrect and deficient roof drain plumbing situation creates a potentially hazardous condition where extensive ponding on the roof surface becomes prevalent, as was observed during this survey, which can lead to roof overloading – and potential life-safe hazards – that are not readily apparent to the building facilities or building maintenance personnel or anyone else in or around the building.

**Photo No. 40** - Photo depicts typical arrangement of roof-side primary and secondary roof drains as was observed at low-slope roof areas. The primary drain and the secondary overflow drain, outfitted with a 2-inch collar, are placed side by side, and both plumbed into the same collector box.

**Preliminary Recommendation:** *Roof drain overflow outlets should always be visible, so that if a primary roof drain becomes clogged and the overflow drain is activated -- the roof water runoff is readily noticeable to building facilities and/or maintenance personnel or building occupants -- so that a knowledgeable person can go up on the roof(s) and clean the primary drain(s) to bring it back into regular and safe service. As such, BET&R recommends the addition of an easily observed outlet for each of the roof overflow drains so as to meet Code and in effort to avoid roof water overloading and a potential life safety issue.*

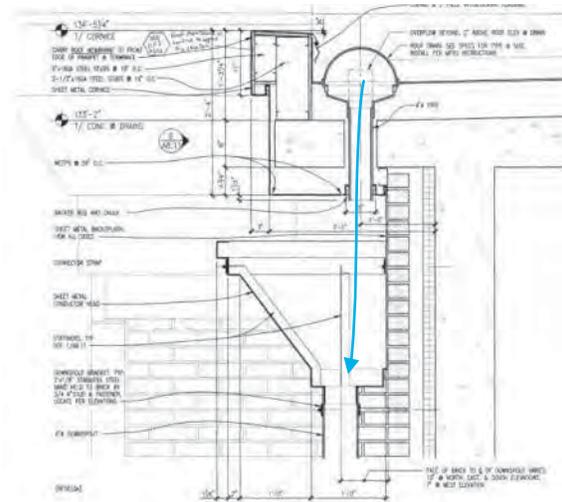
**Photo No. 41** - Excerpted Project Record Drawing illustrates the configuration observed during the survey, with both primary and overflow ~4-inch drains being daylighted into the wall-mounted collector boxes.

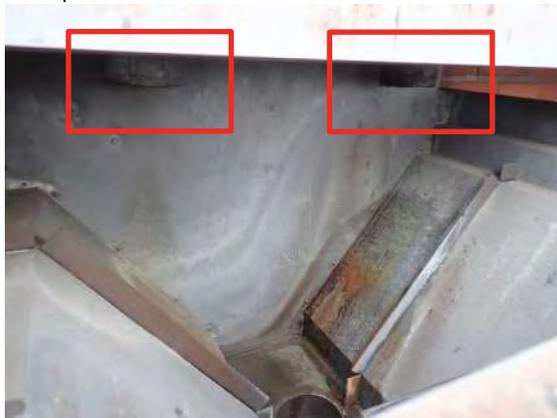
**Photo No. 42** - View of the primary drain and the secondary overflow drain both plumbed into the same collector box.

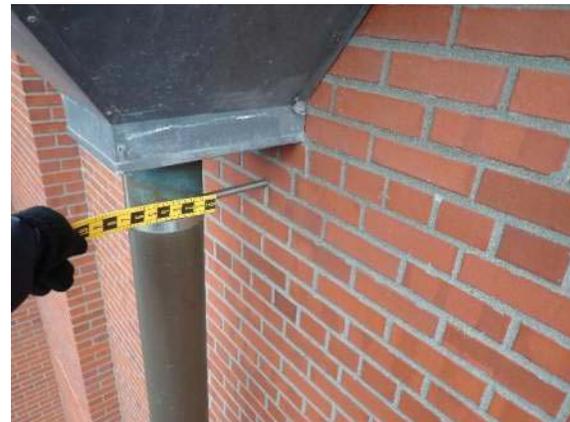
**Photo No. 43** - Depicts 6-inch downspout typically observed at drain locations.

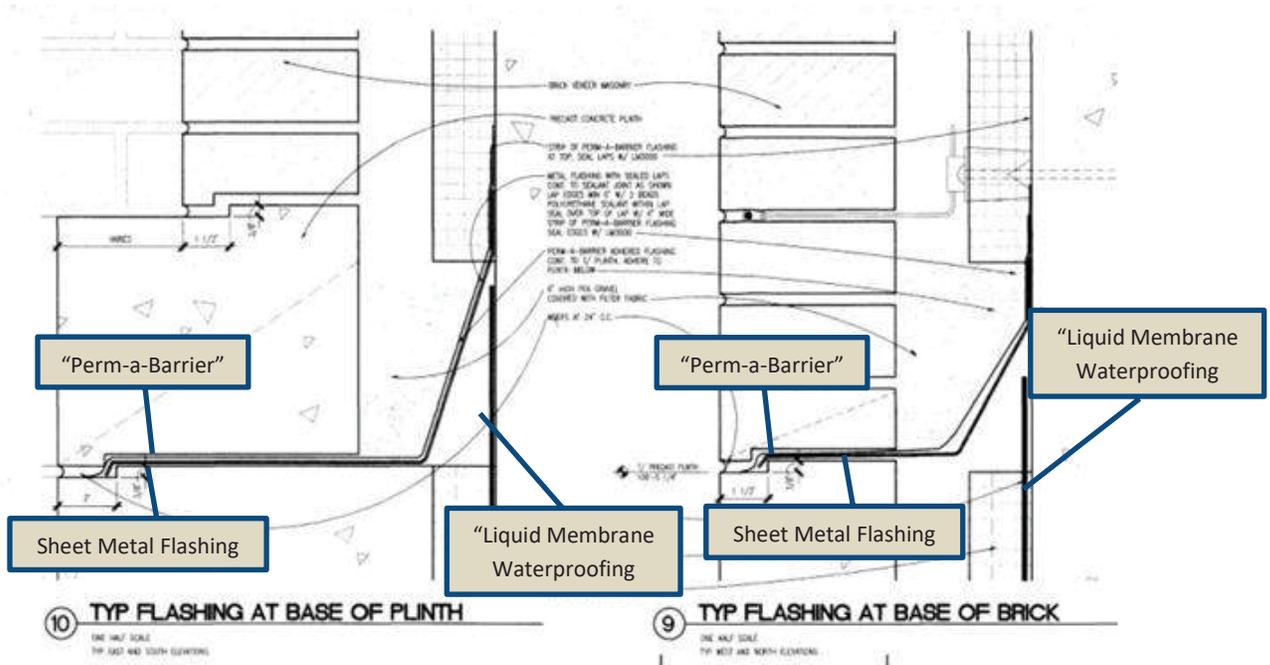
**Figure No. 7.** Details A-8.10/9 and A-8.10/10, excerpted from the Project Record Drawings showing the base of the brick veneer cladding system in section view. The depicted details call out a flexible flashing membrane installed over a rigid sheet metal flashing at base of brick through veneer locations and shows similar through veneer flashing at brick ledger locations. BET&R observed a laminated type flashing in use at select locations.

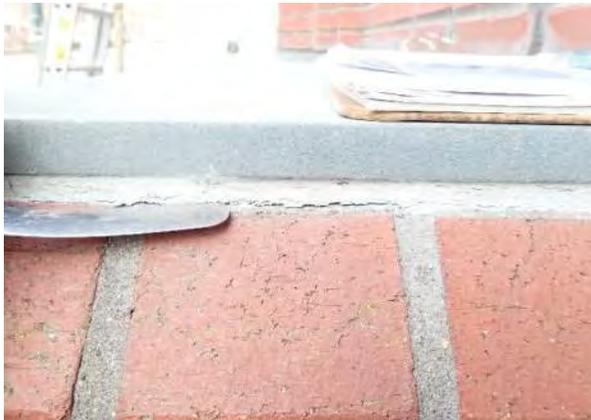
**Photo No. 46** - Depicts flat probe inserted into an adhesively failed sealant joint below steel plate at column base location. This is a typical condition.

**Preliminary Recommendation:** Remove all existing backer rod and sealant joints at brick masonry-to-brick masonry junctures and intersections (Brick Ledger relief angles, expansion joints, and control joints, etc.), steel plate-to-brick masonry transitions, and at radius brick transitions for installation of new properly designed and correctly installed watertight backer rod and sealant joints, fit with weeps where required.

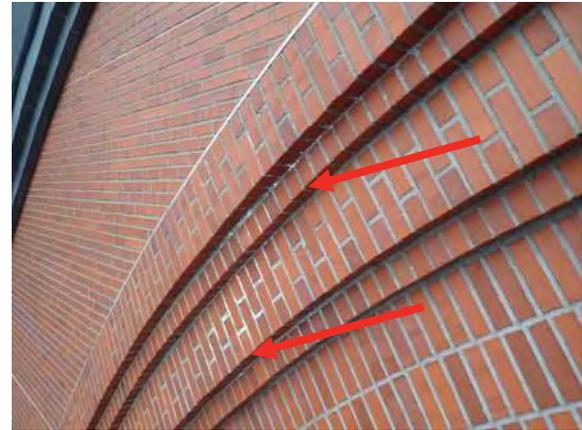
**Photo No. 56** - View of moisture-absorption related efflorescence observed on mortar surface and brick masonry cladding at archway detail brick.
