AGENCY 390: WASHINGTON STATE HISTORICAL SOCIETY  
BI23 CAPITAL BUDGET REQUEST

**390 - Washington State Historical Society  
Ten Year Capital Plan by Project Class  
2021-23 Biennium**

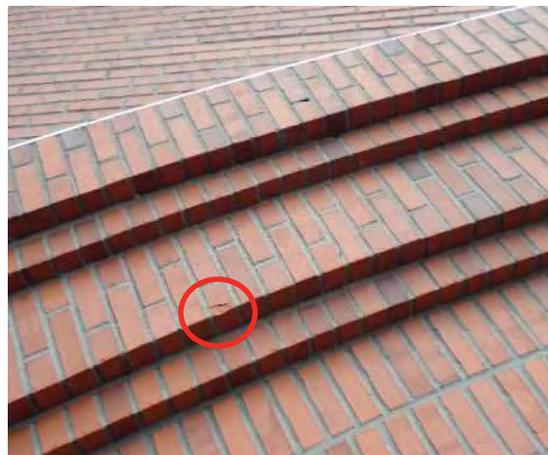
**Photo No. 60** - View of spalled brick unit discovered at the South Elevation of the decorative and projecting portion of the façade of the Facility. This spall, occurring along the lower edge (i.e., a drip edge) of the wider/taller/bigger and prominent projecting band of brick is indicative of where water is held along the lower portion of this brick course before dripping off. Any brick that allows that paused water/moisture to permeate into the face of the fired-clay, along the drip-edge of this brick band, may freeze, expand in the frozen clay matrix, and spall or break the face of the brick. This condition is a sign that the previous water repellent has weathered, dissipating, and "wearing out." At this initial spall's depth, of the moisture permeation, it means that it is time to budget for and soon undertake spot repairs, cleaning, and a water repellent project. Please see specific recommendations below.

**Preliminary Recommendations:** *The spalled brick revealed in Photo No. 60 should be carefully cut out and replaced with a matching brick. Then, this wall and the brick making up the projecting band of masonry should be scheduled for spot routing and pointing of the mortar, warm-water washing or steam cleaning of the brick and mortar after the pointing mortar has fully cured, then two flood-on and back-brushed coats of an appropriately test-selected water repellent should be carefully applied to minimize moisture permeation into the brick masonry.*

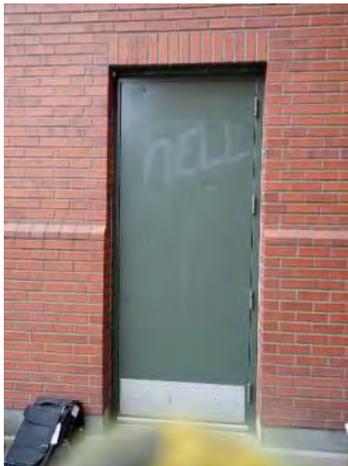
The steel framed emergency exit doors on the West Elevation of the Building have thin mortar joints around their perimeter that reveal signs of hairline cracking and separation where movement is likely occurring at intersection of dissimilar materials. BET&R recommends that these joints be redesigned for retrofit using a polymer-modified grout or specific sealant as a bedding compound for the steel door frames.

**Photo No. 61** - View of typical Hollow Metal Door (HMD) and location of bedding-mortar joints at perimeters of door frame that are cracking due to differential movement.

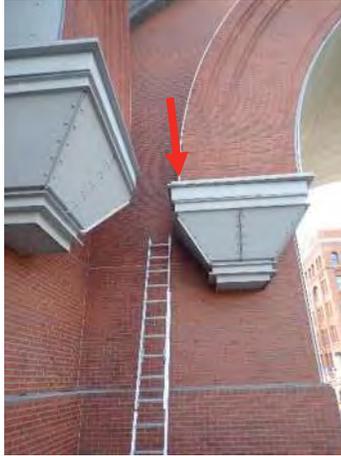
8. **Open Cladding Transitions at Main Entry Arch Bases and Head of Brick Veneer Wall at Anthem Café:** BET&R observed concerning locations that were apparently left opening at the brick veneer-to-column bases at the north entry and at the top of the brick veneer wall at the Anthem Café facade. Wind-driven rain and moisture can easily enter the cladding system at these open locations.

**Photo No. 67** - Overview of column bases at main entry and locations of open brick veneer cladding, which should be corrected.

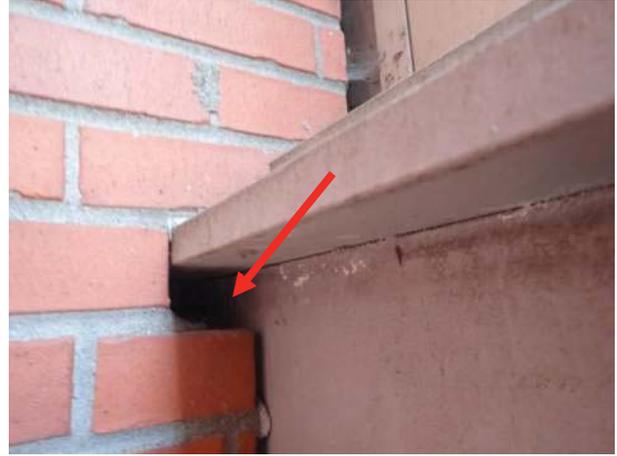
**Photo No. 68** - View of large open gap and unsealed joint along at C-Channel penetration through brick veneer at base of archways near Main Entry Area. This location should be closed with partial brick, properly mortar-set, then a backer rod and sealant joint installed between brick and steel member.

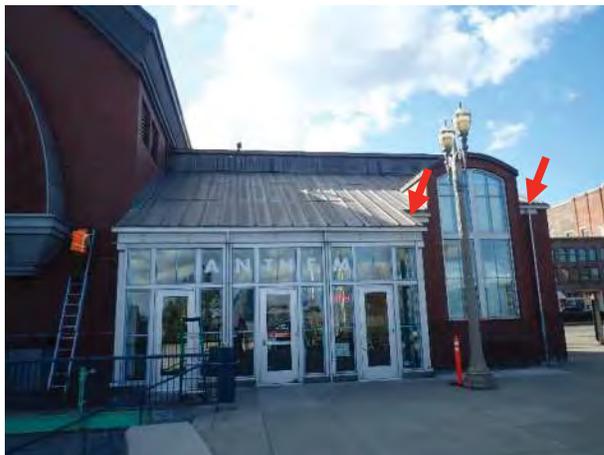
**Photo No. 69** - Overview of East Elevation of Anthem Café and location of open brick veneer cladding transition at head of wall.

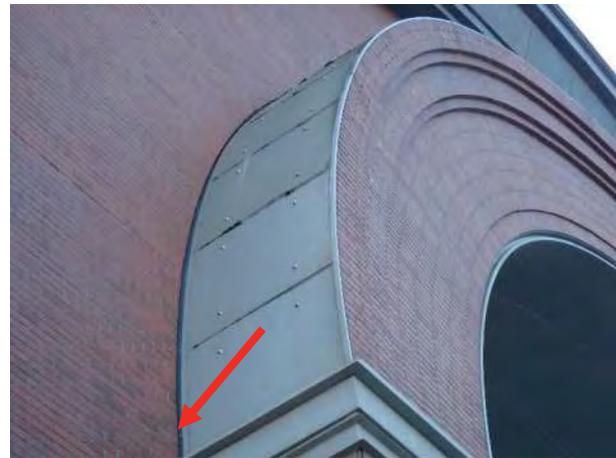
**Photo No. 76** - Overview of wide archway-to-brick veneer intersection near protruding base of archway. See close-ups below for additional information.

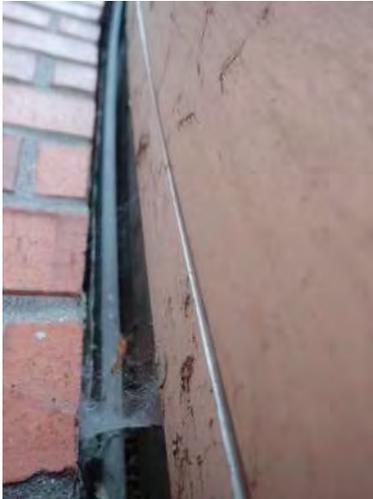
**Photo No. 77** - Depicts large gap, approximately 1-inch + at this archway panel-to-brick veneer ledger angle intersection. It appeared that a flexible self-adhering flashing was applied to “flash” the void, however, the flashing membrane is currently unadhered, open, and exposed to UV degradation, and the intersection is wide open to wind-driven rain and migratory water – on both sides of the steel ledger angle.

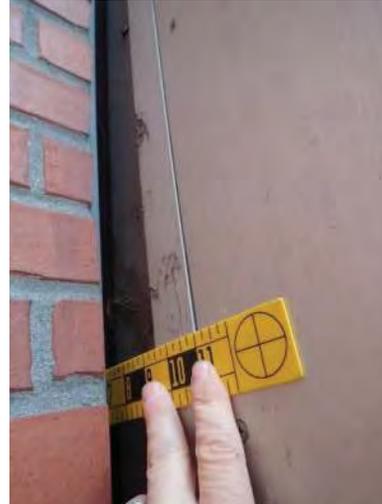
**Photo No. 78** - Ruler inserted into void at brick veneer ledger angle to archway panel cladding at adjacent to the Main Entry Area, which is open to water leakage into the wall assembly, which may be causing hidden degradation and damage to underlying components.

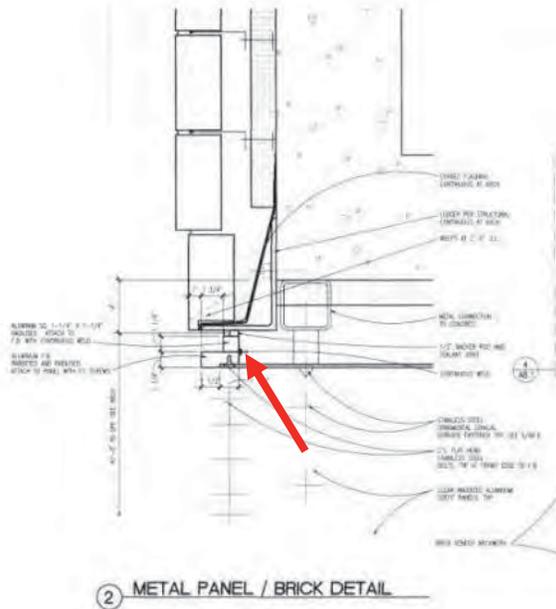
**Photo No. 79** - Depicts through-veneer flashing at brick archway to .125 aluminum cladding system as depicted in Project Record Detail A-8.1/5.

**Preliminary Recommendation:** Carefully clean and prepare brick veneer-to-brick archway juncture for application of an appropriate backer rod and sealant joint. Design and install through-sealant weep tubes at the arch bases to allow proper drainage of incidental water.

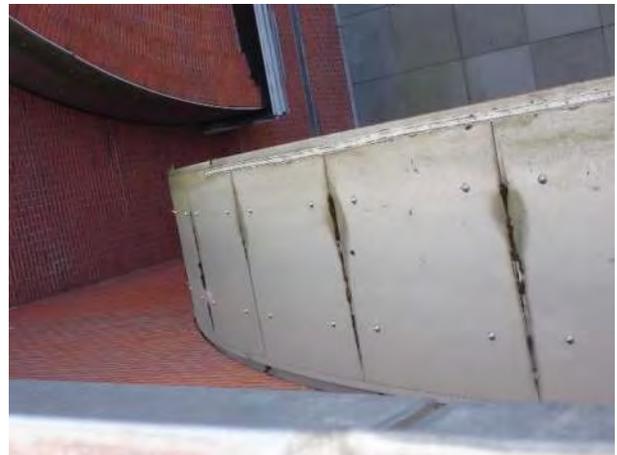
**Photo No. 84** - Another view of decorative aluminum panels at large archway tops, as observed along the two arches near the main entry at the North Elevation, and related moss growth and staining associated with the vulnerable gaps between the 0.50-inch thick aluminum decorative cladding panels, which essentially are serving as roofing and cladding over the arched masonry.

**Preliminary Recommendation:** Carefully clean and prepare brick veneer-to-decorative aluminum panel cladding junctures and intersections, as well as panel-to-panel butt joints for the brick archway intersections for application of an appropriate jacketed-backer rod and sealant joint. Consider the use of through-sealant weeps at the arch bases where necessary to allow drainage of migratory water. Consider the use of a dark colored sealant to maintain the appearance of shadow lines for sealant joints as an aesthetic possibility.

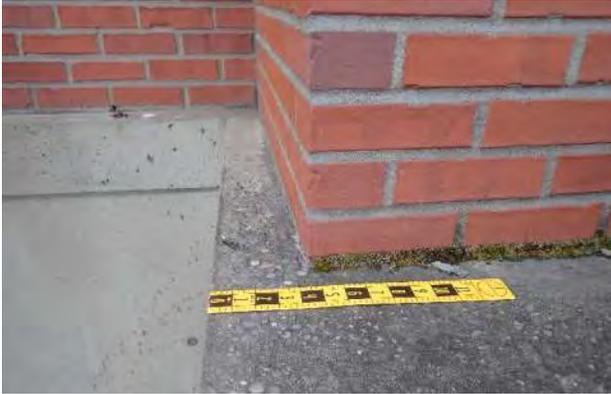
**Photo No. 87** - View of skyward-facing concrete ledges that are susceptible to water pooling, the growth of moss, and other staining, as well as moisture migration, as evidenced by the degree of moss growth depicted in this photo.

**Preliminary Recommendation:** *Thoroughly clean exposed concrete at the base of the building. Apply appropriate penetrating water-repellant after sealing open joints and hairline cracks as appropriate. Consider waterproofing sky-facing ledges with a carefully designed and implemented membrane waterproofing system.*

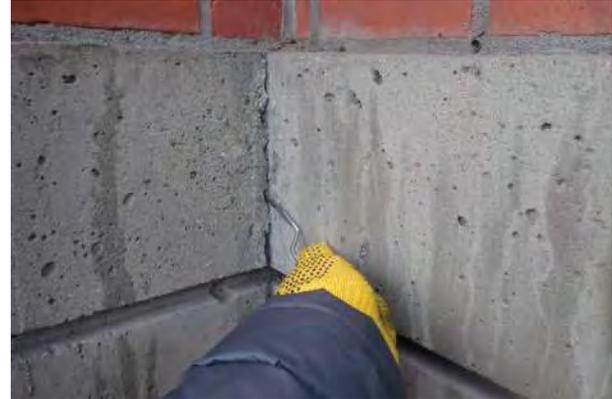
**Photo No. 88** - View of open cold joint at inside corner of CIP wall, as observed at the East Elevation, which is susceptible to water migration and freeze-thaw spalling.

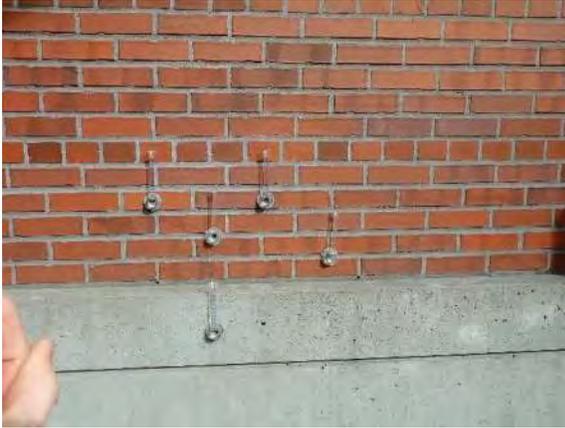
**Photo No. 89** - Depicts overview of RILEM testing at the South Elevation adjacent the parking lot. This area exhibited strong resistance to moisture penetration at all the tested masonry and concrete surfaces.

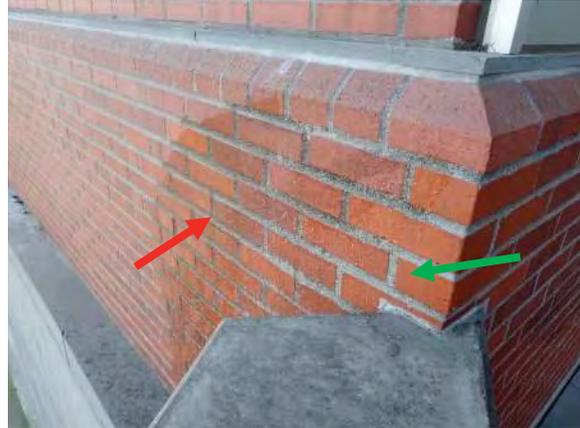
**Photo No. 90** - Depicts the limited surface moisture testing at the North Elevation that revealed localized deficiencies in the clear siloxane-based water repellent, indicating that portions of the water-repellant have reached the end of their useful service life, and are allowing moisture to penetrate into the surface of masonry components. 'Dry' appearing areas of coating at green arrow are more in-tact than the 'wet' appearing area at the red arrow.

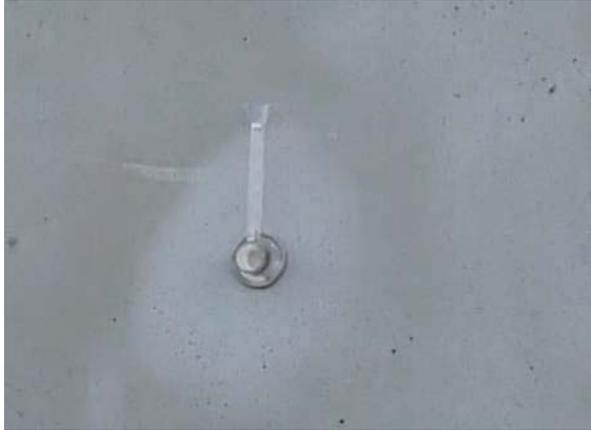
**Photo No. 93** - Depicts RILEM testing at the face of the concrete foundation wall at the East Elevation of the building. The area around the tube was bristle-brush cleaned prior to testing to ensure proper adhesion by the RILEM Tube. The concrete foundation wall locations tested generally exhibited high levels of moisture penetration resistance.

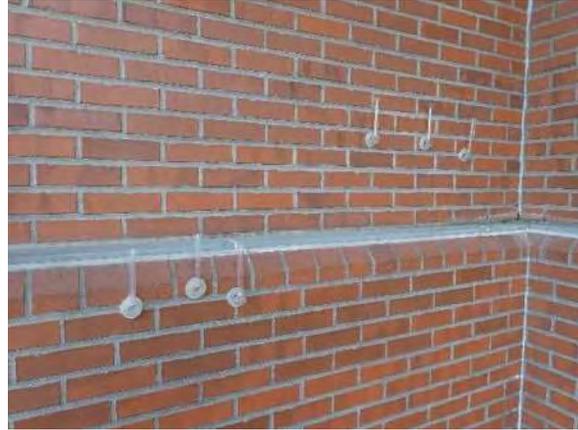
**Photo No. 94** - Depicts an overview of testing conducted to the west of the Main Entrance at the North Elevation. Although the cluster of RILEM Tubes to the right was near an apparent location of moisture drainage from the sheet metal roof above, it performed approximately the same as the area to the left, just below the painted-steel support plate.

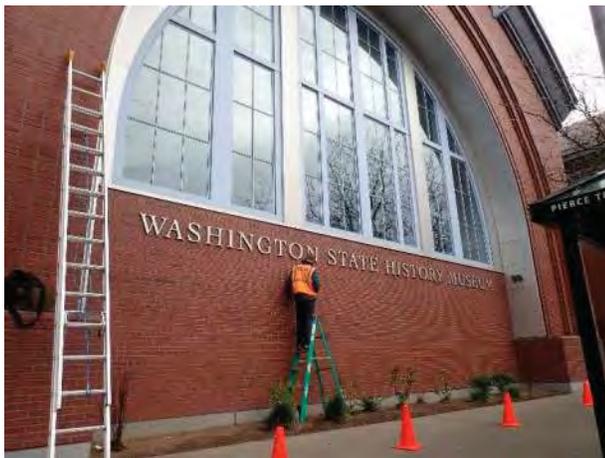
**Photo No. 95** - Overview of large storefront type windows at the west elevation of the Museum. The window system observed at this location is a dual-pane window system set into extruded-aluminum frames surrounded by extruded aluminum trim, with silicone sealant joints at transitions and miter joints.

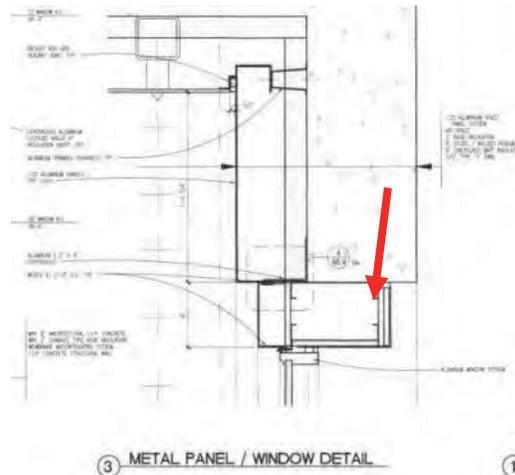
**Photo No. 96** - Depicts Project Record Detail depicting aluminum window system-to-.125-inch thick aluminum panel-transition-to-.125 panel archway soffit panels. Note the window system does not depict rough opening flashings at the rough opening flashing (see red arrow).

**Preliminary Recommendation:** Carefully clean, spot repair, replace, or retrofit all fenestration related glazing seals, the sealant joints, and related sheet metal joinery seals to ensure weatherproof performance. Where sealant joints are failed, failing in adhesion, or deficient, both at the interior and/or exterior, carefully cut out, remove, clean bond faces, and replace with properly designed sealant joints, complete with correctly integrated backer rod and high-performance silicone sealant joints. Where sheet metal joints are open, consider a repair design utilizing injected beads of sealant for short-term performance, or a sealant-bed aluminum cover plate for a longer-term retrofit. Condensation of the problematic window units will continue until the fenestration systems can be replaced in the future with proper thermally broken and insulated units -- unless a foam injected insulation retrofit is desired to be technically devised to mitigate condensation and to limit fungal (e.g., mold) growth on the sealant and interior surfaces and components.

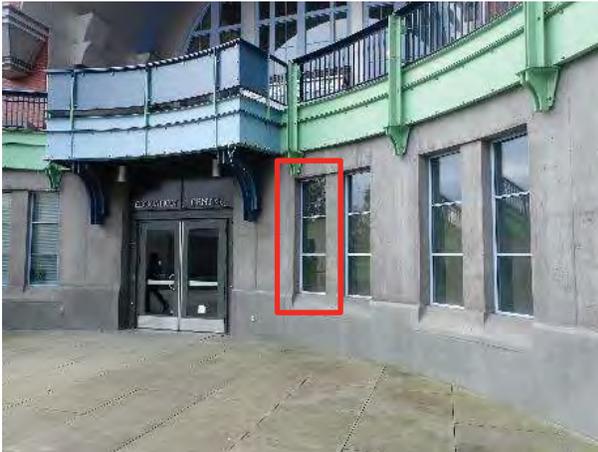
**Photo No. 105** - Overview depicts area where typical extruded-aluminum framed, double-glazed window unit is set in cast-in-place concrete opening. The superimposed red box depicts the specific window unit that was tested. Sealant joints generally appeared satisfactorily -bonded and did not exhibit adhesive nor cohesive failure, surface chalking, crazing, or other visible signs of degradation. This window unit did not allow any water to the interior of the building during the test, and was determined to 'pass the controlled-spray diagnostic water test.'

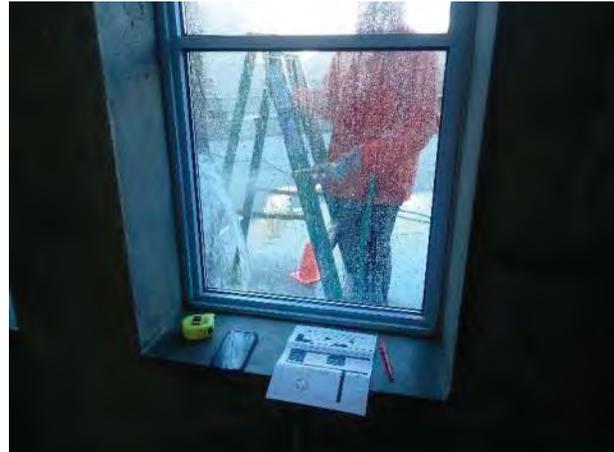
**Photo No. 106** - Depicts the test specimen as viewed from the interior mid-test. BET&R's testing technician is visible outside applying the 25 psi controlled-spray at a distance of approximately 12 to 18-inches from the window target zone. BET&R utilized infrared thermographic imaging to confirm that no bulk water had penetrated the fenestration unit.

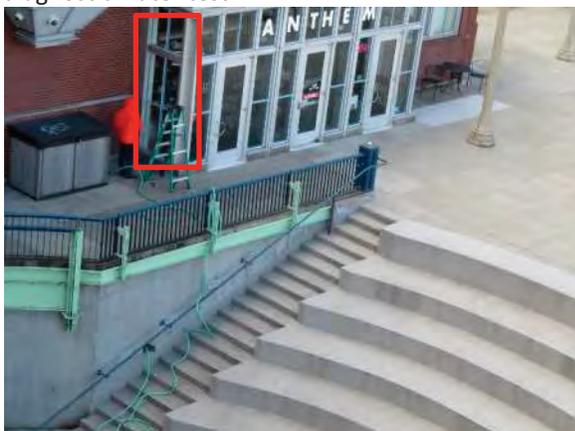
**Photo No. 107** - Depicts an overview of the storefront glazing system from the exterior of Anthem Café, as BET&R's testing technician sets-up equipment at the subject window unit. This area was selected for its accessibility, similarity to the other storefront installed on the facility, yet distance and separation from the main entrance. Note: Employees at the Café did not report any leaks in past experience.

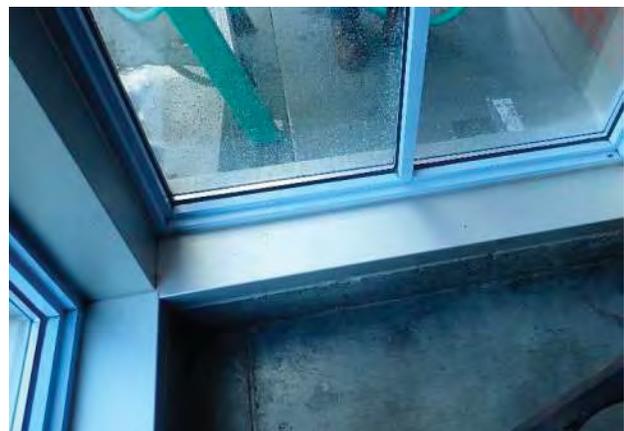
**Photo No. 108** - Depicts the storefront window system as viewed from the interior, moments prior to the start of the water spray test. There did not appear to be visual signs of moisture infiltration or degradation to the adjacent concrete curb or aluminum storefront components during and after testing was conducted.

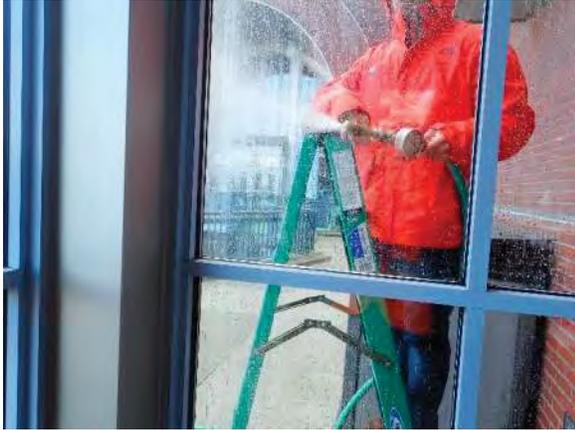
**Photo No. 109** - Depicts the storefront window system during testing, as viewed from the interior. No water was observed penetrating to the interior during the test of this windows', sill, jambs, and the head, as well as its sealant joints. Thermographic imaging did not indicate any moisture penetration during the testing (see next image).

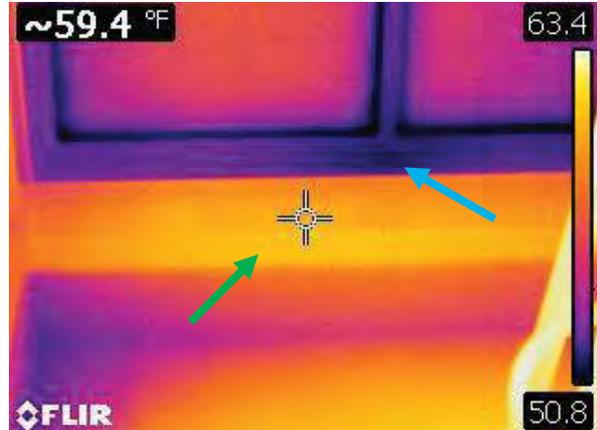
**Photo No. 110** - Depicts an infrared thermographic view of the sill zone of the storefront window system tested at the Anthem Café. The colder temperatures indicated by the purple color at the window sill (blue arrow) are a result from the cold water spray hitting the metal from the exterior. If moisture penetration had occurred, it would be expected to reveal a colder pattern, both inside the aluminum system, and penetrating to the interior of the building, including along the warm, orange colored zone of the aluminum beauty cap (green arrow).

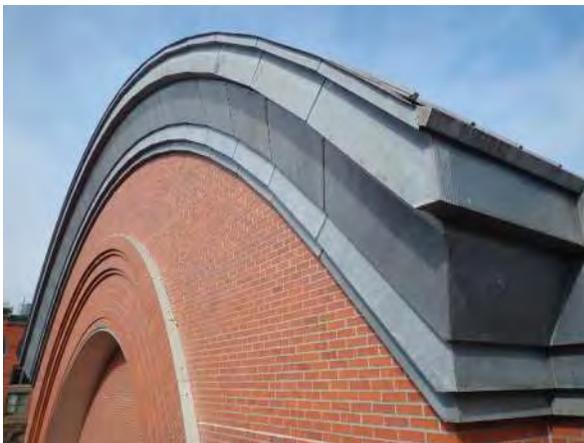
**Photo No. 111** - Overview of sheet metal cornice at South Elevation. Although some staining was observed on the surface of the metal much of the staining appears to be related to roof-edge drainage issues.

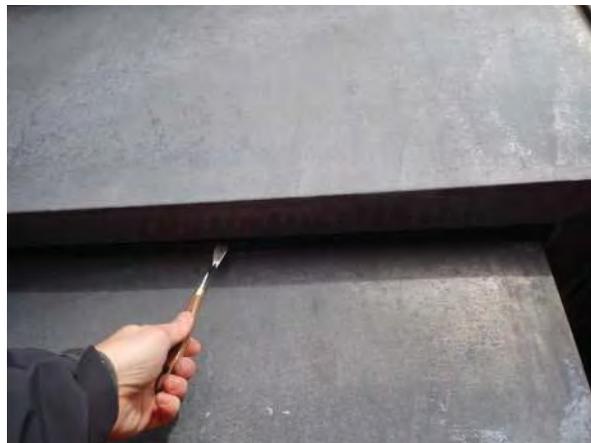
**Photo No. 112** - Depicts a tactile flat probe inserted into failed silicone sealant joint at the underside of the break of the cornice element, which is segmented and installed in sections. The majority of the sealant appears to be in good shape, but spot repairs are needed.

**Preliminary Recommendation:** Spot repair failed silicone sealant joints with compatible and well designed and installed sealant joints. Consider wise spread sealant replacement in 3-78 years depending on elevation, sun and weather exposure, and results of recommended-yearly maintenance inspections.

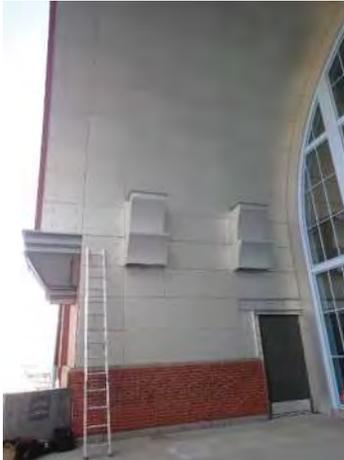
**Photo No. 113** - Overview of aluminum cladding panels which are mechanically attached and comprise the exposed soffit areas of the archways, both large and small. This photo depicts large soffit area outside of Main Entry at the North Elevation.

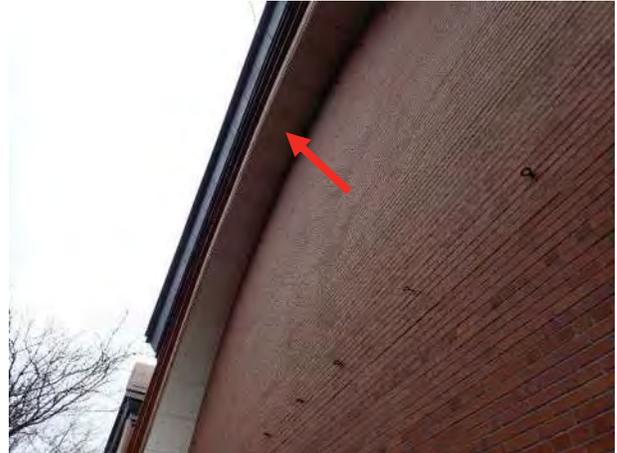
**Photo No. 114** - Overview of aluminum cladding panels at small soffit area at repeating arched bay at the West Elevation.

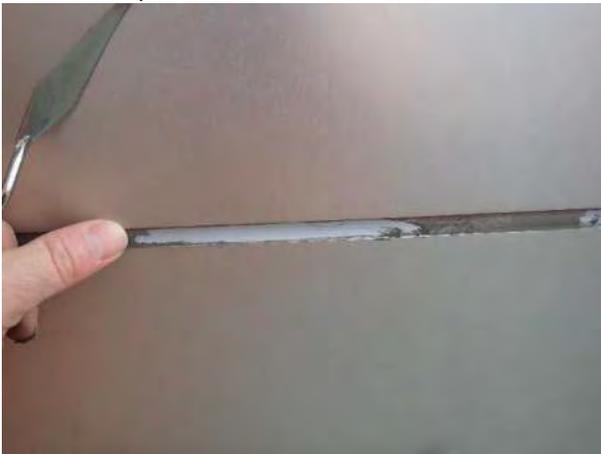
**Photo No. 115** - View of typical silicone sealant joint at aluminum panel butt joint intersections. The majority of the sealant is in relatively good condition and functioning as intended.

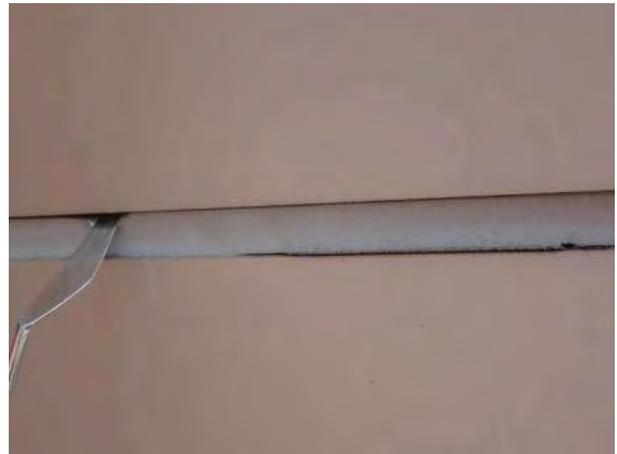
**Photo No. 116** - Depicts one of the locations where the soffit panel joint sealant is adhesively failing off of one or in some places both bond-faces, and is in need of spot replacement.

**Preliminary Recommendation:** Spot replacement of failed sealant joints is needed, and should be accomplished with removal of existing failing sealant back to points of good adhesion on both sides of the joint, clean and prime the panel bond faces, replace backer rod with a compatible foam rod, and seal joint with new high-quality silicon sealant.

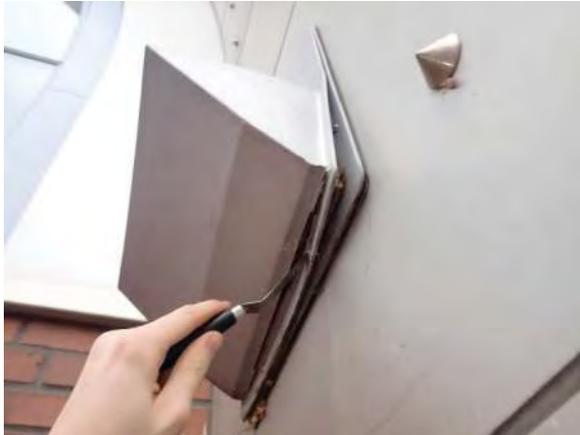
**Photo No. 117** - View of displaced light fixture in need of re-securement and weatherproofing retrofit attention.

**Preliminary Recommendation:** Check all light fixtures for proper and sound securement. Install appropriate and properly backed and primed sealant joint at perimeters for watertight seal and or re-secure snugly against an appropriate weather-sealing marine-vinyl gasket.

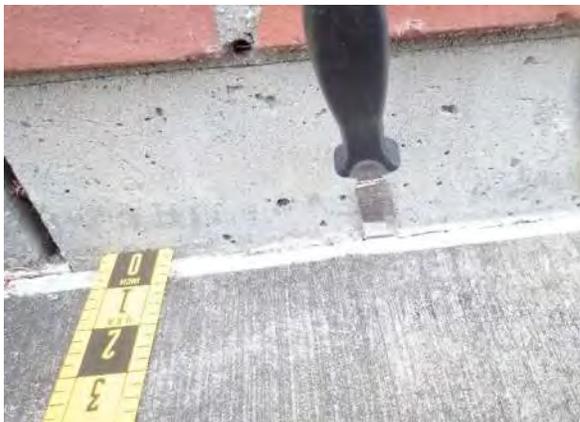
**Photo No. 119** - Depicts flat probe easily inserted into a cohesively failed sealant joint of the expansion joint.

**Preliminary Recommendation:** Remove all existing failed sealant and backer rod at expansion joints for the installation of new appropriately designed and installed sealant expansion joints, which should be accomplished with compatible materials, properly integrated, and compatible with existing intersecting components that are functioning and may remain.

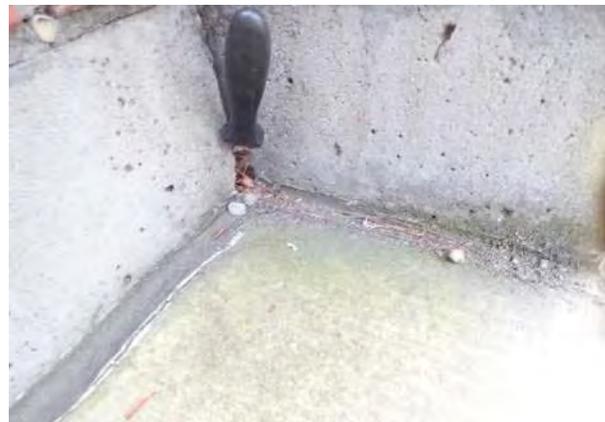
**Photo No. 120** - View of flat probe inserted in to the failed and open inside corner of a different sealant joint at the expansion joint.

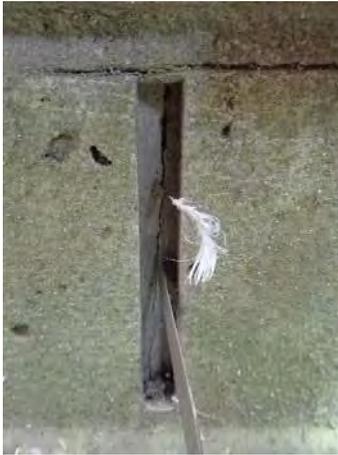
5. **Lack of Sealant Joints at Pre-cast Concrete Plinth Control Joints:** Panel-to-panel control joints at the precast concrete plinths are not sealed at the exterior, however, Project Record Drawings depict the CIP foundation as being waterproofed.

**Photo No. 121** - View of flat probe inserted into the wider-than-hairline crack at the plinth control joint.

**Preliminary Recommendation:** Consider the application of a new properly cleaned, prepared, primed, and backed sealant joint at cracked control joint locations. Note that Project Record Drawings indicate that underlying below-grade concrete foundation walls are waterproofed behind plinth cold joints, however due to the concretes' exposed surface it is recommended these joint be backed and sealed.

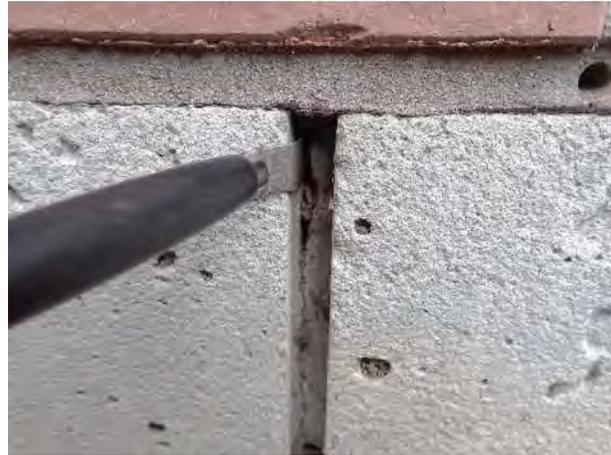
**Photo No. 122** - Close-up view of cohesively failed and open control joint at precast concrete plinth.

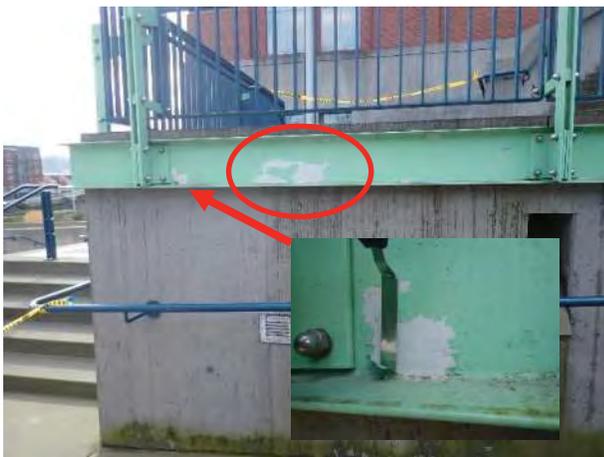
**Photo No. 123** - Locations of paint coating peeling and disbondment at hand railings and related steel fascia and connections were observed adjacent the Main Entry plaza of the Museum facility.

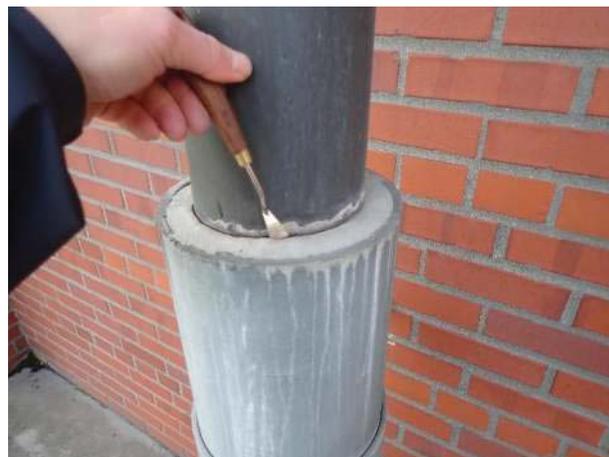
**Photo No. 124** - Failed sealant joints at the downspout to below-grade tight-line stub-up connections with wider diameter leader lines were discovered to need replacement while on-site. This was a typical condition, and should receive replacement to avoid freeze-thaw splitting and damage.

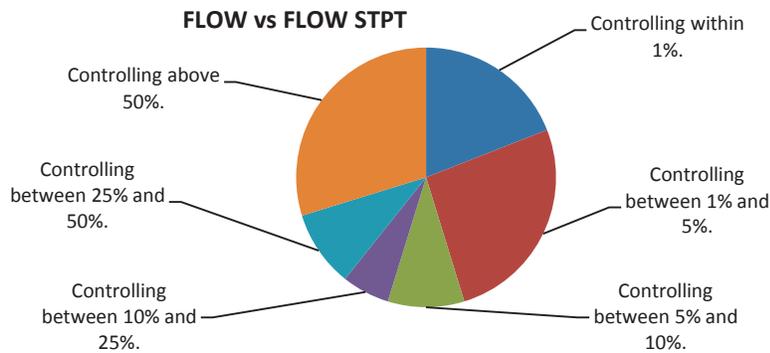
5.1	The control system is unable to maintain airflow setpoints properly due to an abnormal number of overridden points in the system.	See Graph:	McKinstry recommends a controls upgrade to the main building control units and these repairs will be implemented.	Open. Repairs have been integrated into future FIM 04.02

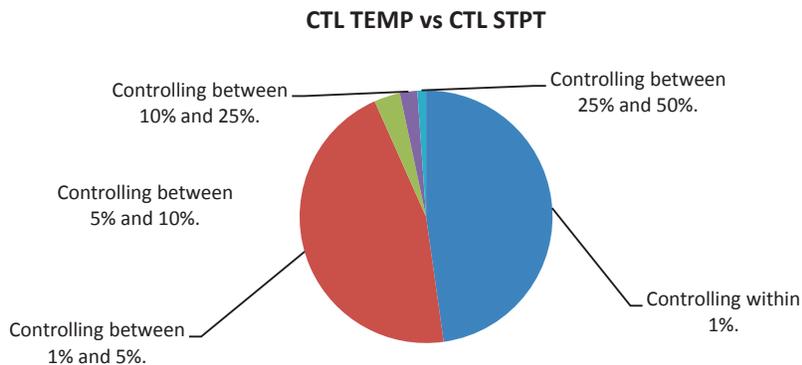
5.2	The control system is unable to maintain zone temperature setpoints in key zones due to an abnormal number of overridden points and a clogged heating water system.	See Graph:	McKinstry recommends a controls upgrade to the main building control units and these repairs will be implemented.	Open. Repairs have been integrated into future FIM 04.02
-----	---	------------	---	--
