WASHINGTON STATE HISTORICAL SOCIETY

2026 Supplemental Capital Budget Request

CAPITAL PRESERVATION

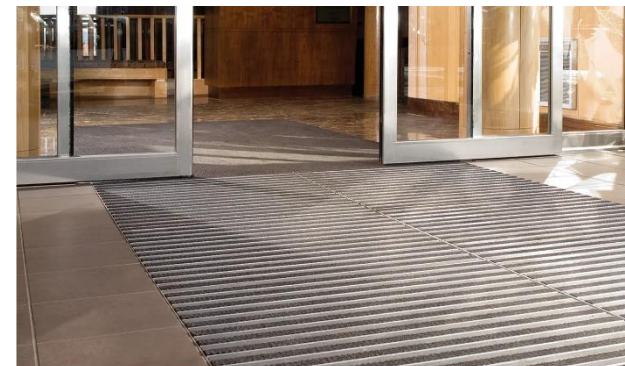
- 2. Walk-off Mats:** Walk-off mats located at the main level and ground level accessible entrances into the museum. These could become a tripping hazard for those with mobility challenges. Consider adding an alternative texture or material these entrances a more permanent way to reduce fall risks and capture outdoor materials.

Integrated walk-off matting that can be embedded in front of both accessible entrances (like the integrated walk-off matting in the vestibule area of the main entrance) could be considered during future renovations.

These systems provide a drop-through design that provides easier ongoing maintenance and reduced slipping during wet and snowy weather.

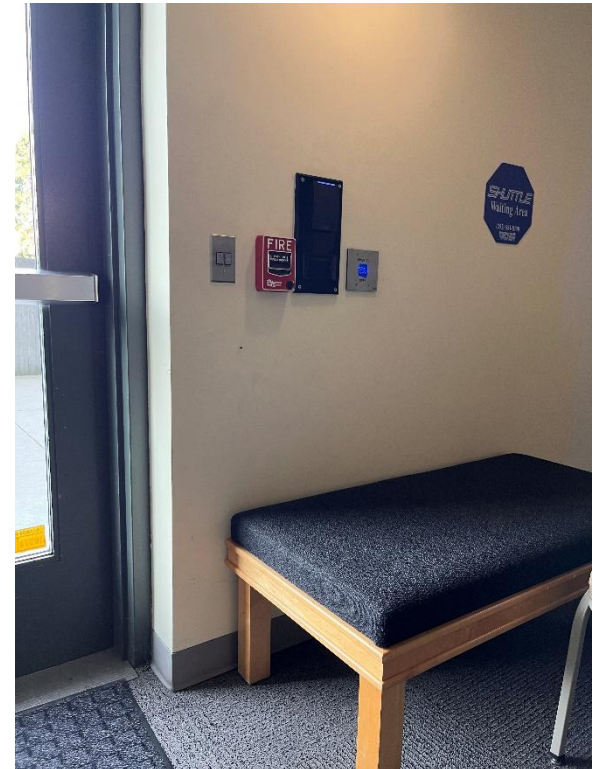
- 3. Permanent Signage:** Permanent signage throughout the museum is inconsistent in meeting the ADA standards. Some signs meet the standard while other signage does not. Some signage has good color contrast while other signage does not. Consider updating all permanent signage in the museum to meet all ADA standards.
- 4. ADA Checklist:** Create a formal accessibility checklist for access to the museum to be done by staff daily/weekly. This can be done using the ADA checklist in the resources folder. Key areas for ongoing ADA checks are the location of trash receptacles or other items that block access to automatic door openers, signage, paper towel dispensers and elevator call buttons. The image to the right shows a bench blocking access to the sensor operated door opener on the ground level accessible entry.
