2022 PROJECT PROPOSAL CHECKLIST
2023-25 Biennium Four-year Higher Education Scoring Process

INSTITUTION	CAMPUS LOCATION
365 - Washington State University	Pullman
PROJECT TITLE	OFM/CBS Project #
Space Optimization (Remote Collection Storage)	40000345
PROJECT CATEGORY	FPMT UNIQUE FACILITY ID # (OR NA)
Renovation - Standalone	N/A
PROPOSAL IS	
New or Updated Proposal (for scoring)	Resubmitted Proposal (retain prior score)
<input checked="" type="checkbox"/> New proposal <input type="checkbox"/> Resubmittal to be scored (more than 2 biennia old or significantly changed)	<input type="checkbox"/> Resubmittal from 2018 (2019-21 biennium) <input type="checkbox"/> Resubmittal from 2020 (2021-23 biennium)
CONTACT	PHONE NUMBER
Kate Kamerrer	Click or tap here to enter text.

INSTITUTION	CAMPUS
Washington State University	Pullman, WA
PROJECT TITLE	
Space Optimization (Remote Collection Storage)

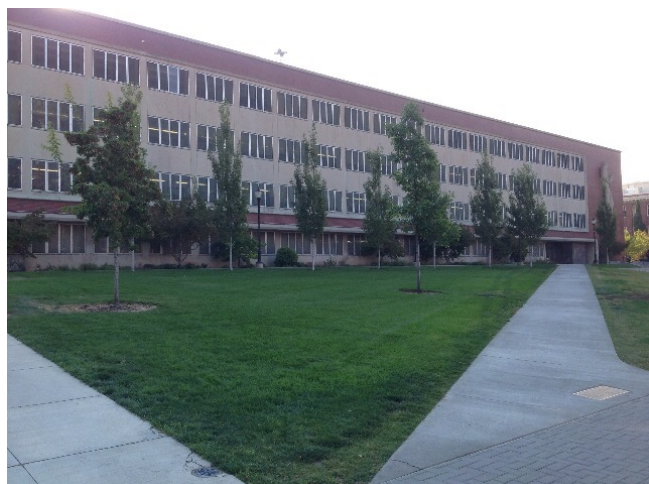
HOLLAND LIBRARY Auditor Touch Photo

Type	Building	Construction Type	IBC - Type II B
Area	203,475 SF	Historical Category	None
Use	LIBRARIES	City	PULLMAN
Floors	6	State/Province/Region	UNITED STATES OF AMERICA
Address 1	1400 TERRELL MALL	Zip/Postal Code	99164
Address 2	-	Architect	-
Year Constructed	1950	Commission Date	-
Year Renovated	-	Decommission Date	-
Ownership	Client Owned

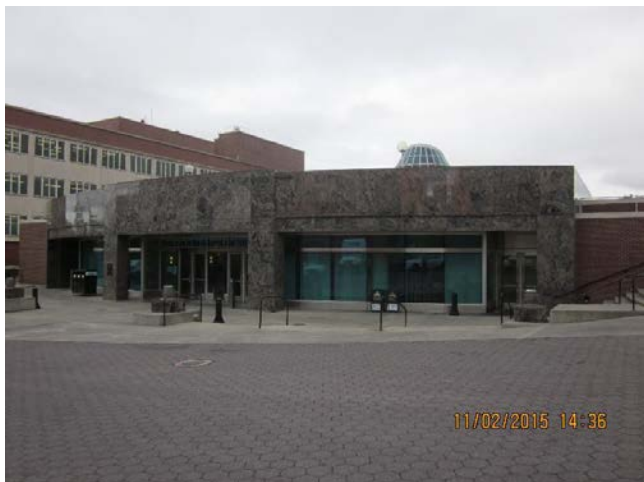
B2010 - Stone Veneer Walls - Marble

Type	Building	Construction Type	IBC - Type II B
Area	285,674 SF	Historical Category	None
Use	LIBRARIES	City	PULLMAN
Floors	5	State/Province/Region	UNITED STATES OF AMERICA
Address 1	1400 TERRELL MALL	Zip/Postal Code	99164
Address 2	-	Architect	-
Year Constructed	1993	Commission Date	-
Year Renovated	-	Decommission Date	-
Ownership	Client Owned

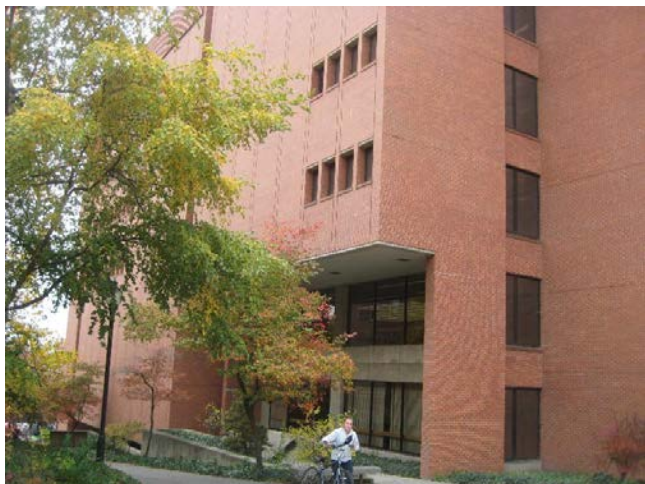
OWEN SCIENCE & ENGINEERING LIBRARY

Type	Building	Construction Type	IBC - Type II A
Area	123,231 SF	Historical Category	None
Use	LIBRARIES	City	PULLMAN
Floors	7	State/Province/Region	UNITED STATES OF AMERICA
Address 1	1255 COLLEGE AVE	Zip/Postal Code	99164
Address 2	-	Architect	-
Year Constructed	1976	Commission Date	-
Year Renovated	-	Decommission Date	-
Ownership	Client Owned

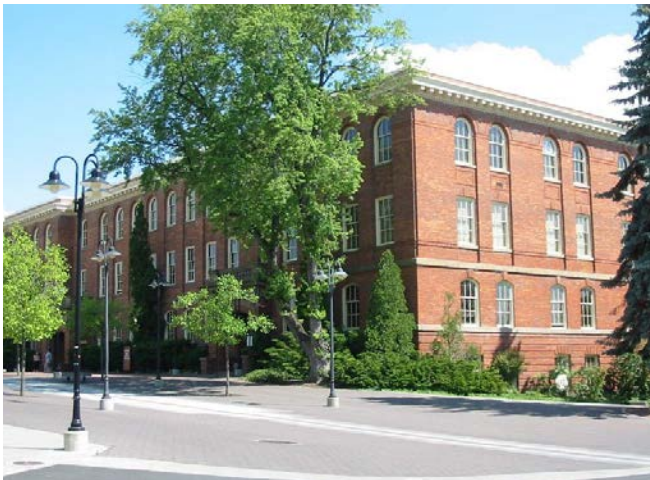
College Hall

Type	Building	Construction Type	
Area	52,409 SF	Historical Category	
Use	ACADEMIC INSTRUCTION	City	PULLMAN
Floors	4	State/Province/Region	UNITED STATES OF AMERICA
Address 1	1345 TERRELL MALL	Zip/Postal Code	99164
Address 2	-	Architect	-
Year Constructed	1909	Commission Date	-
Year Renovated	1983	Decommission Date	-
Ownership	Client Owned

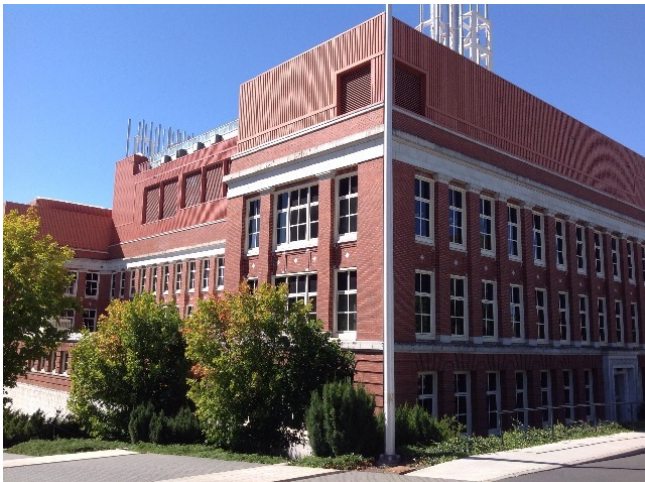
ABELSON HALL Auditor Touch Photo

Type	Building	Construction Type	
Area	101,546 SF	Historical Category	None
Use	ACADEMIC INSTRUCTION	City	PULLMAN
Floors	8	State/Province/Region	UNITED STATES OF AMERICA
Address 1	205 LIBRARY RD	Zip/Postal Code	99164
Address 2	-	Architect	-
Year Constructed	1935	Commission Date	-
Year Renovated	1990	Decommission Date	-
Ownership	Client Owned

level and the upper is steel, and the primary exterior material is brick. Windows are aluminum replacements, not original to the building.

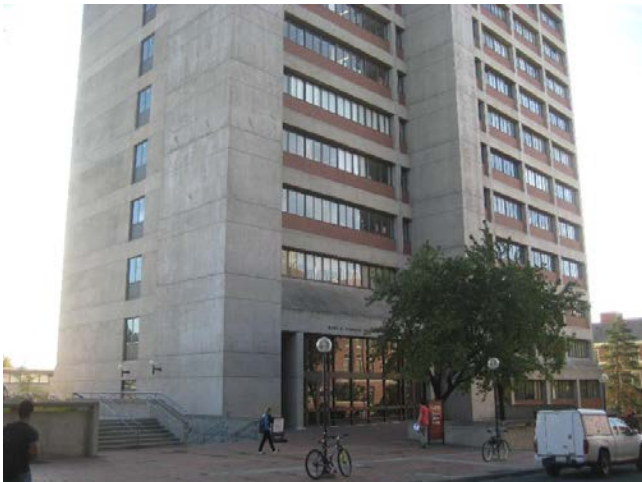
WEBSTER PHYSICAL SCIENCES BUILDING

Type	Building	Construction Type	IBC - Type II A
Area	168,989 SF	Historical Category	None
Use	ACADEMIC INSTRUCTION	City	PULLMAN
Floors	14	State/Province/Region	UNITED STATES OF AMERICA
Address 1	1405 COLLEGE AVE	Zip/Postal Code	99164
Address 2	-	Architect	-
Year Constructed	1974	Commission Date	-
Year Renovated	-	Decommission Date	-
Ownership	Client Owned

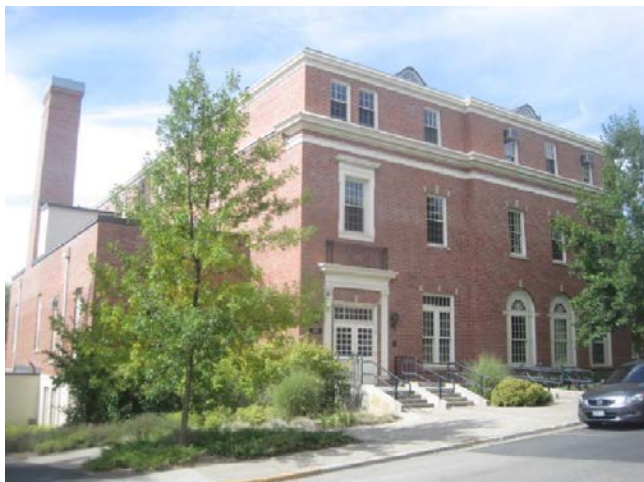
COMMONS

Type	Building	Construction Type	
Area	35,351 SF	Historical Category	None
Use	GEN ADMIN/LOGISTICAL	City	PULLMAN
Floors	4	State/Province/Region	UNITED STATES OF AMERICA
Address 1	225 IDAHO ST	Zip/Postal Code	99164
Address 2	-	Architect	-
Year Constructed	1924	Commission Date	-
Year Renovated	2004	Decommission Date	-
Ownership	Client Owned

primary exterior material is brick. Windows are wood replacements, not original to the building.
